AusNet

Sub-transmission Towers, Insulators and Ground Wires

AMS – Electricity Distribution Network

Document number: AMS 20-64

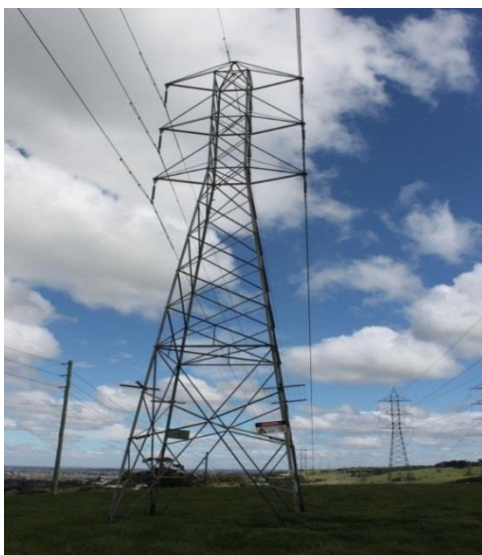
Figure 1: Typical 132kV tower.

Ancillary items such as anti-climbing devices (ACDs), fall arrest systems, ladders and signage Figure 1 shows Tower 297 on the Narre Warren to Pakenham line. This tower is a double circuit structure with single conductor per phase.

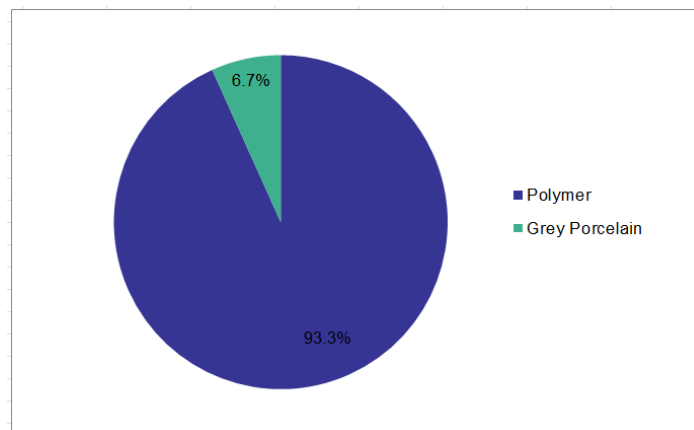
Figure 2: Insulators by type.

The AusNet's sub-transmission network supported by steel lattice towers has 2,445 composite insulator strings and 180 porcelain disc strings. Figure 2 below shows grey porcelain insulators account for 6.7% of the population and polymer type insulators account for 93.3% of the population.

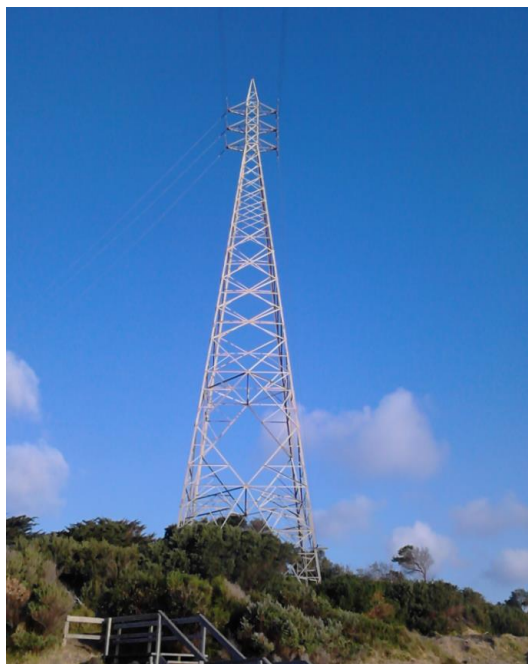
Figure 3: San Remo Tower

Exceptions to the benign environment are for the two tall towers used in a span at San Remo providing supply to Phillip Island.

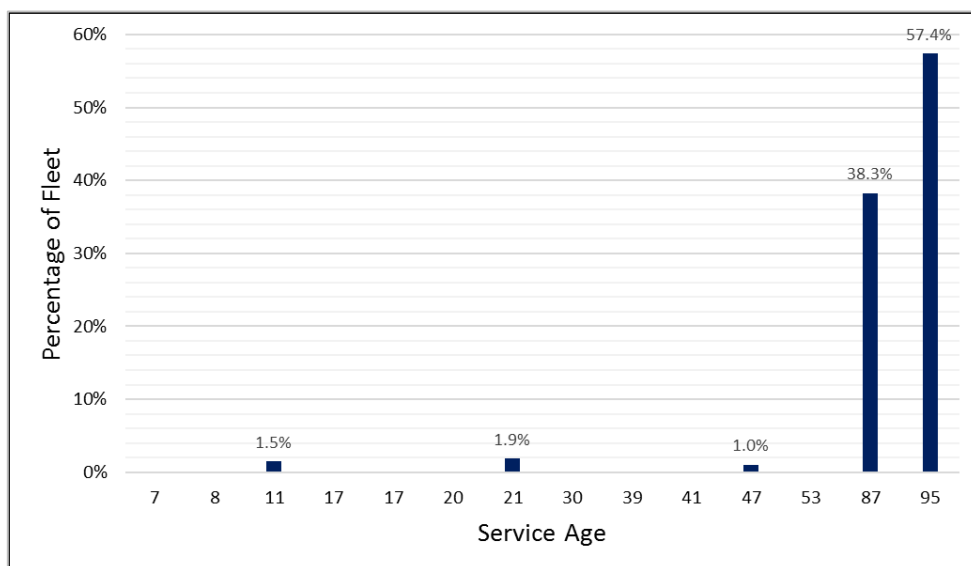
Figure 4: Service age of the steel lattice towers.

As can be seen in Figure 4, 57.4% of towers have an age of 95 years, 38.3% of towers have an age of 87 years, 1.0% of towers have a service age of 47 years, 1.9% are 21 years of age and 1.5% are 11 years of age.

The ground wires that were installed when the tower line was built are still in-service on the sub-transmission fleet and follow the age profile of the tower structures as shown in Figure 4, except sections that have been replaced on the YPS-WGL/Moe No 2 line.

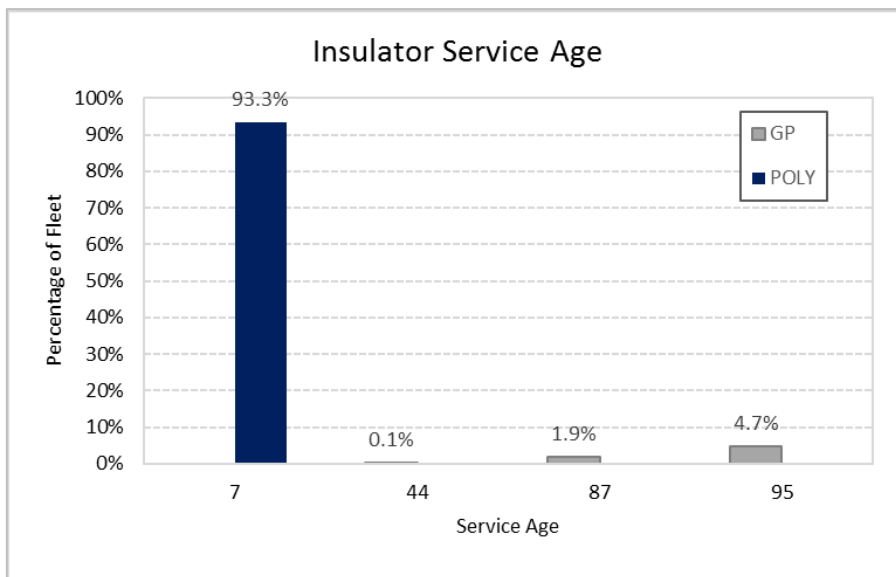
Figure 5: Service age of tower insulators

Figure 5 shows the age profile of AusNet's' sub-transmission insulators on steel lattice towers.

As depicted in Figure 5, 4.7% of the insulators population have a service age of 95 years, 1.9% has a service age of 87 years and 0.1% has a service age of 44 years. These strings are the original grey porcelain discs used on the towers when they were constructed.

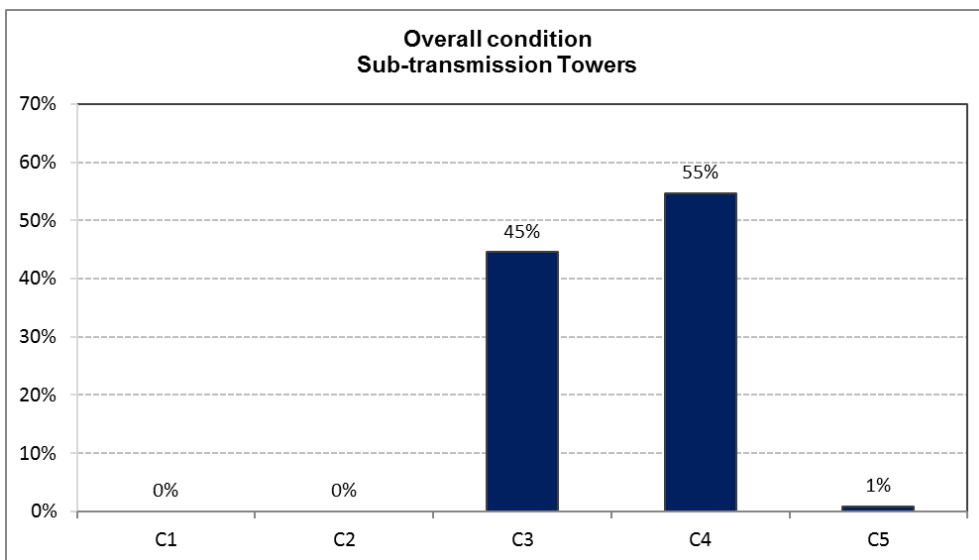
Figure 7: Condition scores of the sub-transmission towers population

At present, approximately 45% of the tower fleet are at C3 condition, 55% at C4, and only 1% at C5 as shown in Figure 7. The towers at C5 are still structurally adequate to support the gravity loads coming from the conductors as well as the wind acting on the conductors and itself. However, these structures will have to be monitored on a regular basis with some level of refurbishment or replacement required on certain components, i.e. bolts and members which have started to lose sectional area to assure its reliability and public safety.

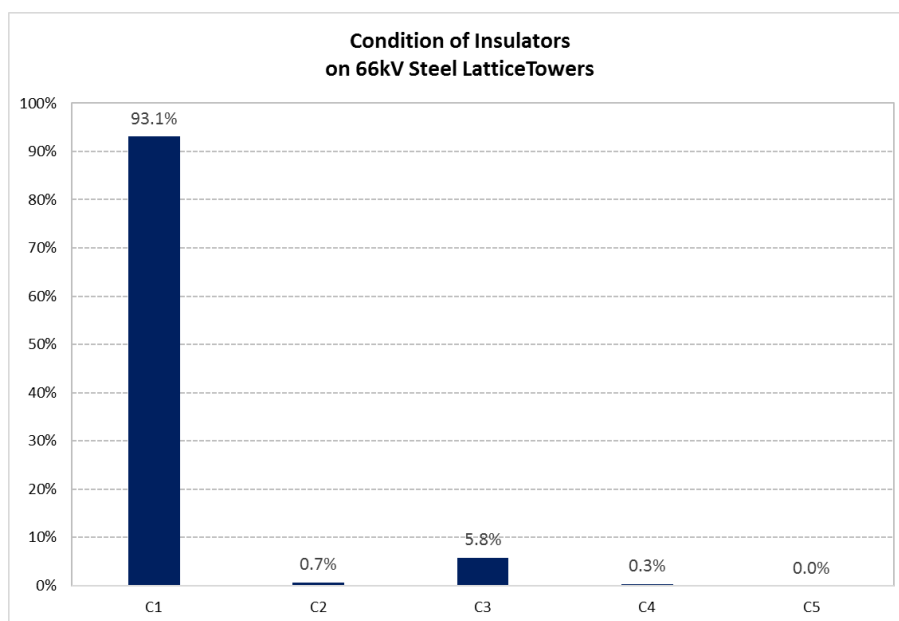
Figure 9: Insulator condition on 66kV lattice towers

As most of the insulators on the YPS to NRN³ 66kV line have been recently replaced, 93.1% of the fleet are in C1 condition, with 0.7% at C2, 5.8% at C3, and 0.3% at C4. The reliability and safety of the lines have improved with the added benefit of cost savings. This is due to less maintenance due to the self-cleaning properties of the polymeric insulators, which do not require regular washing.

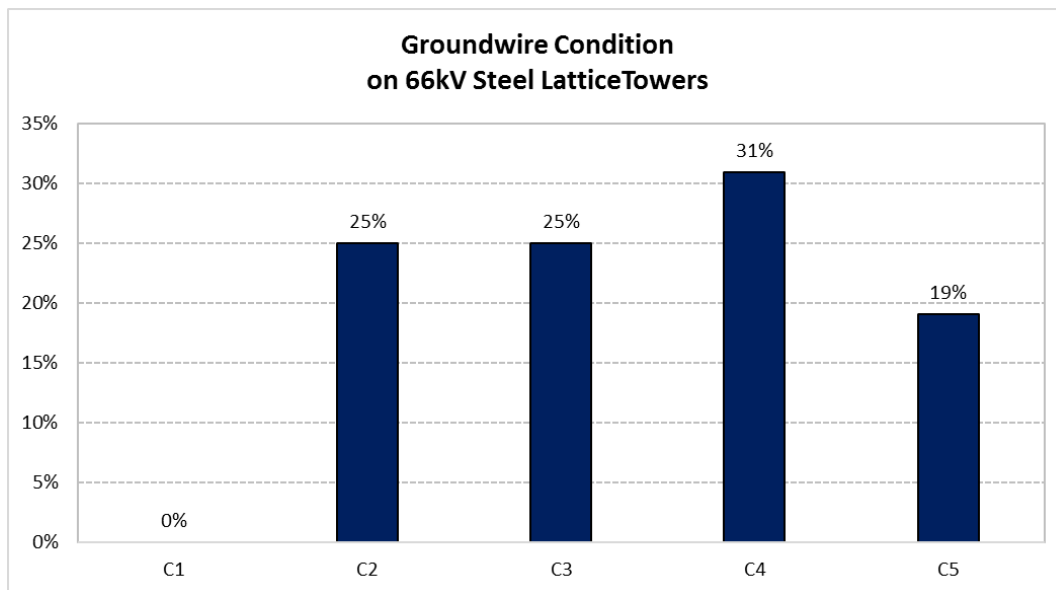
Figure 10: Steel ground wire condition

The steel ground wires along the line has seen an average service life of more than eighty years. As such, 25% are in C2 condition, 25% in C3, 31% in C4 and 19% of the fleet have become C5, which is the worst condition.

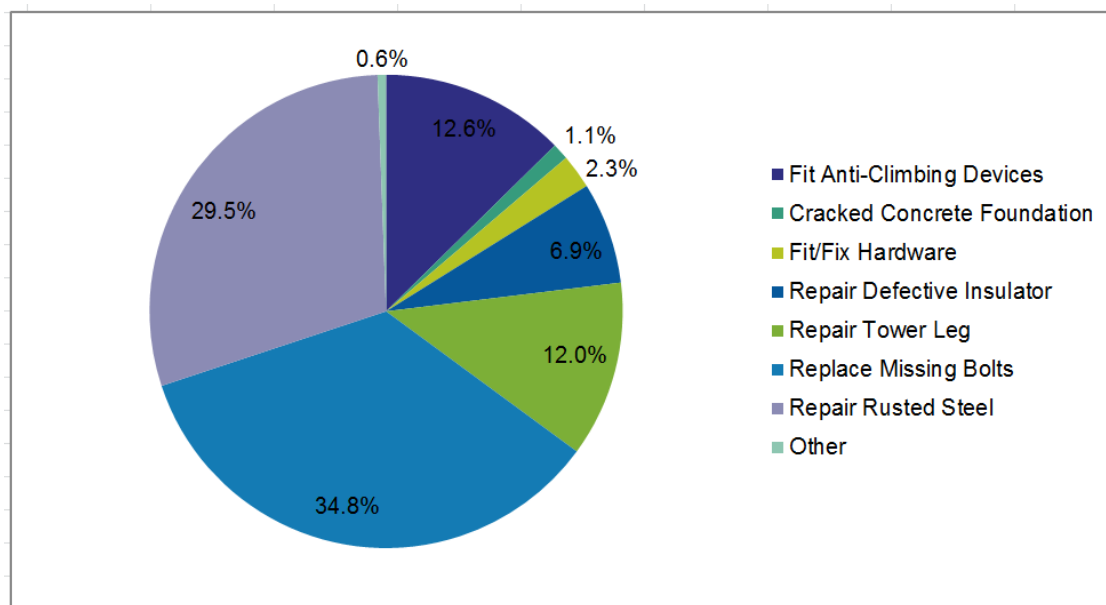
Figure 11: Work orders by percentage of total.

The following ZA (Condition-Based Maintenance) and Work Order analysis takes into account all work created from 2011 to 2019. It excludes any work orders related to conductors and focuses on sub-transmission towers and insulators only. A total 3,111 NOTIs and work orders were analysed, the breakup of the work orders shown in Figure 11.

Figure 11 shows that the majority of the ZA Notifications over the last nine years have been based around replacing missing bolts, repairing rusted steel, fitting anti-climbing devices and repairing tower legs. The 'Other' description includes painting tower legs as part of the ground level corrosion protection system program, repairing damaged steel, repairing hot spots, washing insulators and installing/replacing sub transmission cross arms.
