Bushfire Mitigation Plan

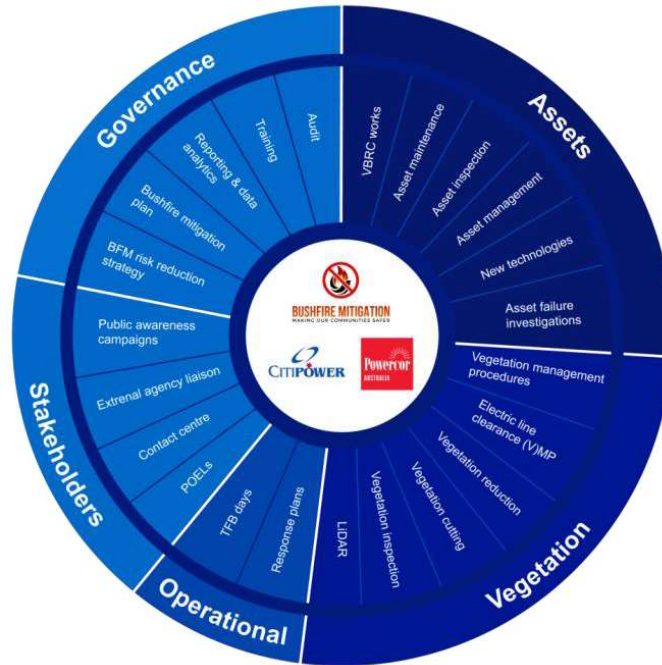
Figure 2: Bushfire Mitigation Framework

CitiPower's bushfire mitigation framework is shown in Figure 2 and demonstrates a comprehensive and whole of business approach. The proactive planning and scheduling of this program is based principally on a whole of asset life approach that includes design, construction, operation, maintenance and decommissioning. The annual governance systems of vegetation and asset inspection and maintenance activities are supported by a regime of reporting and auditing.

The response aspects of the plan include our operational processes to faults and Total Fire Ban (TFB) days, asset failure investigations, and fire start reporting.

The framework also has a significant aspect of proactive stakeholder management, including Private Electric Line (PEL) owners, Councils (vegetation management), other agencies, specific community messaging and our ongoing interface with customers.

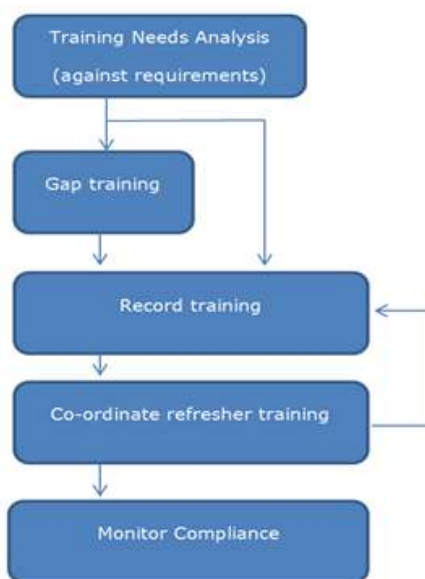
Figure 4: Competency and training process

The key steps that CitiPower has in place to manage competency and training requirements are illustrated in Figure 4.

CitiPower has an established and documented system to ensure that employees and contractors who are working on or near the electricity network are suitably competent and adequately trained to carry out their duties.
