# ASSET CLASS OVERVIEW

## ZONE SUBSTATION SWITCHGEAR

CP BUS 4.09 – PUBLIC  
2026–31 REGULATORY PROPOSAL

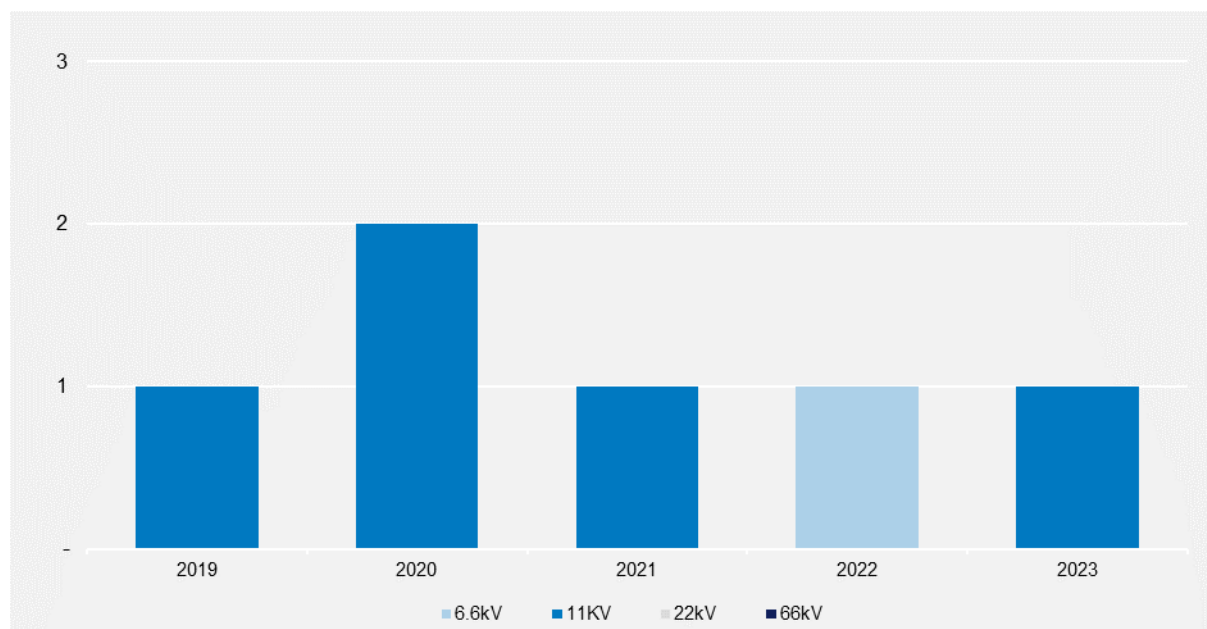
**FIGURE 2** ZONE SUBSTATION CIRCUIT BREAKER FAILURES

Zone substation switchgear are traditionally very reliable as evidenced by the low annual number of failures. However, we have experienced circuit breaker failures annually since 2019 as shown below in figure 2.

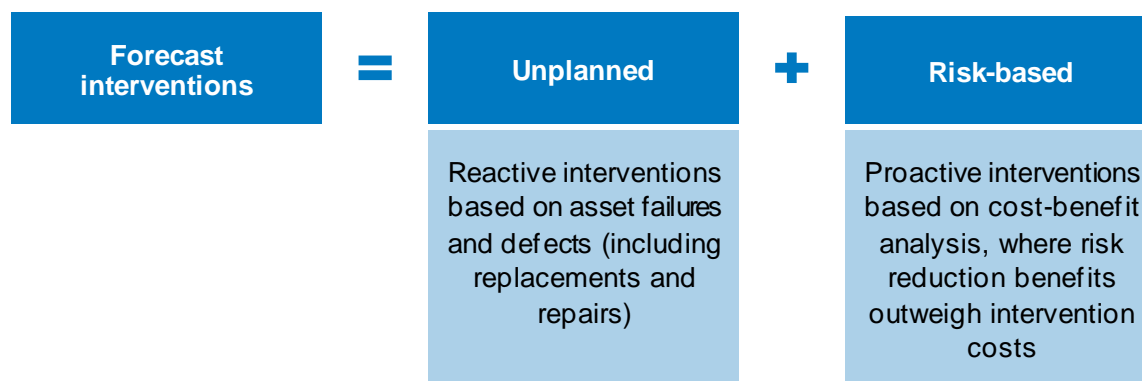
**FIGURE 4 FORECAST CATEGORIES**

We constantly revise our plans based on the latest information regarding cost, reliability and risk of these assets to ensure that we are meeting our obligations. As these inputs and understandings change, our forecast will fluctuate accordingly. Our forecast is based on the two categories, as shown in figure 4.

- unplanned interventions are responses to asset failures and defects, which include replacements and repairs. These repairs are considered capital expenditure as they extend the life of the asset
- risk-based interventions are determined by a cost benefit analysis, where risk reduction benefits outweigh the intervention costs.

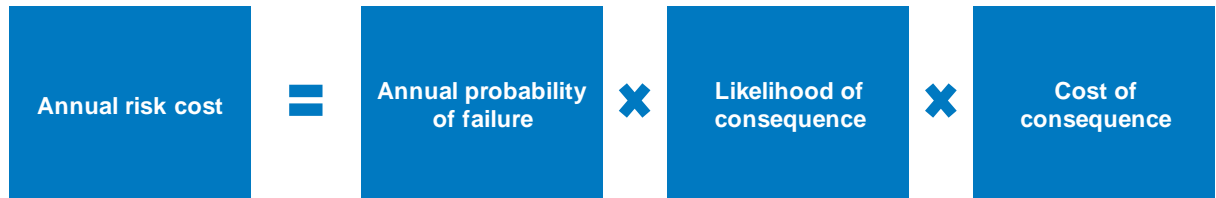
**FIGURE 5 RISK MONETISATION APPROACH**

Our risk assessment is underpinned by a risk monetisation approach summarised in figure 5. This approach ensures we invest only when the cost of replacing existing infrastructure exceeds the total value of the underlying risks.

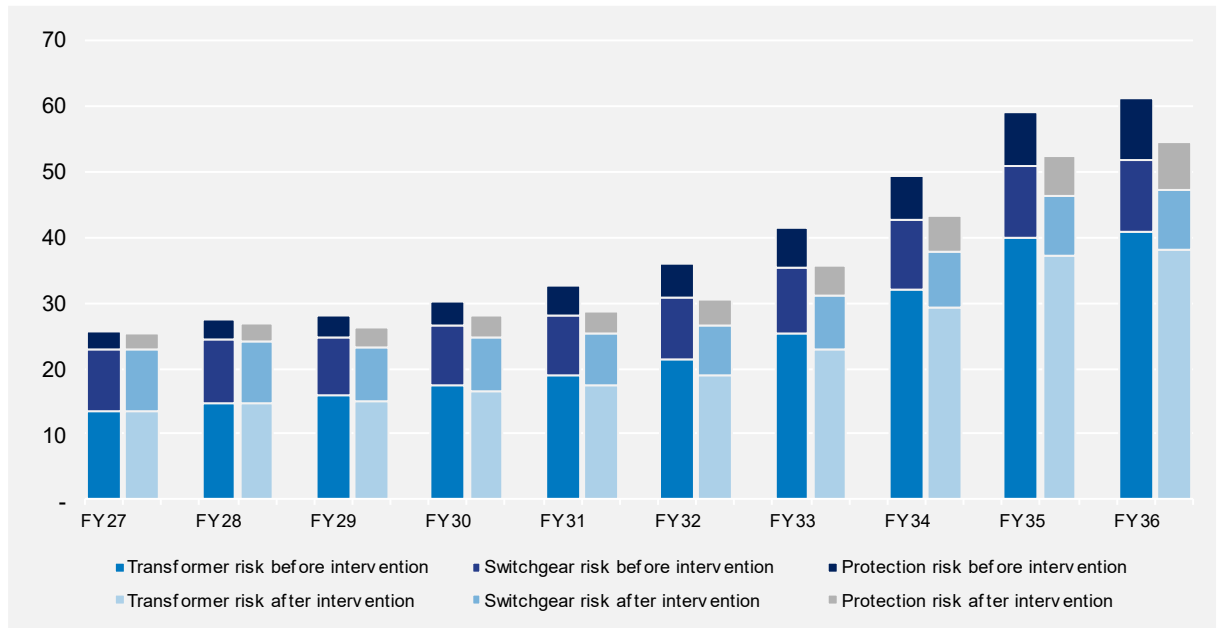
**FIGURE 8 ZONE SUBSTATION RISK: COMBINED STATION ASSETS (\$M, 2026)**

However, as shown in figure 8, total zone substation level risks will still increase between FY27 and FY31, even after our proposed interventions (i.e. our combined zone substation works program will still not maintain overall zone substation reliability). Collectively, we consider our switchboard replacements are a key component of our long-term management plans for our zone substations, and are prudent to deliver in the 2026–31 regulatory period.
