# Plan

## Bushfire Mitigation

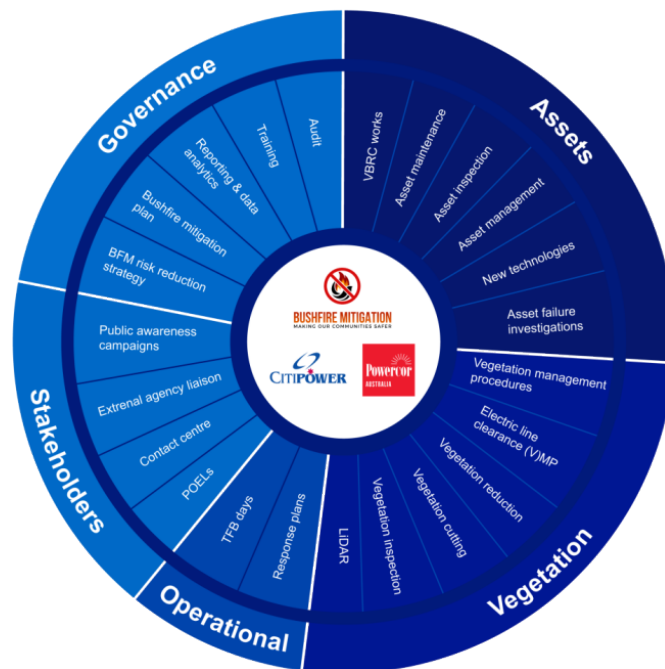
Figure 2: Bushfire Mitigation Framework

Powercor's bushfire mitigation framework is shown in Figure 2 and demonstrates a comprehensive and whole of business approach to what is the biggest risk in the business. The proactive planning and scheduling of this program is based principally on a whole of asset life approach that includes design, construction, operation, maintenance and decommissioning. The annual governance systems of vegetation and asset inspection and maintenance activities are supported by a regime of reporting and auditing.

The response aspects of the plan include our operational processes to faults and Total Fire Ban (TFB) days, asset failure investigations, and fire start reporting.

The framework also has a significant aspect of proactive stakeholder management, including Private Overhead Electric Line (POEL) owners, Councils (vegetation management), other agencies, specific community messaging and our ongoing customer interfacing.

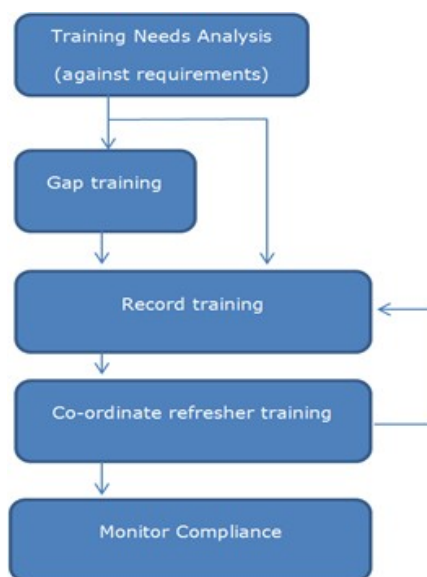
Figure 7: Competency and training process

The key steps that Powercor has in place to manage competency and training requirements are illustrated in Figure 7.
