# ASSET CLASS OVERVIEW

## POLE TOP STRUCTURES

PAL BUS 4.02 – PUBLIC  
2026–31 REGULATORY PROPOSAL

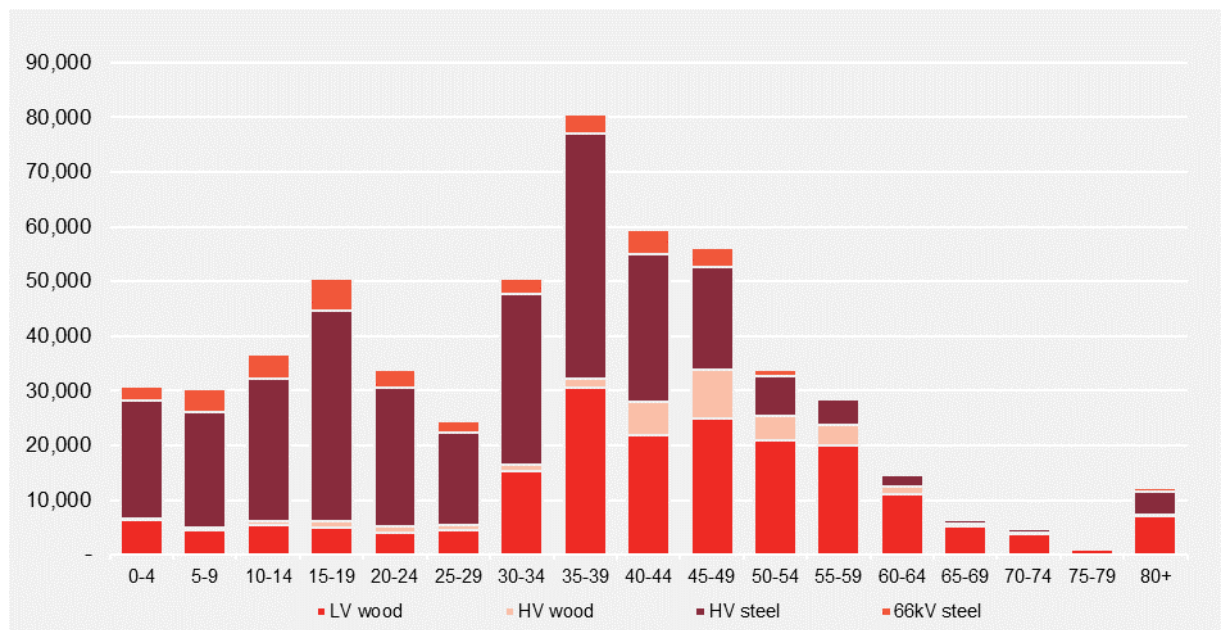
**FIGURE 1 NUMBER OF CROSS-ARMS BY MATERIAL AND AGE (YEARS)**

The corresponding age profile of our cross-arm asset population is shown in figure 1.

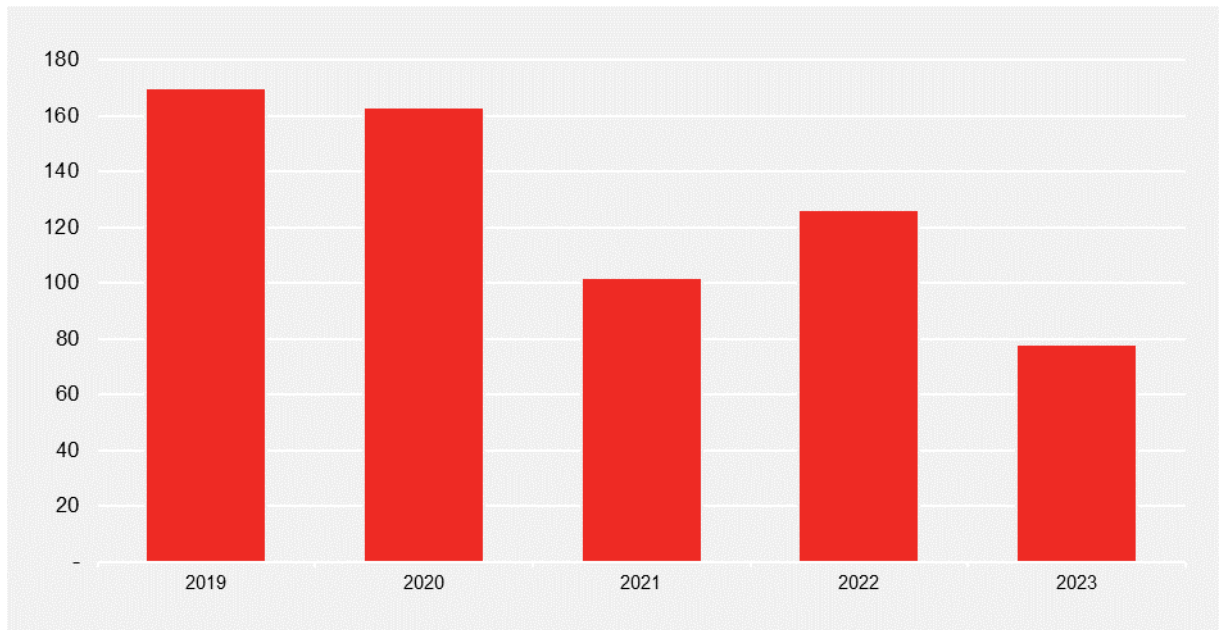
**FIGURE 2 CROSS-ARM FAILURES**

Our cross-arm failures since 2019 are shown in figure 2.

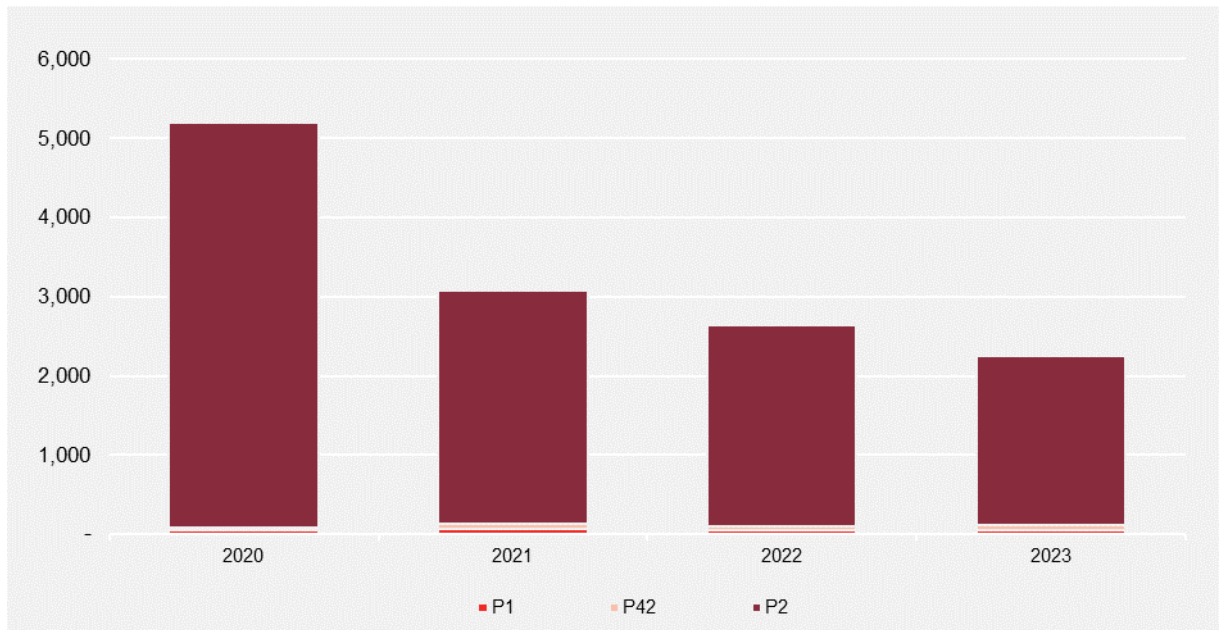
**FIGURE 3 HV CROSS-ARM DEFECTS**

To reflect the impact of this change in our inspection practice, figure 3 and figure 4 below show HV and LV cross-arm defects from 2020 onwards. The majority of these are P2 defects.
