STRATEGY

ELECTRICITY PRIMARY PLANT ASSET CLASS STRATEGY

ELE-999-PA-IN-008

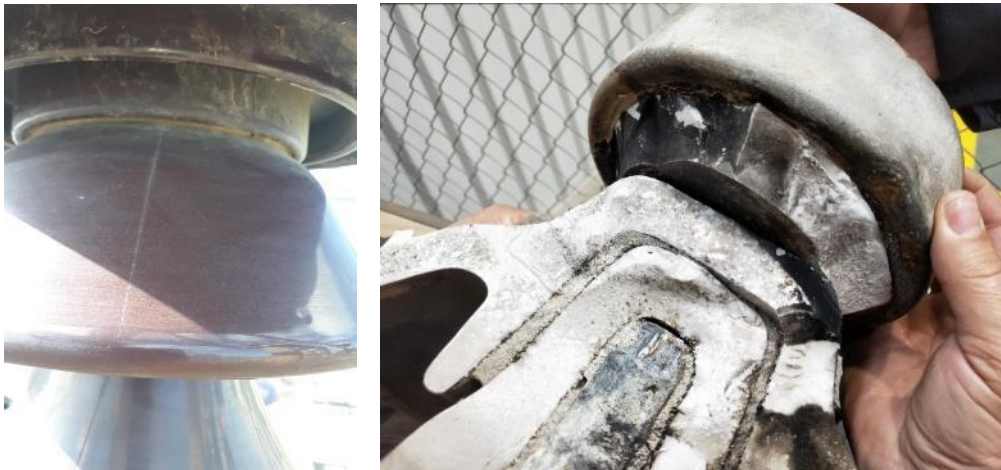
- On 1st February 2020, the No.1 66kV bus, TTS Feeder and No.1 transformer tripped on X and Y protection. Upon inspection the 1-3 66kV bus tie CB No.1 bus side white phase isolator failed. The white phase insulator at the pivot end of the underslung isolator was found shattered, and the isolator blade which forms part of the insulator remained attached to the CB dropper just above ground level. Refer to cracked insulator shed and damaged porcelain insulator due to fault current, below. An incident investigation report was prepared.

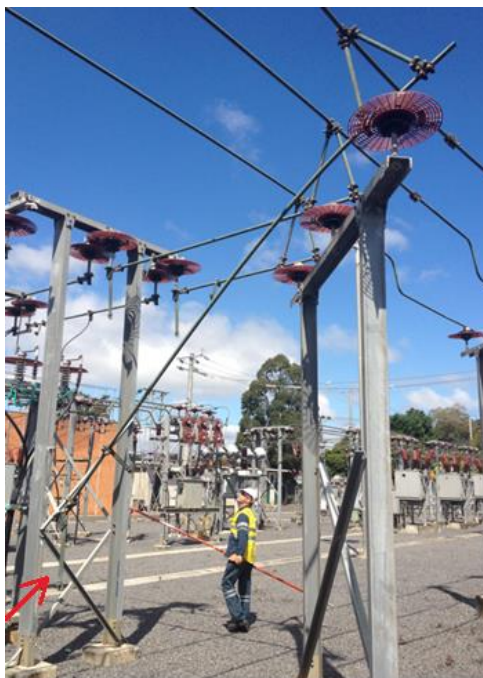
Figure 4–17: Failed Pin and Cap Insulator

- In 2011 a pin and cap insulator failed in a Victorian electricity network. The failure caused the insulator to separate from its support structure, resulting in the transfer bus isolator together with the pin of the insulator and the tubular bus to be left unsupported. As a result, the tubular bus has bent due to cantilever forces, leaving the pin, isolator and tube hovering approximately 1 metre from the ground. It remained live and was discovered by personnel carrying out ground maintenance. The hovering insulator is identified by the red arrow in Figure 4–17.

Porcelain has very high compressive strength (80,000 psi), sixteen times greater than its tensile strength (5,000psi). Pin and cap insulators have a generic design deficiencies when subjected to tensile forces which can lead to the porcelain cracking and eventual failure of the cement joint due to moisture ingress and increased pressure due to corrosion and thermal expansion.

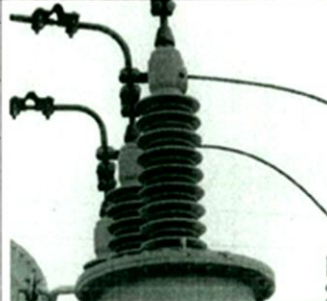
OIP Bushings (ABB GOB/GSA, after 1982)

Measured Result	Means...

Result > 0.7 %

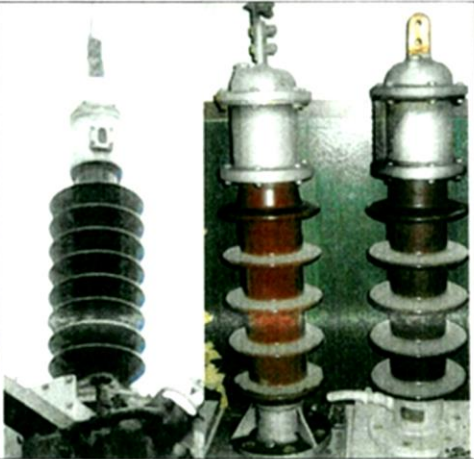
RBP Bushings (all older types pre-1982, EE, MIC, etc)

Measured Result	Means...

C1 Result > 1.5 %

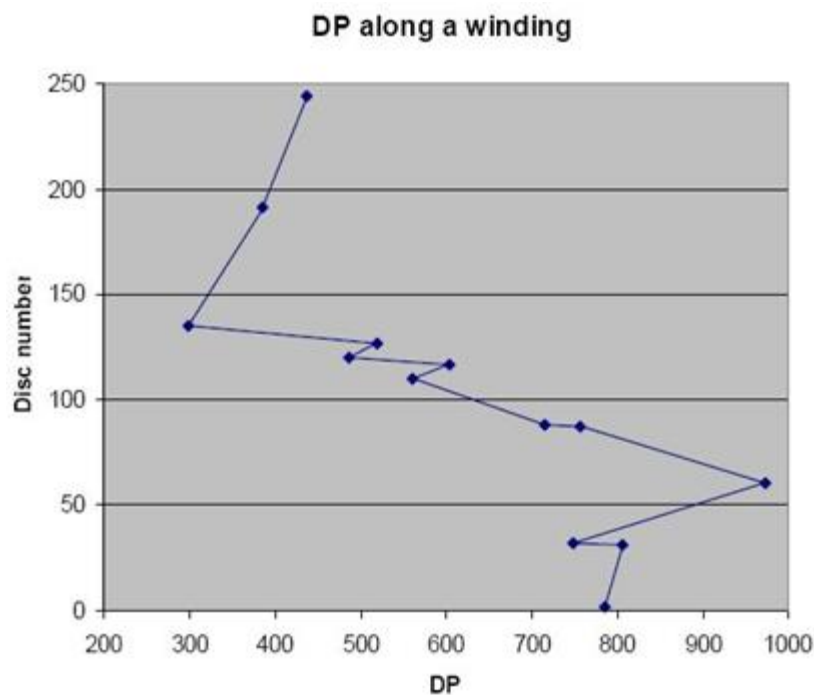
Figure 7–2: Degree of Polymerisation throughout a transformer winding

Figure 7–2 shows the results from paper sample Degree of Polymerisation (DP) measurements taken from different positions along the height of the winding of a dismantled transformer.

- The hottest part of the transformer—the middle of the winding—exhibits the lowest DP value.
- The insulation at the base of the transformer remains cool for most of its life and typically suffers little degradation.
