**MANAGEMENT PLAN 2011**

**OVERHEAD SYSTEM AND  
STRUCTURES**

DOCUMENT NUMBER: NW-#30161322-V5

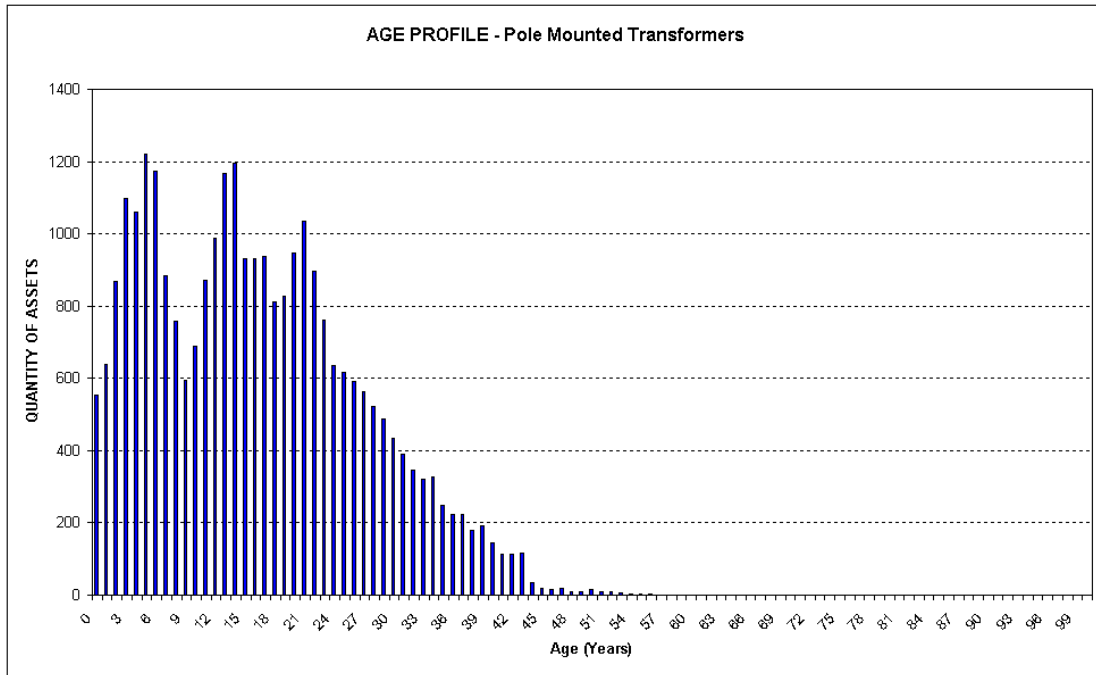
Figure 1 shows the age profile of the pole mounted transformers installed in the system.

Figure 1: Age profile pole mounted transformers

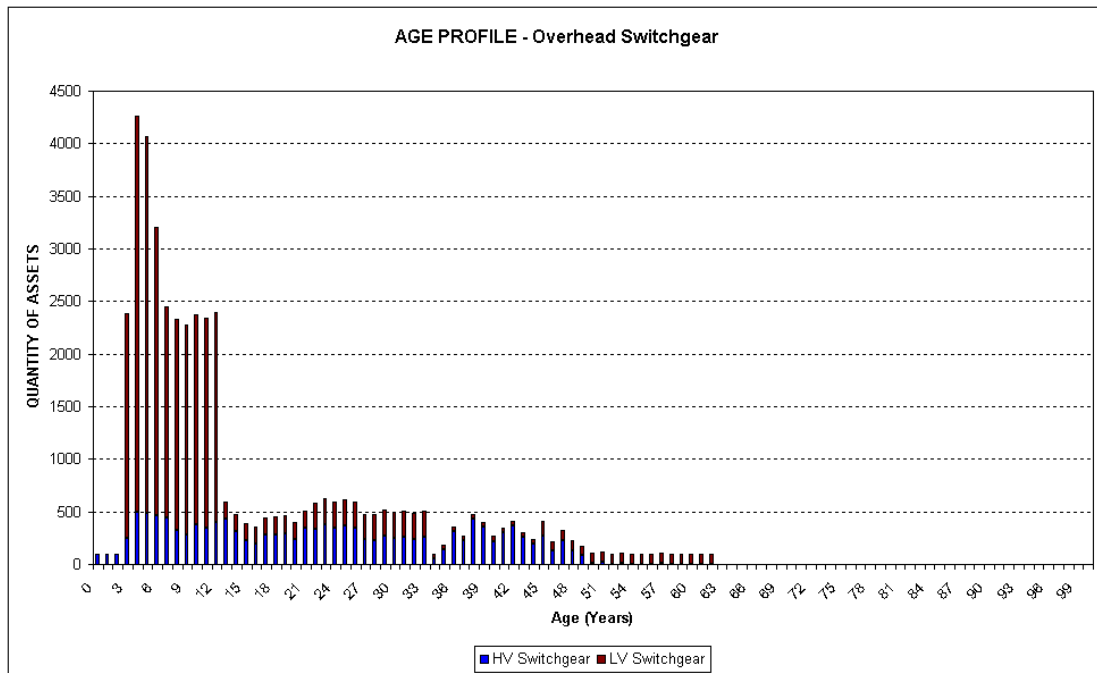
Figure 2 shows the age profile of the overhead switchgear installed in the system.

**Figure 2: Age profile overhead switchgear**

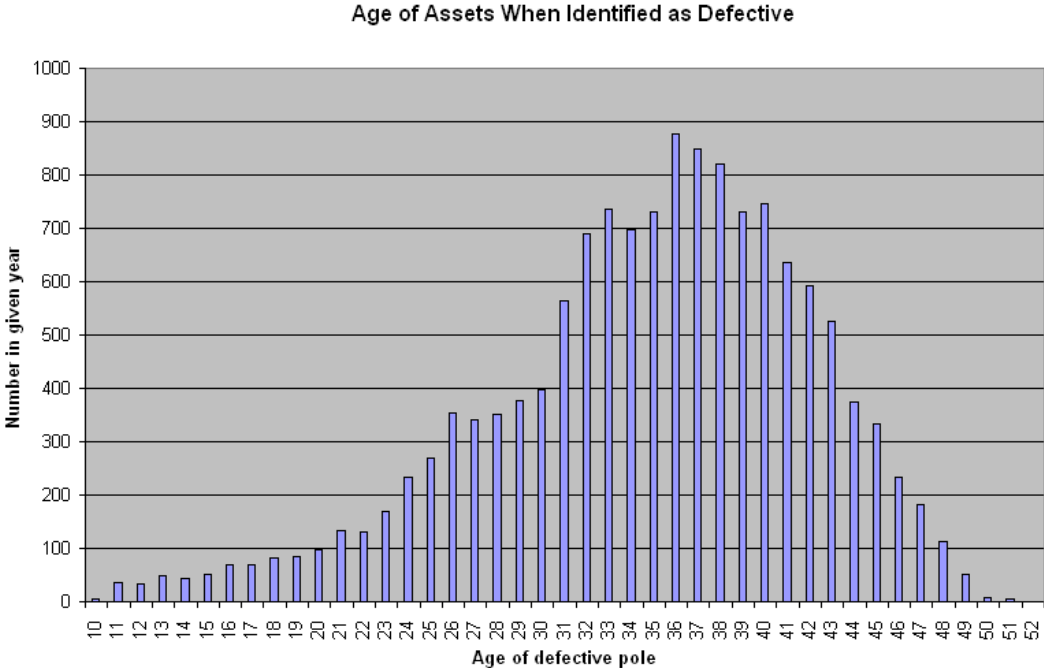
## A.1 Age of Condemned/Failed Poles (from 2000 to 2010)
