MANAGEMENT PLAN 2011

PUBLIC LIGHTING

DOCUMENT NUMBER: NW#-30148124-V5

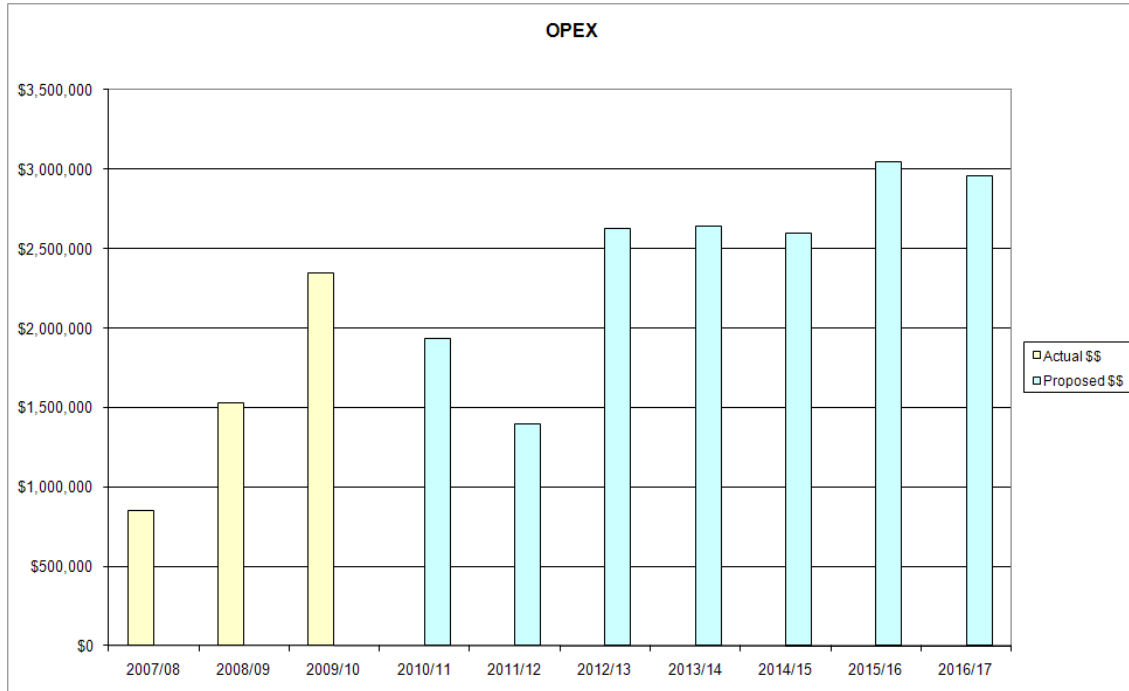
Figure 1: Public Lighting OPEX (Actual and Proposed)

The OPEX reductions in 2010/2011 and 2011/2012 as shown above have been adjusted to meet the OPEX cap as set by the Aurora Network management team. Reductions in the amount of discretionary spending in work programs such as the Bulk Lamp Replacement program (RLBLR) have been made to achieve the reduction.

The increase in expenditure in 2012/2013 is attributed to returning expenditure the required levels to keep the bulk lamp replacement volumes to the requirements that maintain a four-year replacement cycle.

The forecast increase in expenditure in 2016/2017 is attributed to the start of the third four-year cycle of the Bulk Lamp Replacement program. In this year it is forecast that all the 80-watt Sylvania B2224 fittings will have been replaced in the prior four-year maintenance cycle and there will be an increased number of luminaires requiring maintenance not replacement in this year.

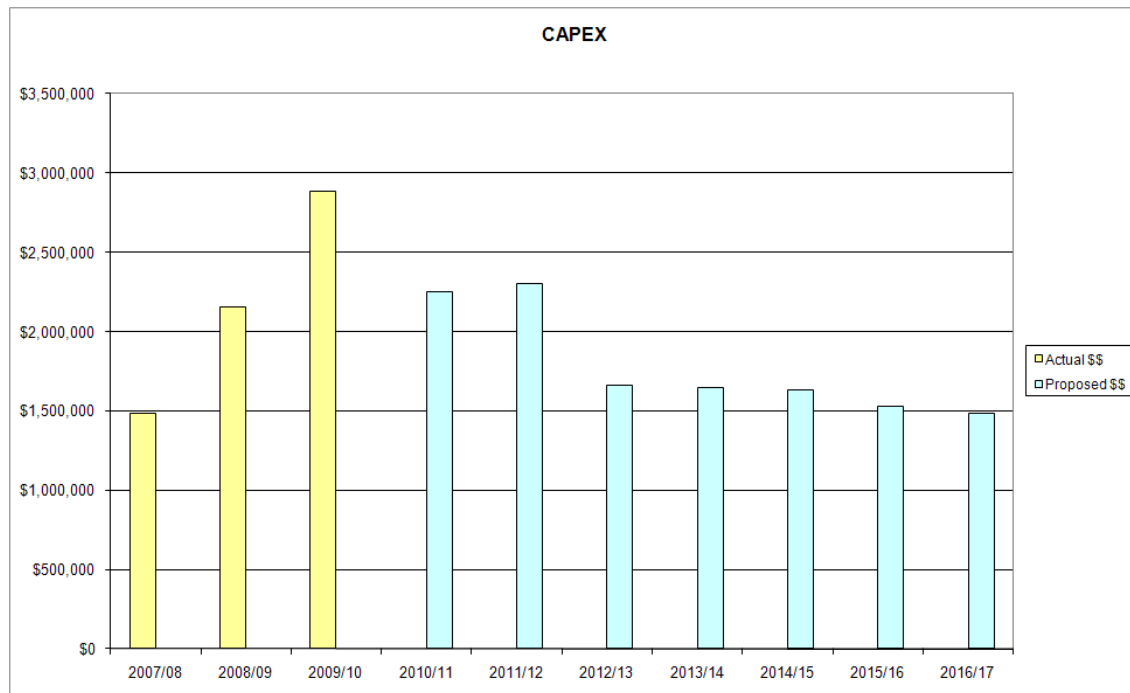
Figure 2: Public Lighting CAPEX (Actual and Proposed)

The reductions in capital expenditure are attributed to two factors:
