Regulatory Submission Support - Phase 3

ACTEWAGL

CAPEX/OPEX Trade-off Issues

QH10545RP0004 | B

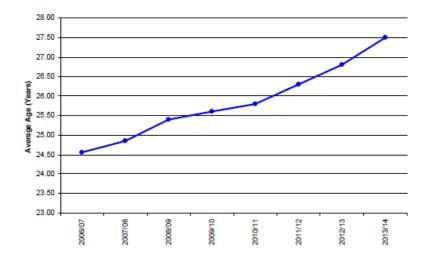
Figure 1-1 – Forecast weighted average of network

In 2008 ActewAGL/SKM forecast that the weighted average age of the network would increase from 24.88 years in 2007/08 to approximately 26.8 years in 2012/13, as shown in the following graph:

This was based on the assumption that the requested level of replacement/refurbishment CAPEX in the ActewAGL regulatory proposal would be approved, and expended. It should be noted that the average ages and lives shown above are not numerical averages, but are weighted by the replacement cost (RC) value of each asset category.

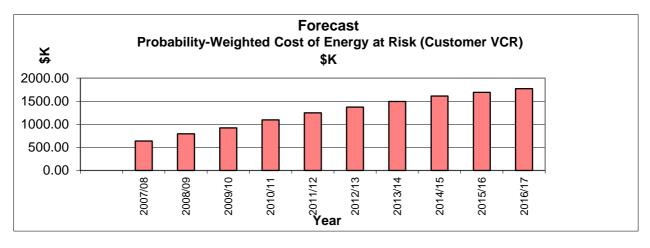
The probability weighted cost of energy at risk is shown in Figure 2-1 below, and this combined with the NPV analysis of the capital and operating costs of the four options clearly indicated the economic justification for replacement of the ageing Civic switchboard in the 2009-14 regulatory period (options 2 and 4).

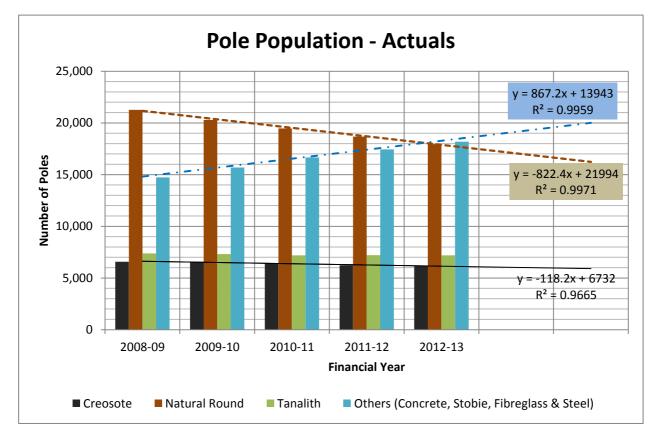
Figure 3-1 – Pole population actuals

ActewAGL have an aged population of timber poles as evidenced in Table 3-1 and Figure 3-1 below.

As the average service life for a timber pole is 45 years, ActewAGL is facing a bow wave of poles reaching the end of their serviceable life.

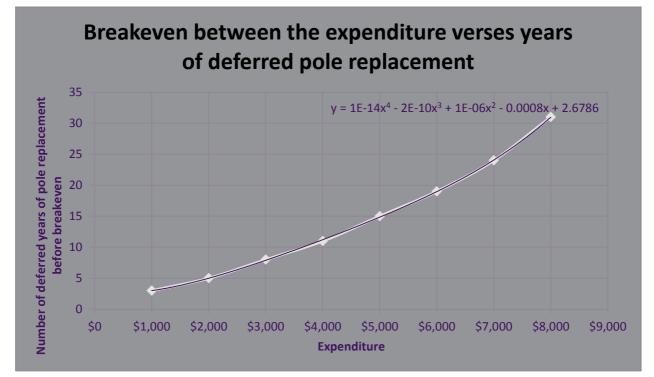
This breakeven analysis is based on:

- Pole replacement is inevitable
- Pole replacement cost of \$12,600
- Wood pole inspection every three years at \$236
- 7.7% discounted rate and 3% inflation

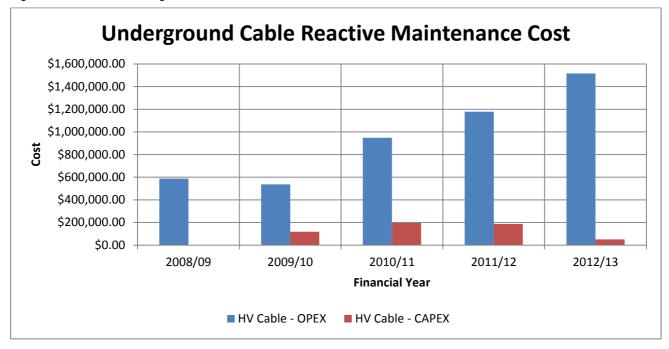
Figure 4-1 - Historical underground cable maintenance cost

It has been ActewAGL's practice in the past, to run the underground cables to failure. Cable repairs have generally been limited to the removal of faulted sections. Over the previous 5 years, reactive repairs and replacements have been increasing, see Figure 4-1.

Most repair work has been on the cable joint or termination, and an increasing number of underground cables are reaching the end of their life. This was especially observed in Griffith and Kingston where the steel armour tape and the lead metallic sheath of the cable showed signs of corrosion during cable repairs. These cables were installed in 1943.

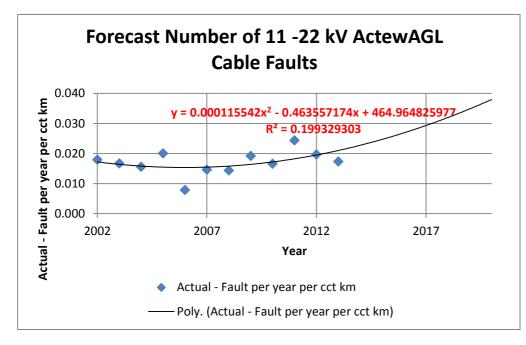
It can be seen that the HV cable fault rate is trending upwards. By 2020, we may expect up to 64 high voltage cable faults in that year (Figure 4-2). If this remains as the status quo, there is a risk of expenditure on possible cable repairs of up to \$7.1 million in 2020, see Figure 4-3, with essentially no reduction in the future risk of cable failure.
