Asset Specific Plan

Poles

Generated Date: 2014-05-28

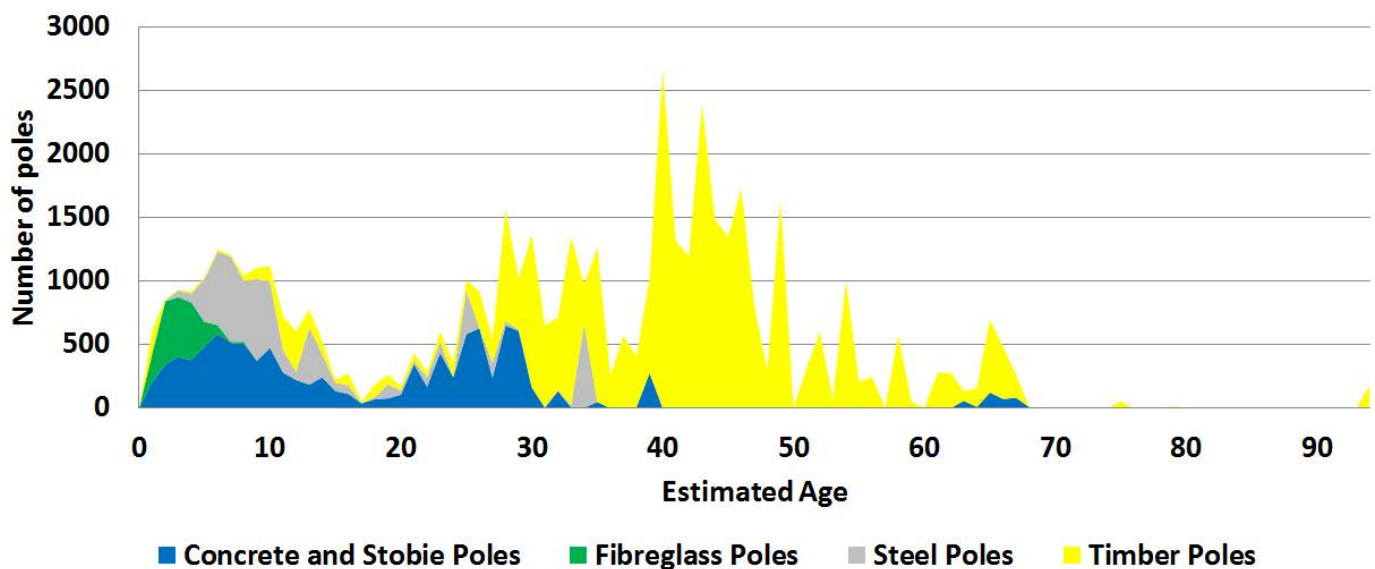
Pole Population Age Profile

Note: Poles with unknown estimated age is not plotted on this chart

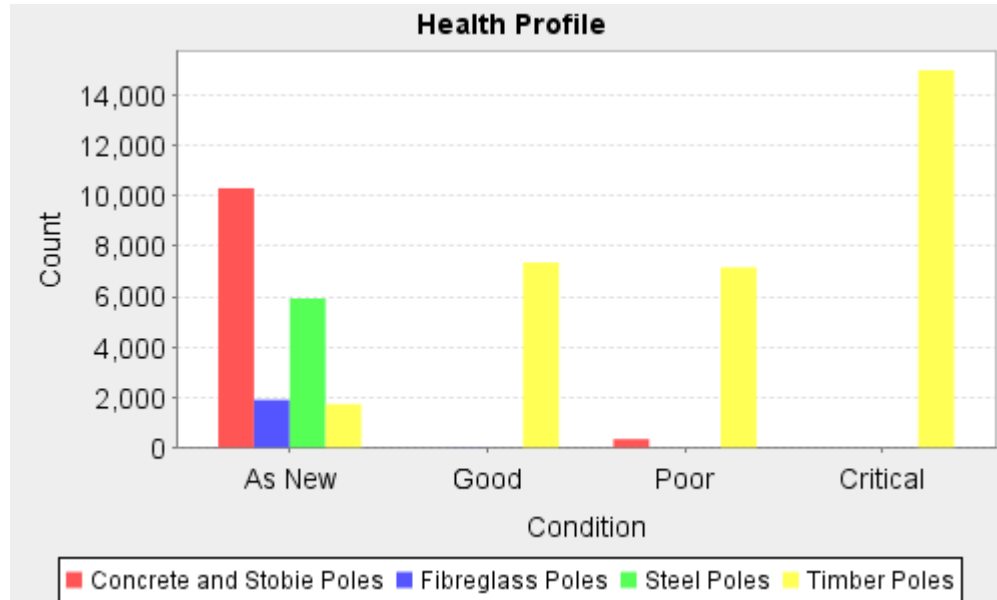
Health profile is determined by combining the asset condition rating with its criticality rating. Condition is determined by the asset's capacity to meet requirements, the asset reliability and its level of obsolescence. Obsolescence will be determined by maintenance requirements and availability of support from manufacturers. Criticality is determined from operational, safety and environmental consequences due to asset failure.

*Health Score: As New(100-95), Good(95-75), Poor(75-50), Critical(50-0)

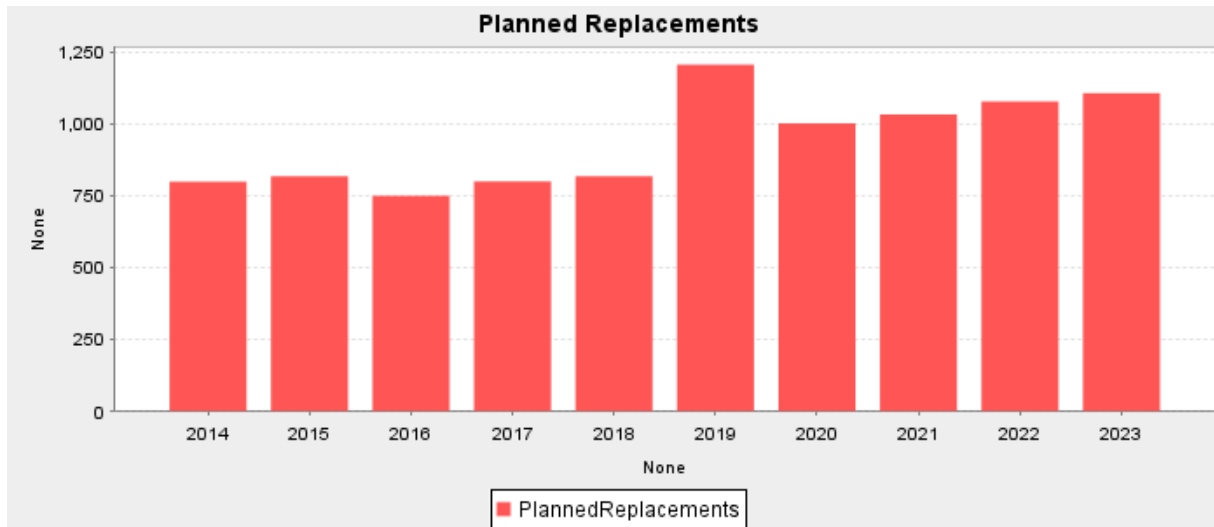
This is a summary of the units being replaced or refurbished each year. In general, assets with the lowest health will be scheduled for earliest replacements.
