AusNet Electricity Services Pty Ltd

Electricity Distribution Price Review 2016–20

Appendix 7B: Enhanced Network Safety (Public Version)

Enhanced Network Safety Strategy **(PUBLIC)**

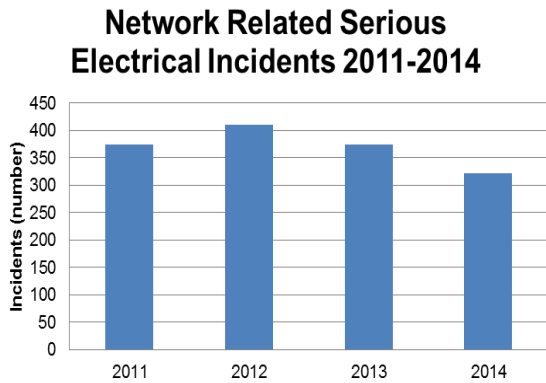
Figure 1 – Number of network related serious electrical incidents, inclusive of electrical shocks and fires 2011-2014

management strategies designed to manage risk SFAIP. The number of network related serious electrical incidents and shocks are shown in Figure 1 and Figure 2 respectively.

Serious electrical incidents are categorised in accordance with established criteria and reported to Energy Safe Victoria (ESV) and currently AusNet Services’ reports approximately 371 incidents per annum. Of this total, approximately 265 per annum can be attributed to network related incidents. Service cable failures are the primary cause for electric shock incidents reported to ESV and are discussed in more detail in section 4.1 ‘Service Cables’.

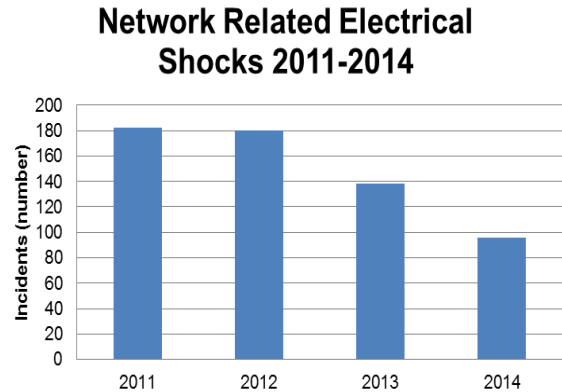
Figure 2 – Number of network related electrical shocks, 2011-2014

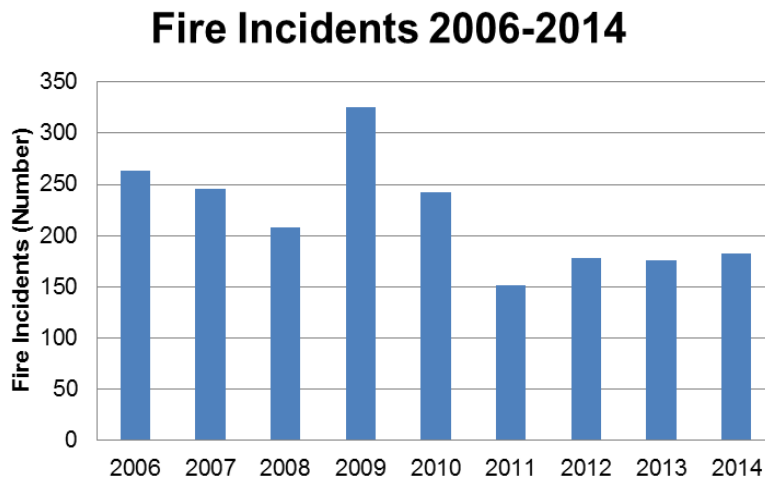
Figure 3 – Number of fire incidents 2006-2014

AusNet Services’ goal to reduce the number of network related incidents has a focus on reducing the number of asset and ground fires. Fires can occur on the assets themselves (such as a timber pole fire) or can be ignited on the ground adjacent to the network. Both asset and ground fires are monitored by the Network Safety Management Committee. The number of fire incidents is shown in Figure 3.

Despite an abnormal spike in 2009, the total number of fire incidents declined after 2010 and has remained relatively constant since then. The causes of asset and ground fires are in Figure 4.

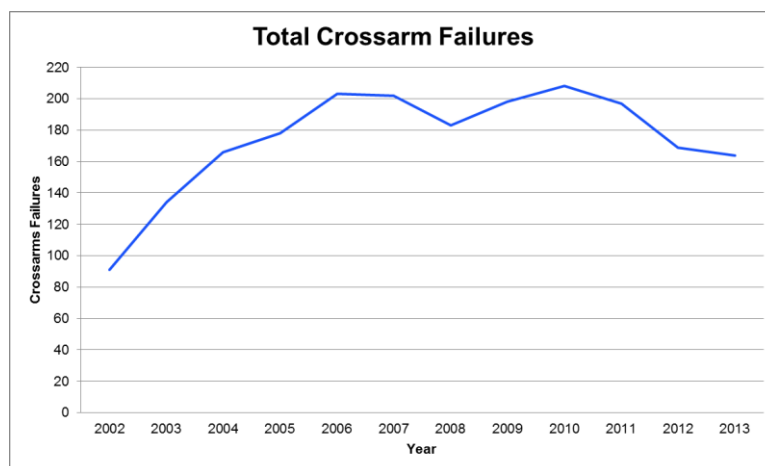
Figure 8 – Cross-arm Failures 2002 to 2013

The *Asset Management Strategy (AMS) – Cross-arm*⁶ indicates timber type as requiring targeted asset replacement strategies to counter an increasing failure rate which coincides with an increasing mean service age profile. Cross-arm failure can result in live conductors being dislodged and breaching regulatory safety clearances and/or serious incidents such as high voltage injections into customer installations that have resulted in fire. With the failure rate in excess of 160 per annum as shown in Figure 8, this type of asset failure represents a material network safety risk impacting the public, customers and employees.

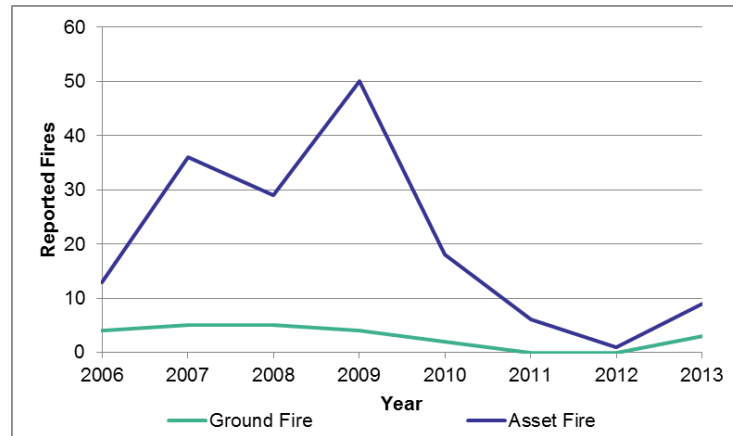
Figure 9 – Fire Starts Attributed to Cross-arm Failures

A cross-arm failure can cause a fire ignition to occur. In 2011, “F-Factor” was introduced as a scheme to incentivise Distribution Businesses to reduce the number of asset failures causing fire ignitions. AusNet Services has successfully implemented programs targeting at reducing fire ignitions, the resulting decline in asset fires is shown in Figure 9.

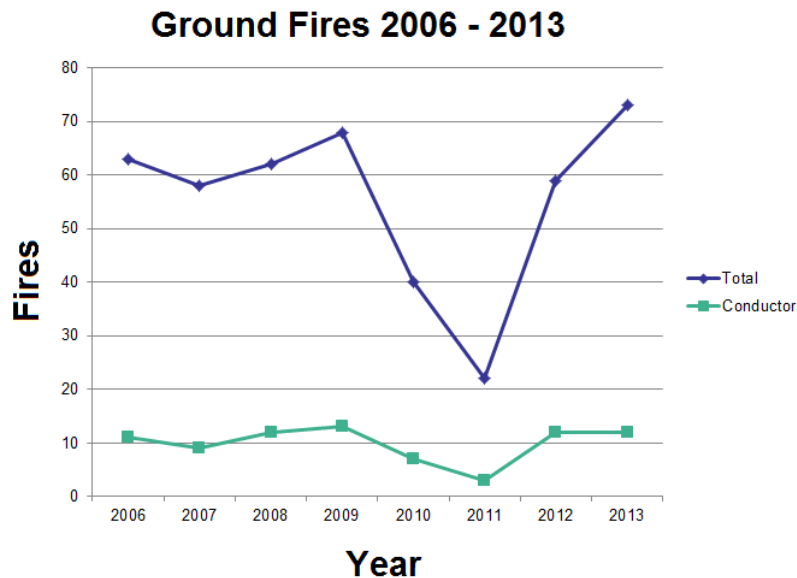
Figure 12 – Ground fires

Conductor failures continue to be a material cause of asset and ground fires as shown in Figure 12. Conductor failures represent 8% of all asset and ground fires. The number of ground fires caused by conductor failure remains around 10 per annum with the potential for extreme consequences including property damage, loss of life and loss of infrastructure.

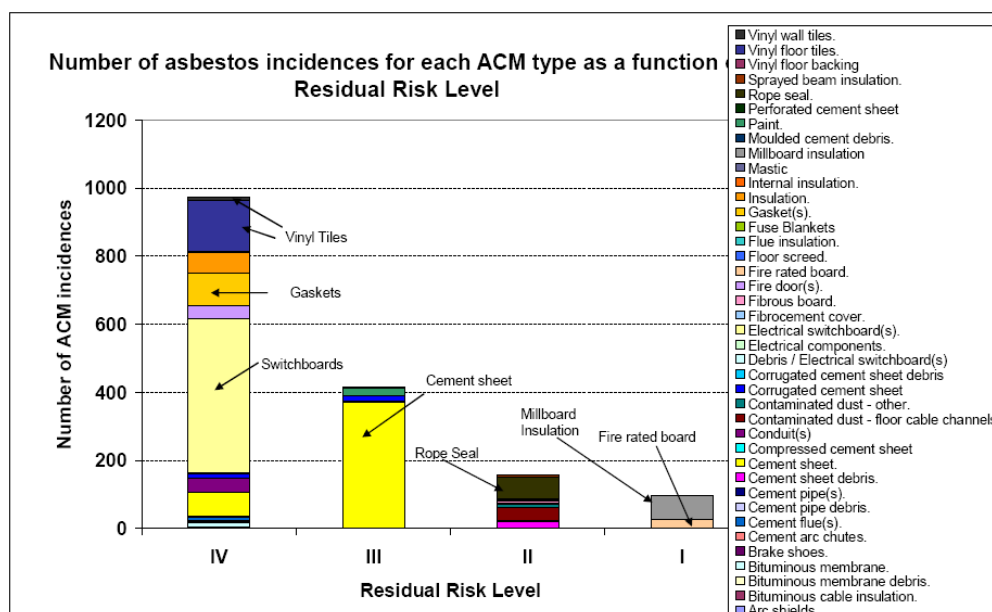
Figure 14 – Asbestos Type

In accordance with the asbestos strategy AusNet Services proposes addressing Level II risks during the 2016-2020 price review period which involves initiatives that can be undertaken independently of asset replacement projects and are of the nature illustrated in Figure 14. This Figure indicates rope seals around electrical cabinets as the major component together with removal of loose materials, debris and dust.
