AMS 10-75 Transmission Line Insulators

2023-27 Transmission Revenue Reset

Document number	AMS 10-75
Issue number	10
Status	Approved
Approver	P. Ascione
Date of approval	6/07/2020

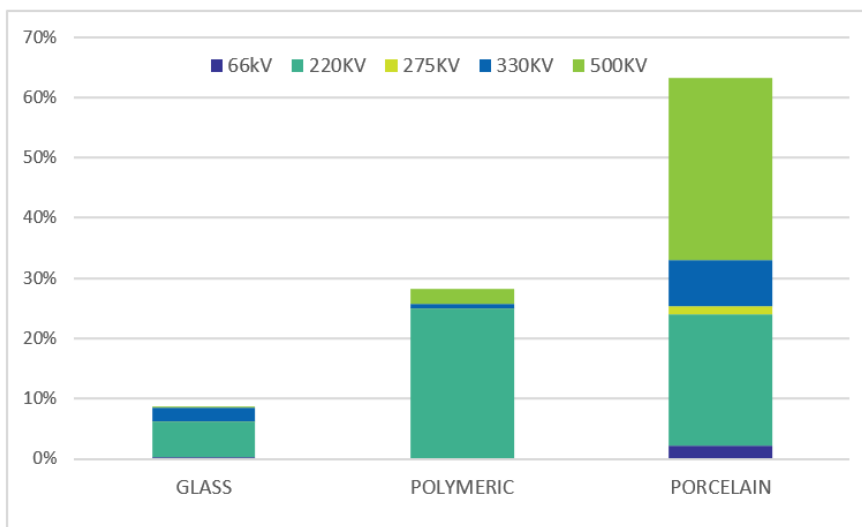
Figure 2: Volumes of insulator strings by type and voltage

Since 2006, deteriorated porcelain and glass insulator strings have been proactively replaced with polymeric insulators. Figure 2 is a graphical representation of the transmission line insulator fleet by type and voltage cohorts.

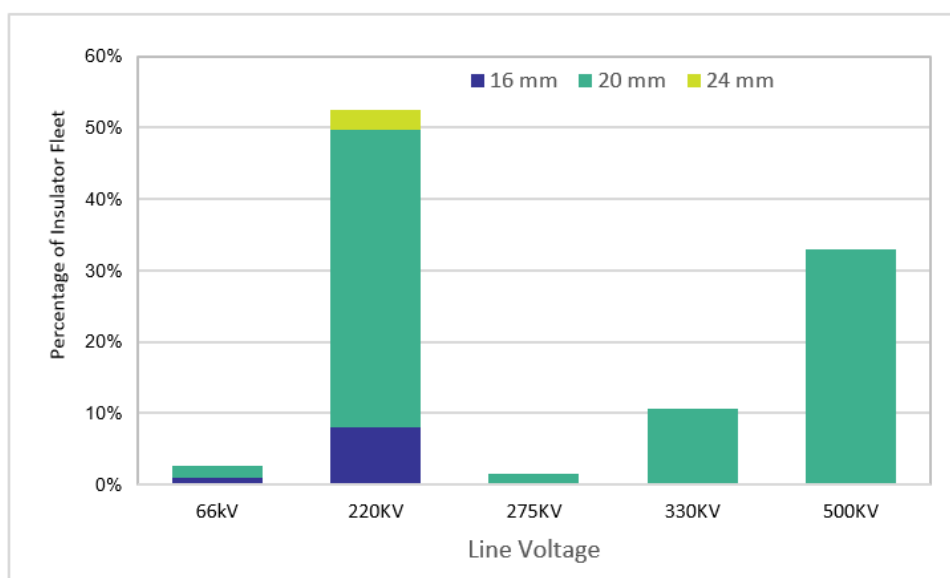
Figure 4: Insulator strings by voltage and size of connection pin

Figure 4 displays the volume of each insulator pin size against the operating voltage of the line its supporting.

As new insulators introduced into the network since 2006 have been predominantly polymeric strings, the population of disc strings with 16 mm pins have decreased steadily from thirty two percent in 2006 down to nine percent in 2020. For the rest of the fleet, eighty-eight percent of transmission line insulators have 20 mm diameter pin sizes, and only three percent of the fleet have 24 mm diameter pins.

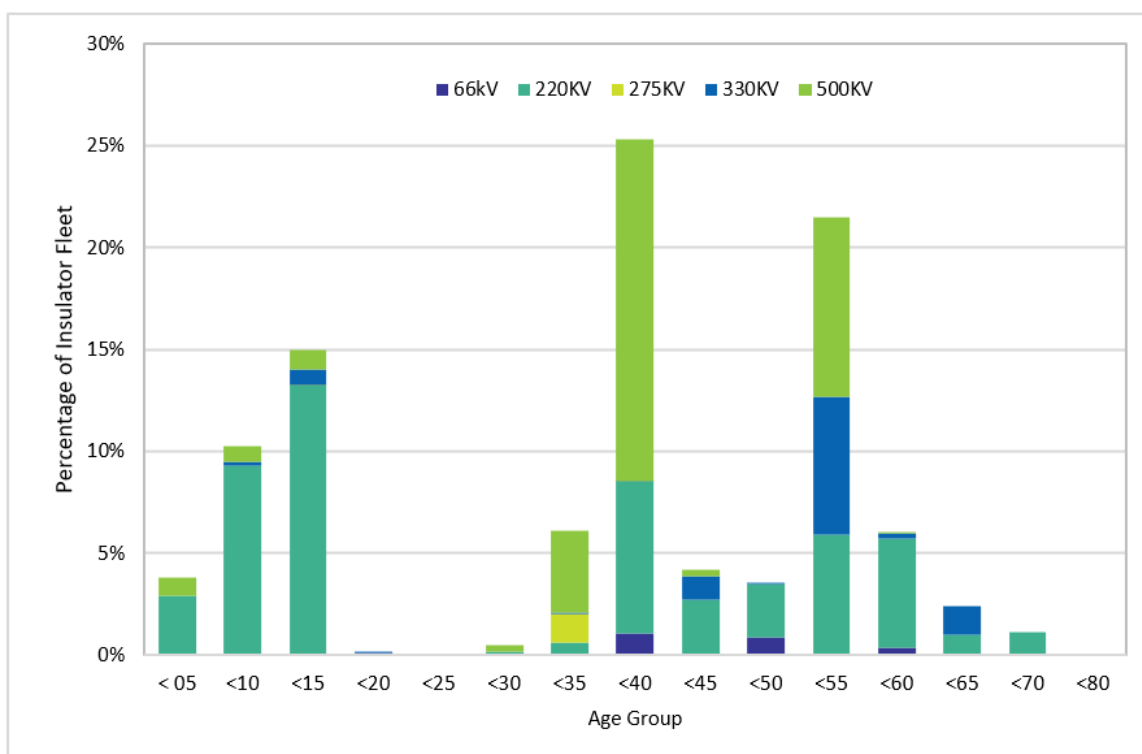
Figure 5: Transmission line insulators Age Profile by Voltage

Figure 5 shows the age of the transmission line insulator population by voltage. There are approximately 8,100 insulator strings with a service age exceeding 55 years; majority of these insulators operate on the 220 kV network, with some strings belonging to the 66 kV, 330 kV and 500 kV circuits.

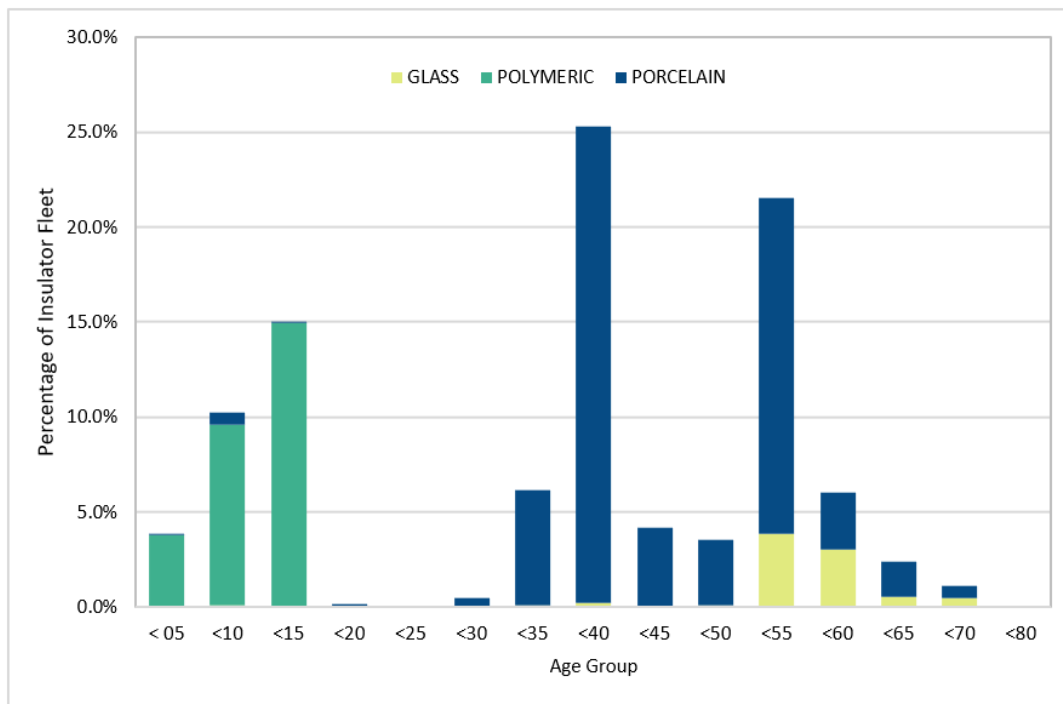
Figure 6: Insulator Service Age by type

Figure 6 shows the age of the transmission line insulator population by type, with the oldest transmission line insulators being either porcelain or glass type.

The majority of insulator strings with an age of 15 years or less are polymeric types, with new porcelain disc strings used only as bridging insulators on strain towers due to its weight, i.e. to keep bridging conductors from swinging too close to the structure during high winds.

- Expected life of insulator in operating environment – this is based from experience in operating the transmission network, as well as industry knowledge and bodies of research. A good indication of expected service life for a type of insulator (i.e. glass, porcelain and polymeric) is by looking at the fleet’s service age (Figure 6) and the failure age (Figure 11).

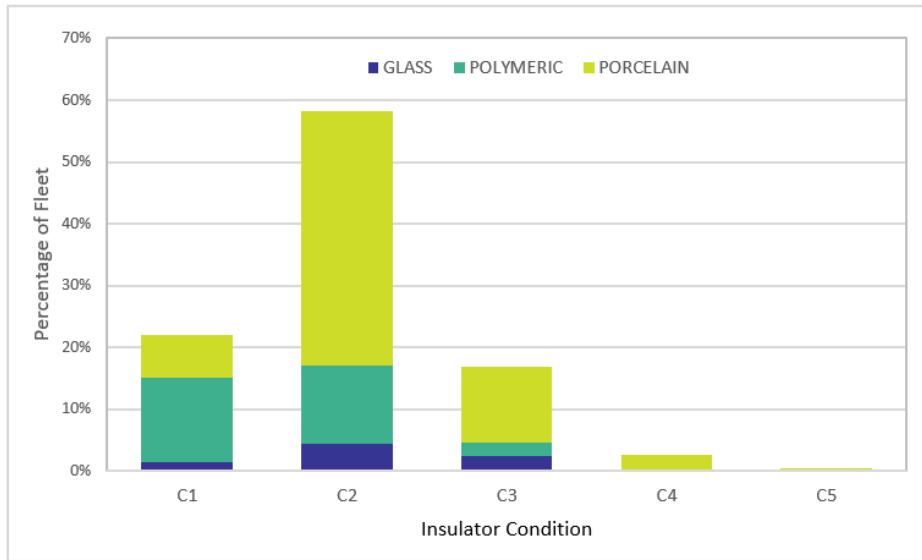
Figure 7 – Insulator condition by type

Figure 7 shows the condition of transmission line insulators by type. More than eighty percent of insulator strings in service on the transmission network exhibit minimal fitting wear or light levels of rust in line with condition grades C1 or C2.

A total of 2,289 insulator strings or 2.6 percent of the total insulator fleet currently belongs to C4 condition which exhibits light rust, or <10% wear. While 291 insulator strings, or 0.3 percent of the total transmission insulator fleet currently exhibits levels of fitting wear or pin corrosion in line with condition grade C5.

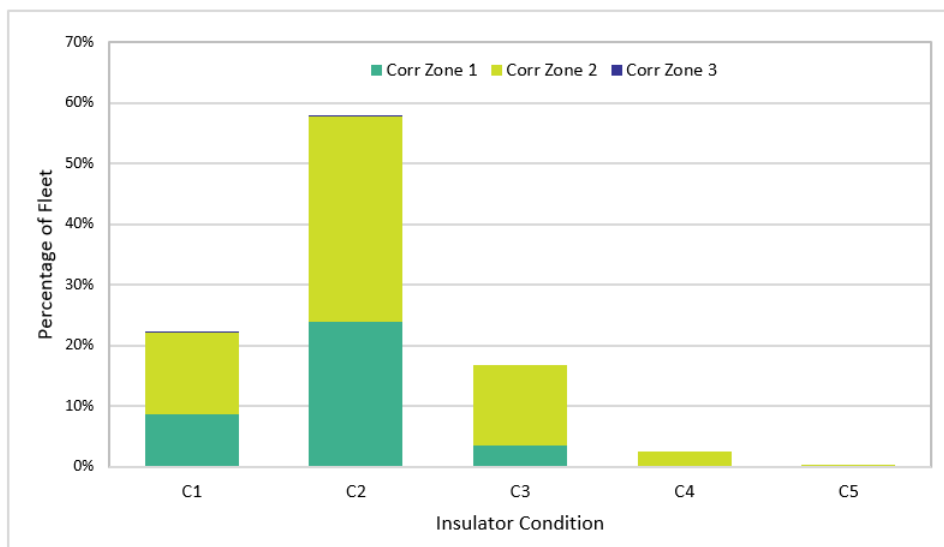
Figure 8 –Insulator condition by corrosivity zone

Figure 8 displays transmission line insulator condition by Corrosivity zones. Thirty-three percent of transmission line insulators which are currently assessed as condition grade C5 are situated in the low to moderate corrosivity zones, while the insulators situated along the severe environment (Corrosivity zone 3) either at C1 or C2 condition.

The insulators in Corrosivity zone 3 were recently replaced with polymeric insulators as these are more resistant to the marine environment. The strings in C1 condition, all located in HYTS-APD #2 circuit were replaced in December 2019 as the previous insulator strings, which were supplied from a particular manufacturer were inadequate for the aggressive environment at Portland, Victoria¹⁰. The C2 insulators which are installed on the HYTS-APD #1 circuit are from a different manufacturer and is approximately 12 years old.

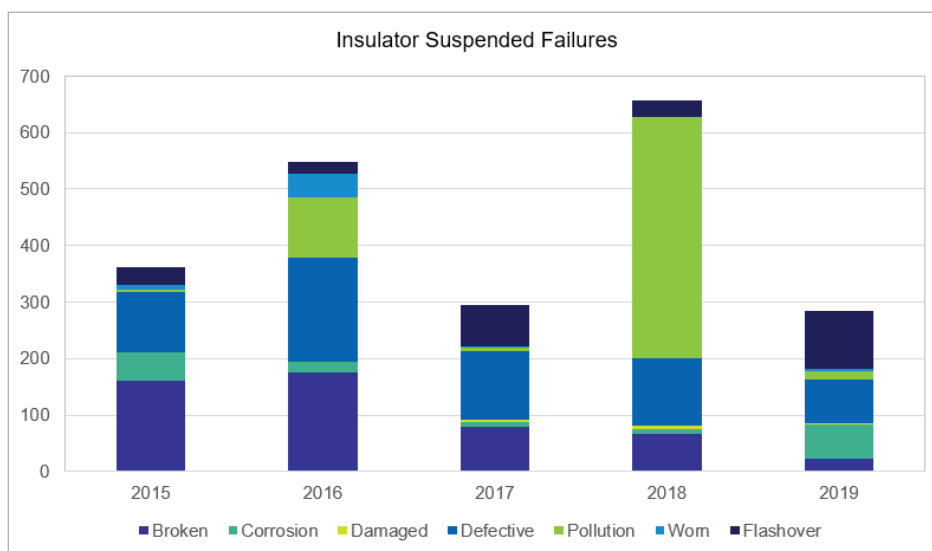
Figure 9: History of suspended insulator failures

A high volume of dirty¹⁵ insulator strings were identified and washed in 2018, which increased the suspended insulator failures that year as illustrated in the following Figure 9. The increase was the result of the drought the previous two year which caused the vegetation along the easement to die and ground to dry out. The high and frequent winds in the South-West area of Victoria caused airborne dust to rise into the atmosphere and settle on the insulator discs of the HYTS-SESS 275 kV circuits.

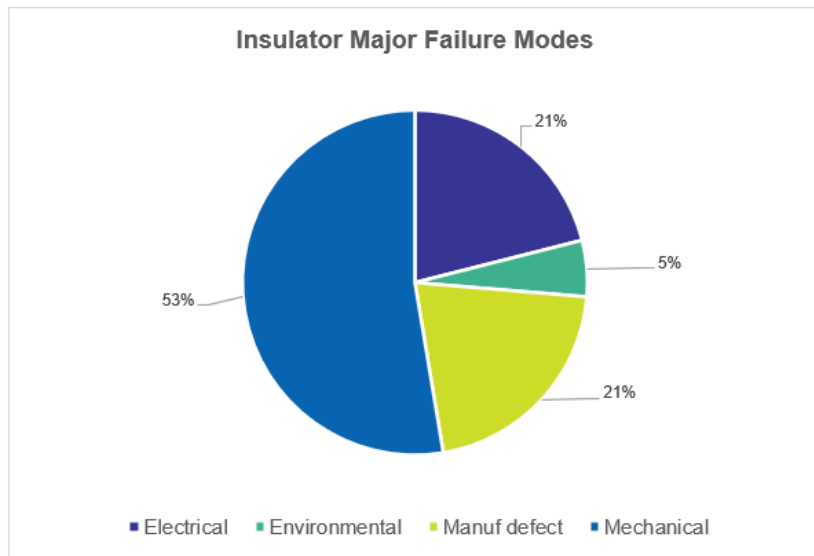
Figure 10: Transmission line insulator failure modes

There have been 19 incidents of insulator functional failure over a period of 36 years as shown by Table 6 with the details of the failure events, while **Figure 10** displays the percentage split of total transmission line insulator failure modes.

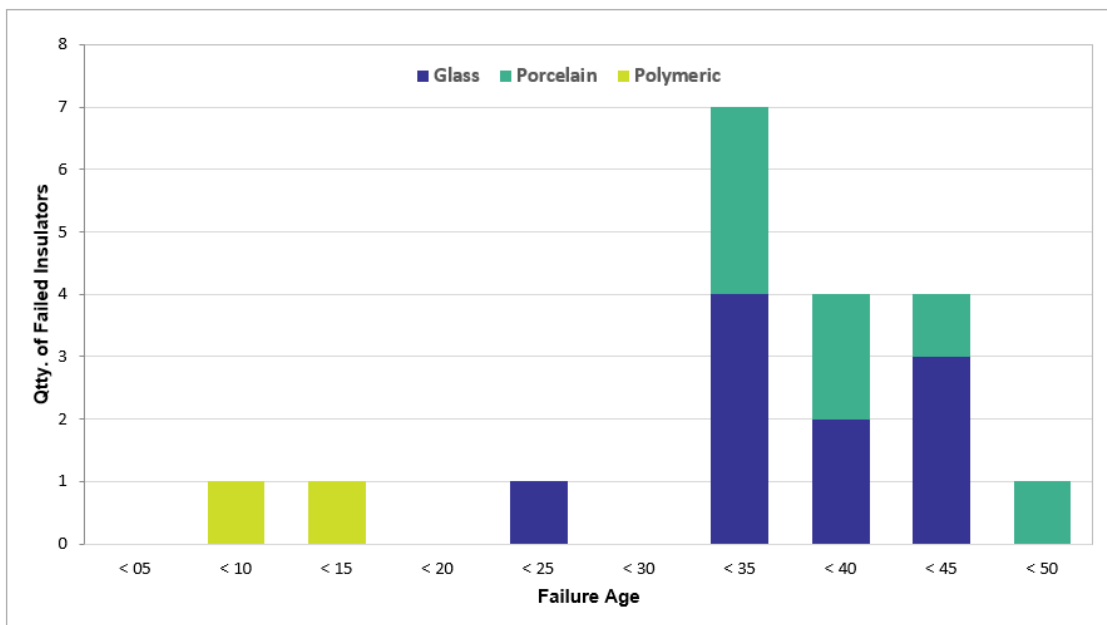
Figure 11: Transmission line insulator age at time of failure

The mean service age at the time of failure for transmission line insulators made from either glass or porcelain discs is 42 years, while the polymeric strings have a mean age of 10 years. Figure 11 shows the distribution of insulator ages at time of failure, as well as the insulator type.

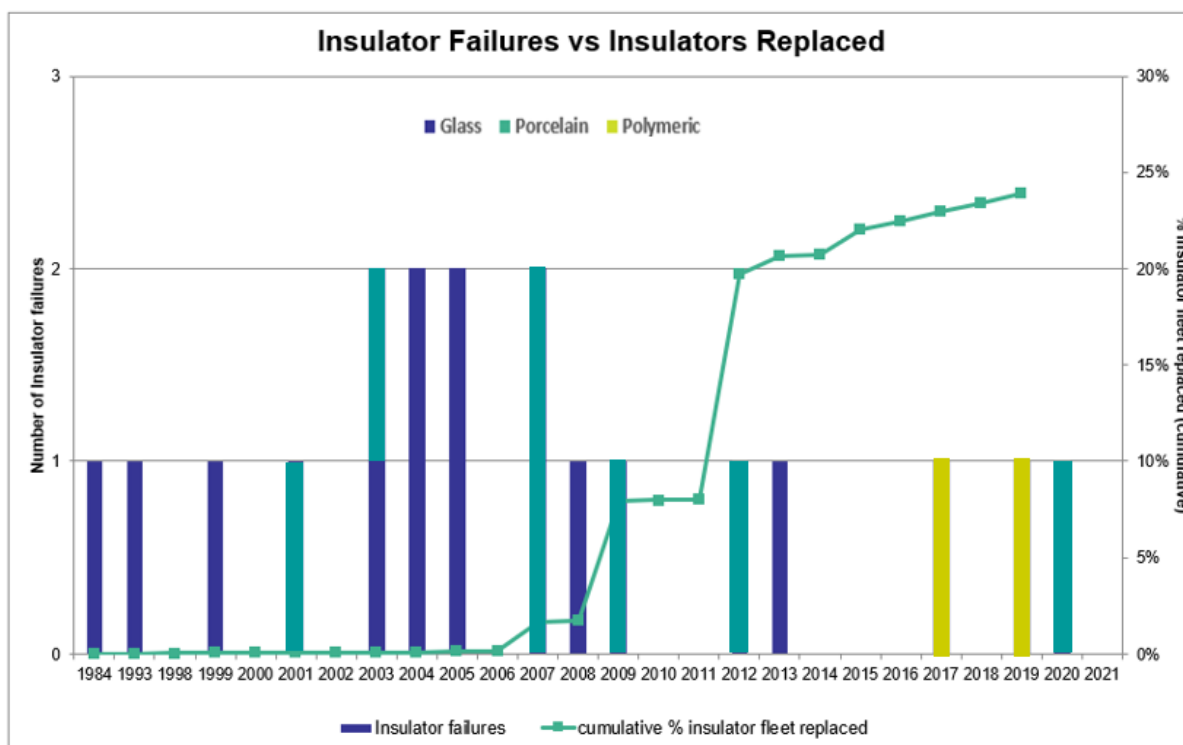
Figure 12: Insulator Failures versus Insulators Replaced

Figure 12 shows the cumulative percentage of replaced insulator strings over the number of failures. There is an approved project (TD-4197) to replace 1,940 insulator strings on various transmission lines over two financial years from 2017/18 to 2020/21.
