• 132kV steel tower failure • risk mitigation • • • • • •

Case for investment FY23
February 2022

Investment Title	132kV steel tower failure risk mitigation
<< project # / code >>	
Portfolio	Repex
CFI Date	18 February 2022
Pre RIT-D	<input type="checkbox"/>
Final CFI	<input checked="" type="checkbox"/>
Other	<input type="checkbox"/>

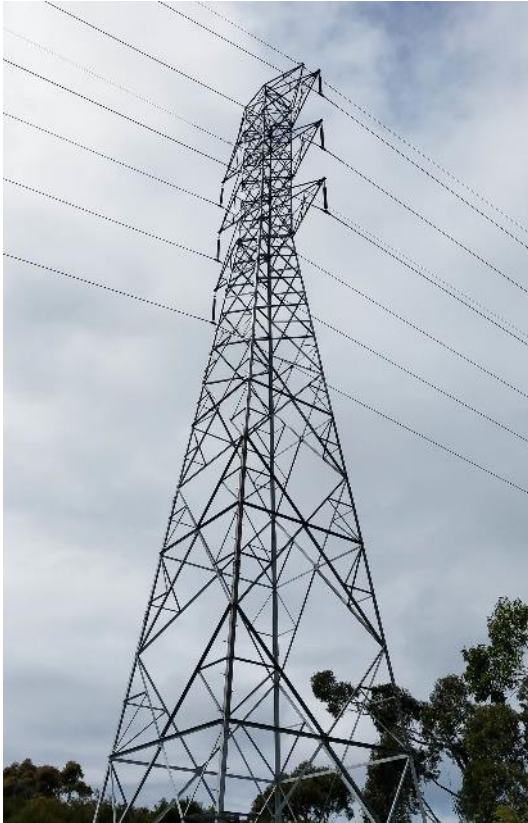
Typical 132kV double circuit tower near the coast.

Calendar age 68 years (in 2022)

Conditional age 80 years (in 2022)

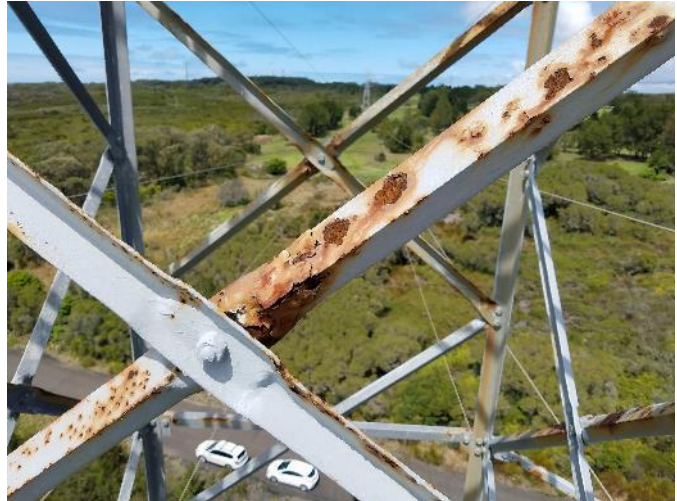
Close up view of structural corrosion

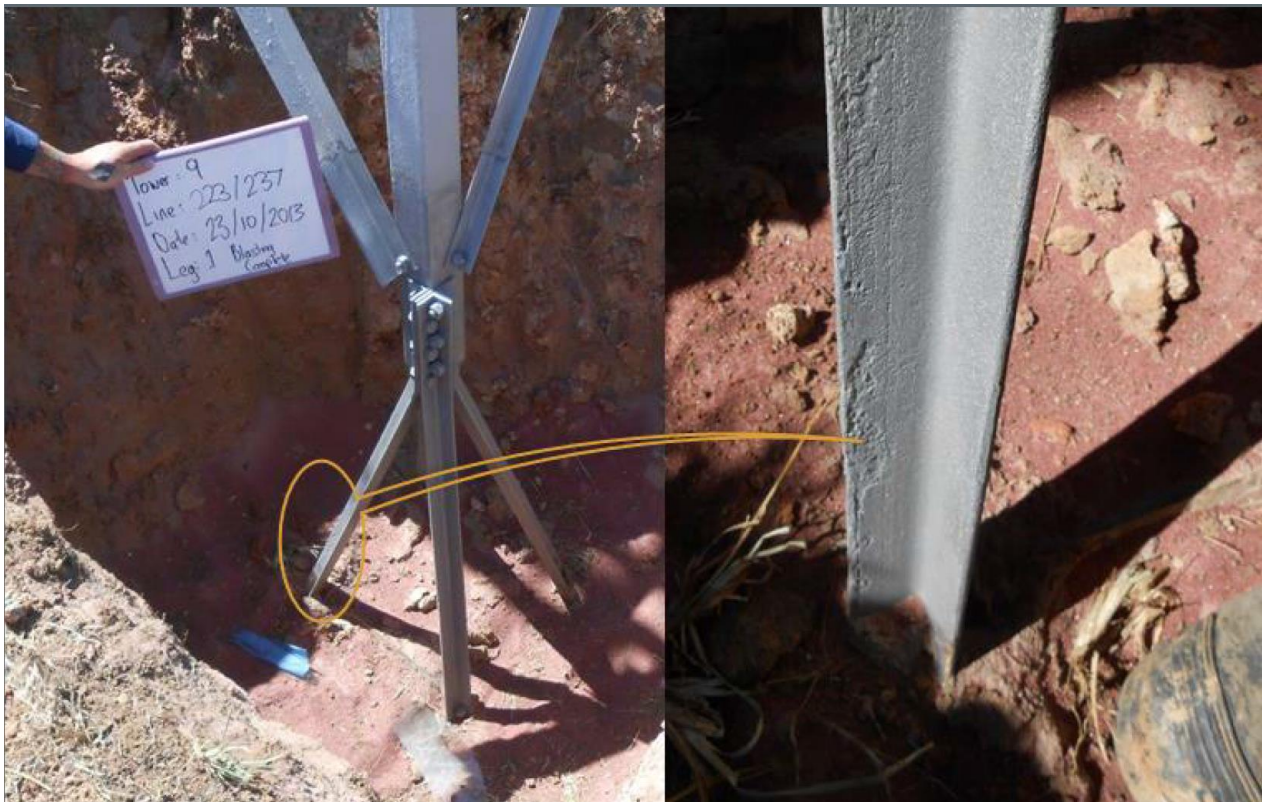
Grillage foundation with minor corrosion damage, after refurbishment.

Located in Western Sydney. Calendar age 53 years (in 2022)
