ATTACHMENT 5.05

Investigation reports for reliability projects

Reliability Investigation

Feeder 7962 – Braeside Road, Greystanes

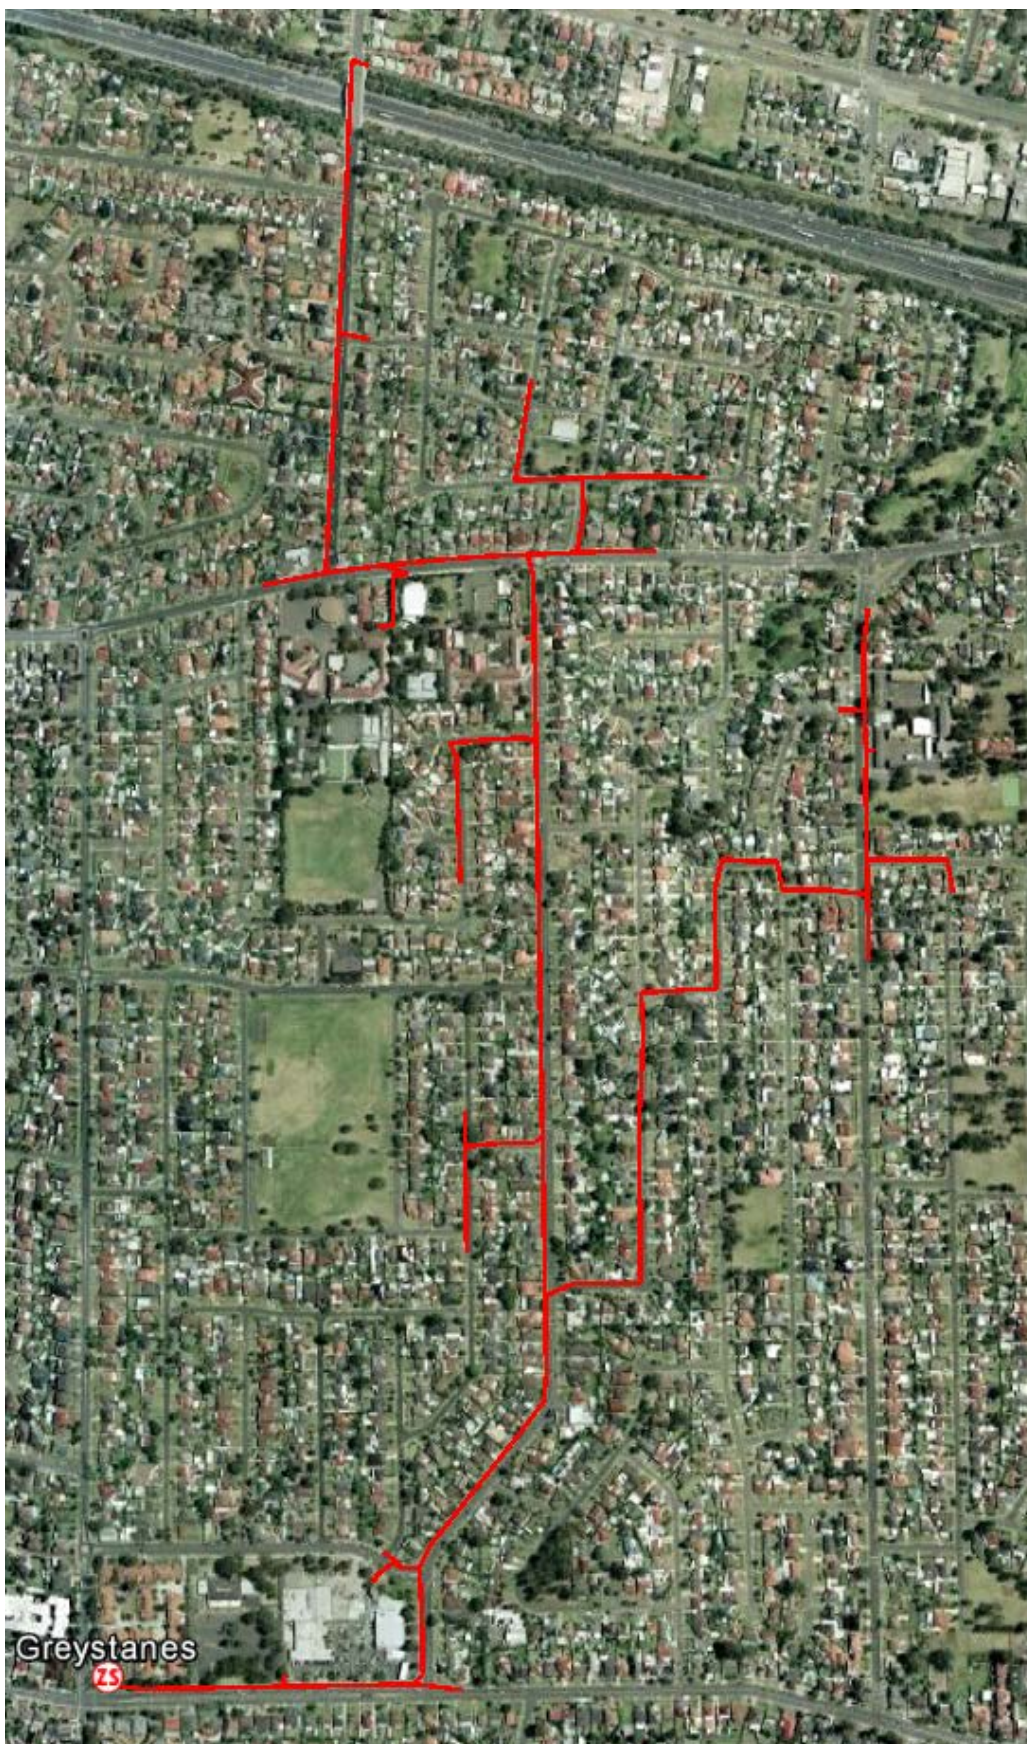
2.1 Feeder Layout

11 kV feeder 7962 is supplied from Greystanes ZS. This feeder is mainly overhead which provides power to residential customers in the Greystanes area.

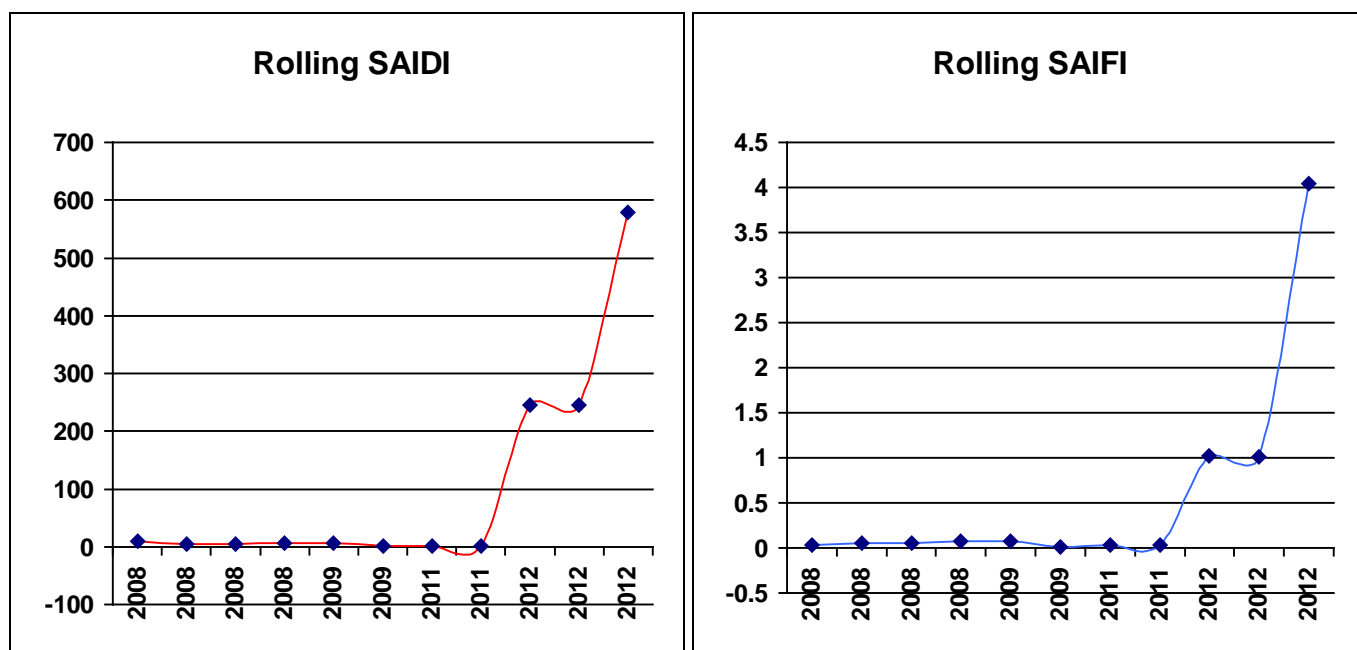
Reliability Performance by Quarter (Graph)

Prior to the September 2012 quarter, this feeder had very good reliability performance. This is the first quarter in which the feeder has been non-compliant or indicated as a >0.3 minute organisational SAIDI feeder. Feeder 7962's non-compliance is a result of several equipment failures throughout 2012.

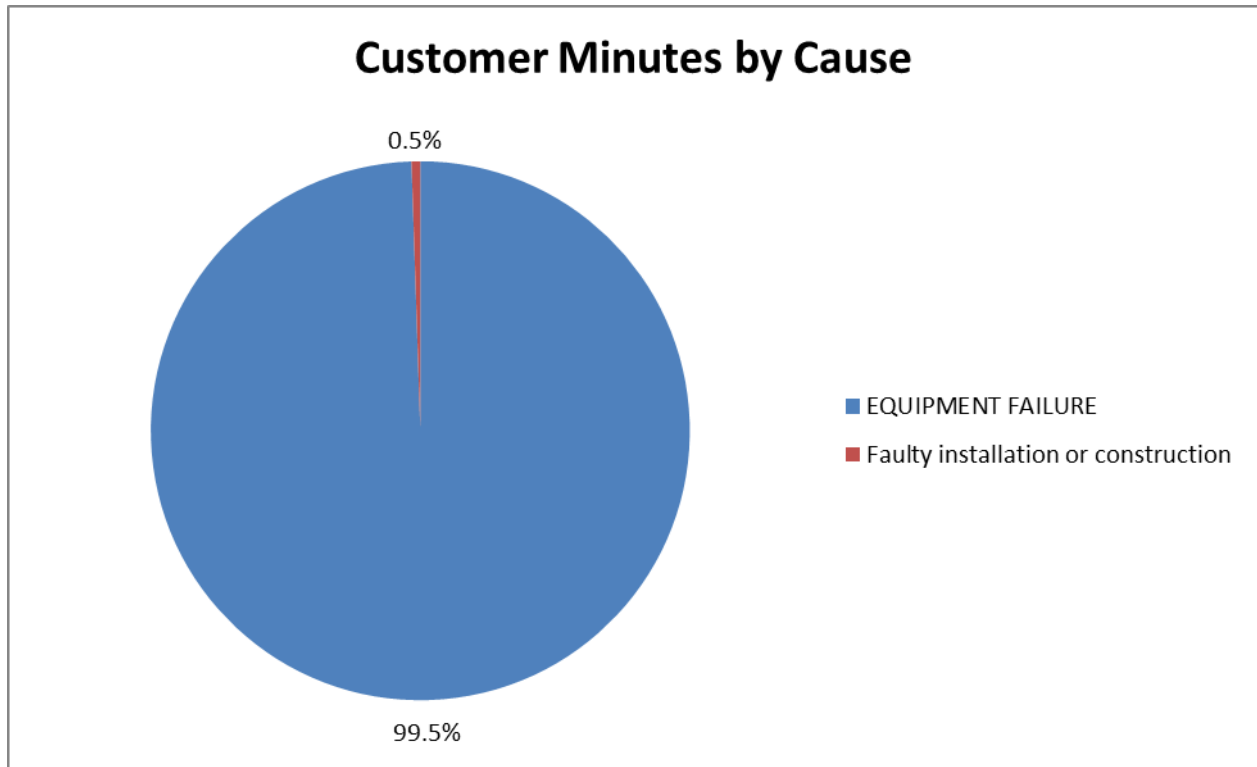
5.1.1 SAIDI Contribution by cause type

99.5% of outages on this feeder in the past 12 months have been due to equipment failure. Two particular events have contributed 80% of the total feeder SAIDI in this period.

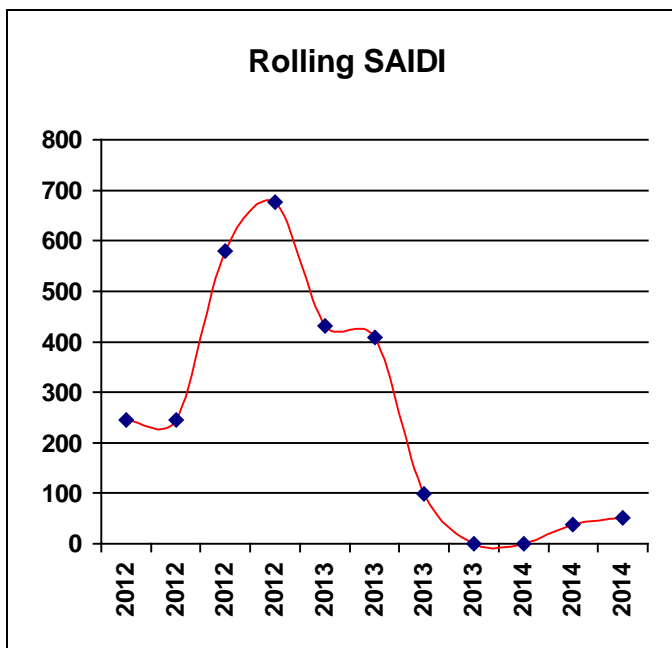
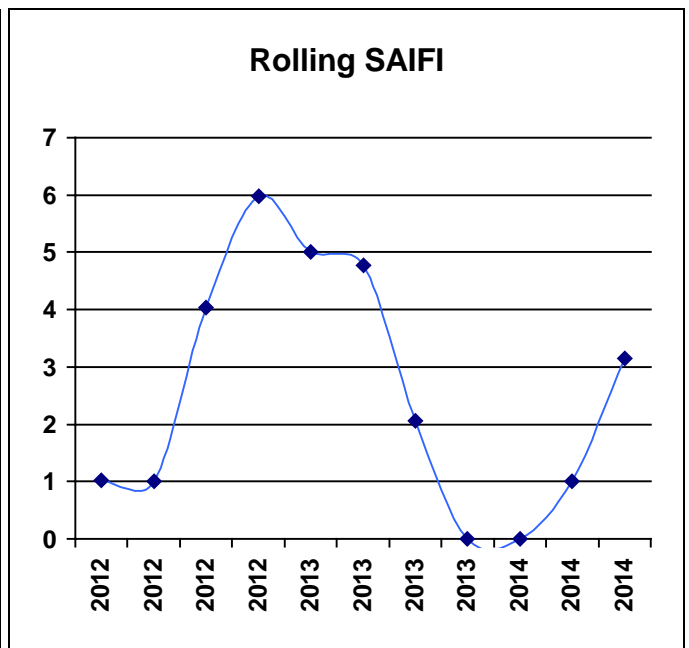
Recent performance of this feeder has shown significant reliability improvement (particularly in SAIDI). This is demonstrated by the following table and graphs:

As expected, further sectionalisation of the feeder has improved the reliability significantly. This can be attributed to the minimisation of customers affected by faults in addition to the ability to fault find and restore unaffected customers more quickly. It is expected that this feeder will remain compliant into the future.

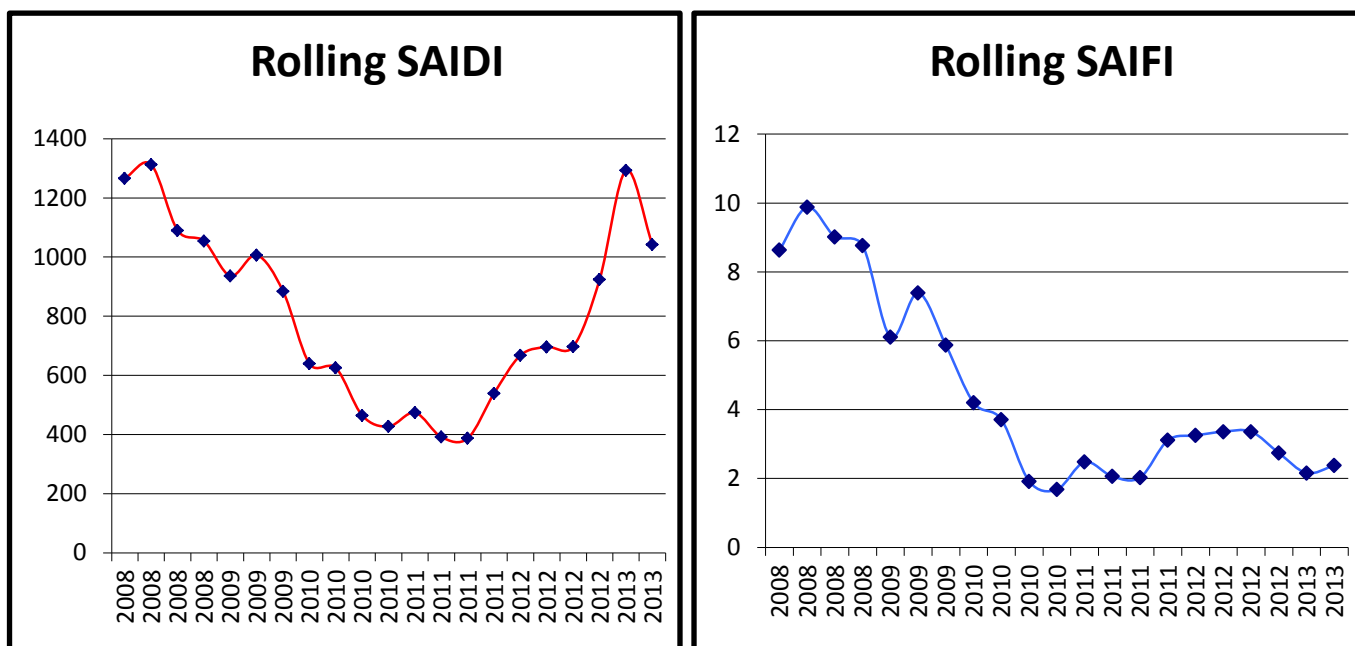
Reliability Performance by Quarter (Graph)

Two outages in the most recent quarter have ensured this feeder has remained non-compliant in terms of the NSW Reliability Licence Conditions. The majority of SAIDI can be attributed to two separate outages (in November 2012 and January 2013 respectively), contributing a combined 1104 minutes.

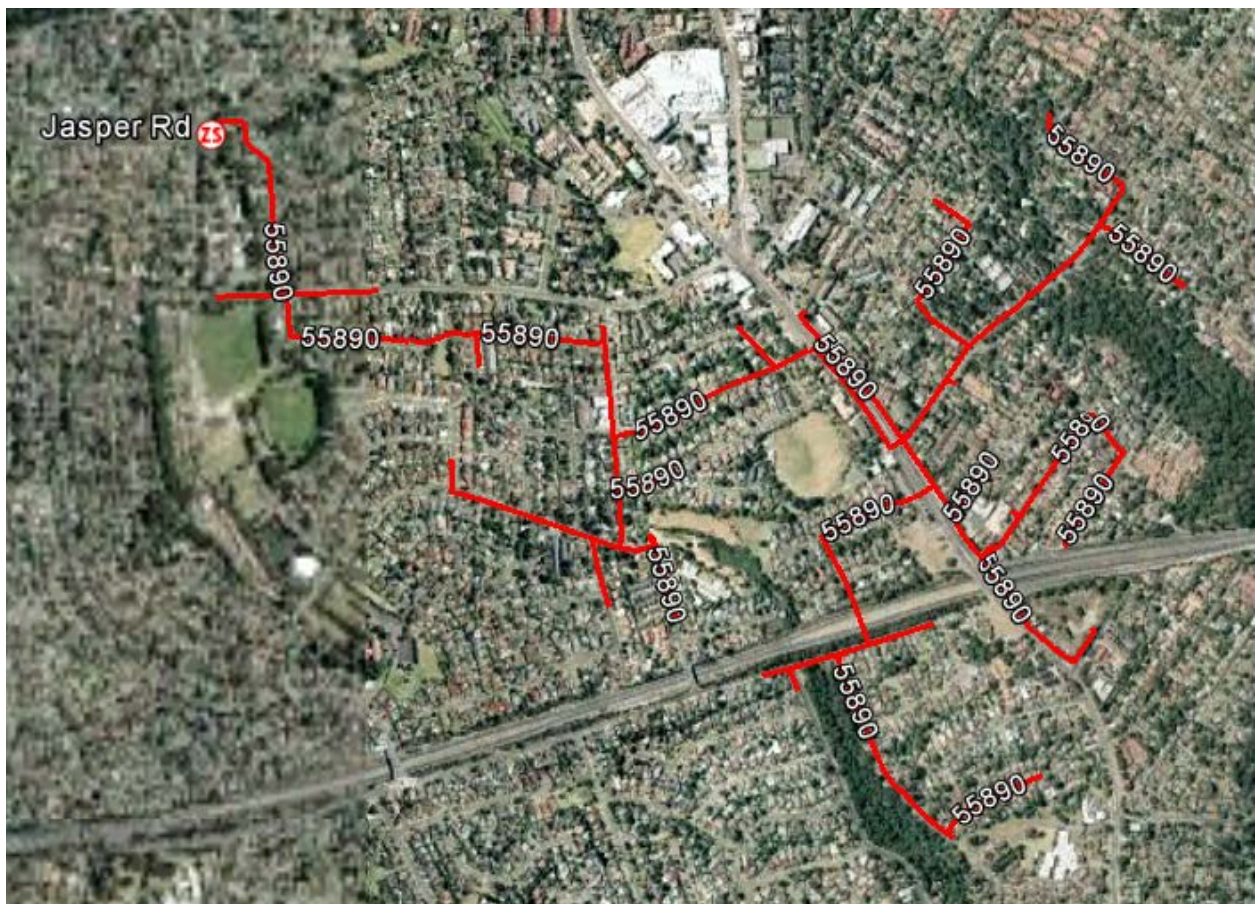
2.1 FEEDER LAYOUT

Feeder 55890 supplies power to 1500 customers in the Baulkham Hills and Winston Hills areas. The feeder has 4 ties to other feeders; two to other Jasper Rd ZS feeders (55876 and 55867), one to Northmead ZS (3357) and one to North Rocks ZS (8744).

The network is residential with a mix of overhead and underground (with the majority underground). Due to this majority of underground cable the highest risk of outages is due to equipment failure.

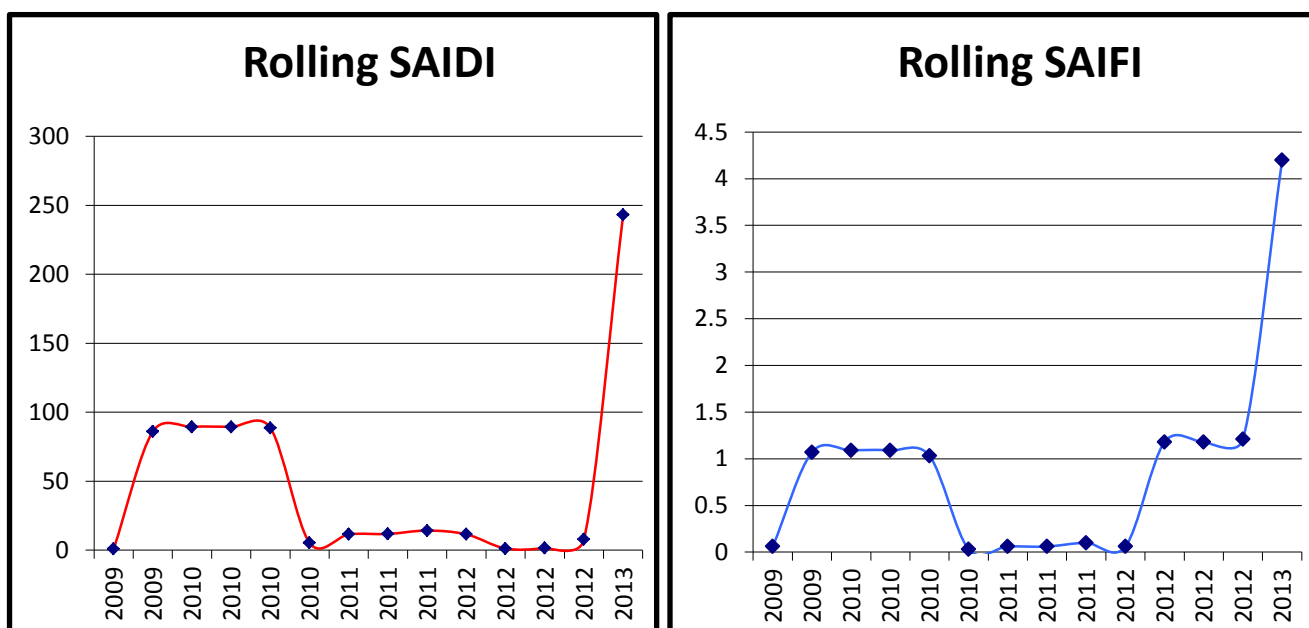
Reliability Performance by Quarter (Graph)

In recent history, this feeder has been a strong performer in terms of reliability; however, 4 significant outages in the past 2 months have increased the SAIFI of the feeder to 4.2, which is above the NSW Reliability Licence Conditions.

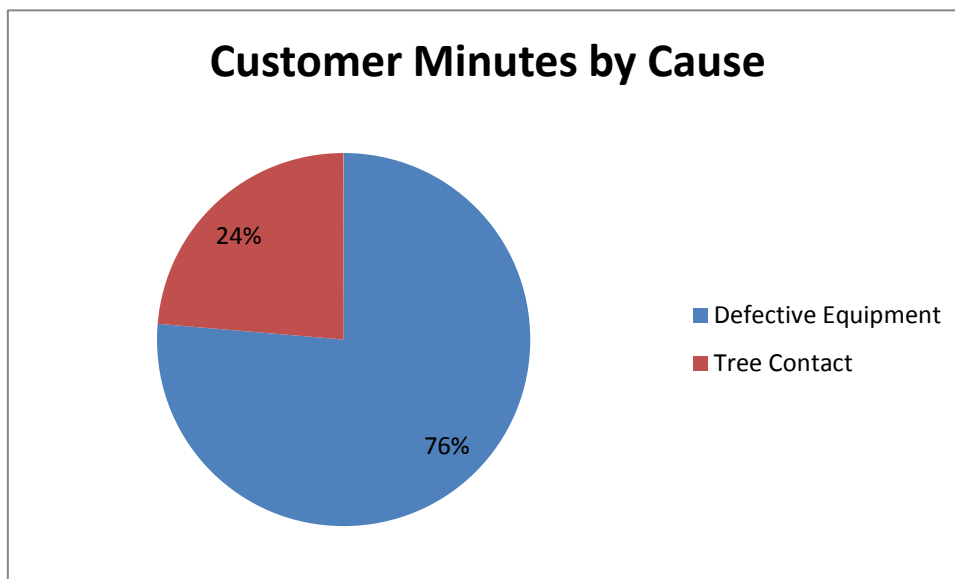
5.1.1 SAIDI CONTRIBUTION BY CAUSE TYPE

As can be seen in the following pie charts, outages in the past 12 months can be attributed to defective equipment and tree contact.
