Business cases for SCADA and Network Control Protection

Prepared by Endeavour Energy

Zone and Transmission Substations
RTU Renewal Plan
Program AU004
Statement of Asset Need

TRANSMISSION AND ZONE SUBSTATIONS SCADA RTU REPLACEMENTS

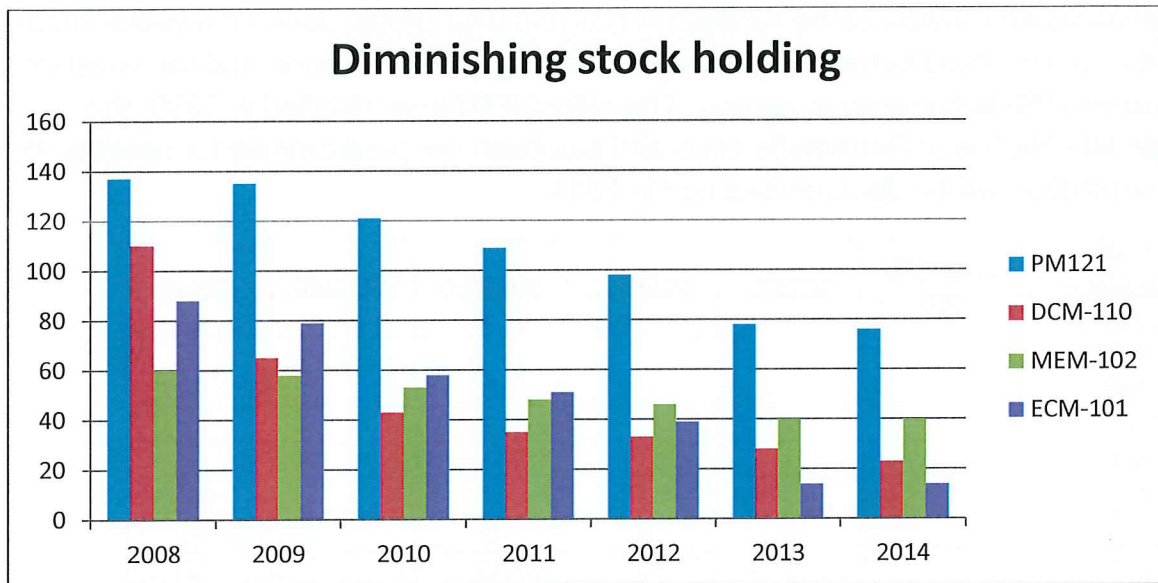
The chart below shows only the estimated critical spare parts holdings and usage patterns over the last five years. The number of spares held includes stock in P&C vehicles, regional P&C field service centres and the central store.

At the current rate of failure the present stock would be depleted by 2015, resulting in no spares being available to expand any MD1000 RTU or repair any failed RTUs beyond that date.

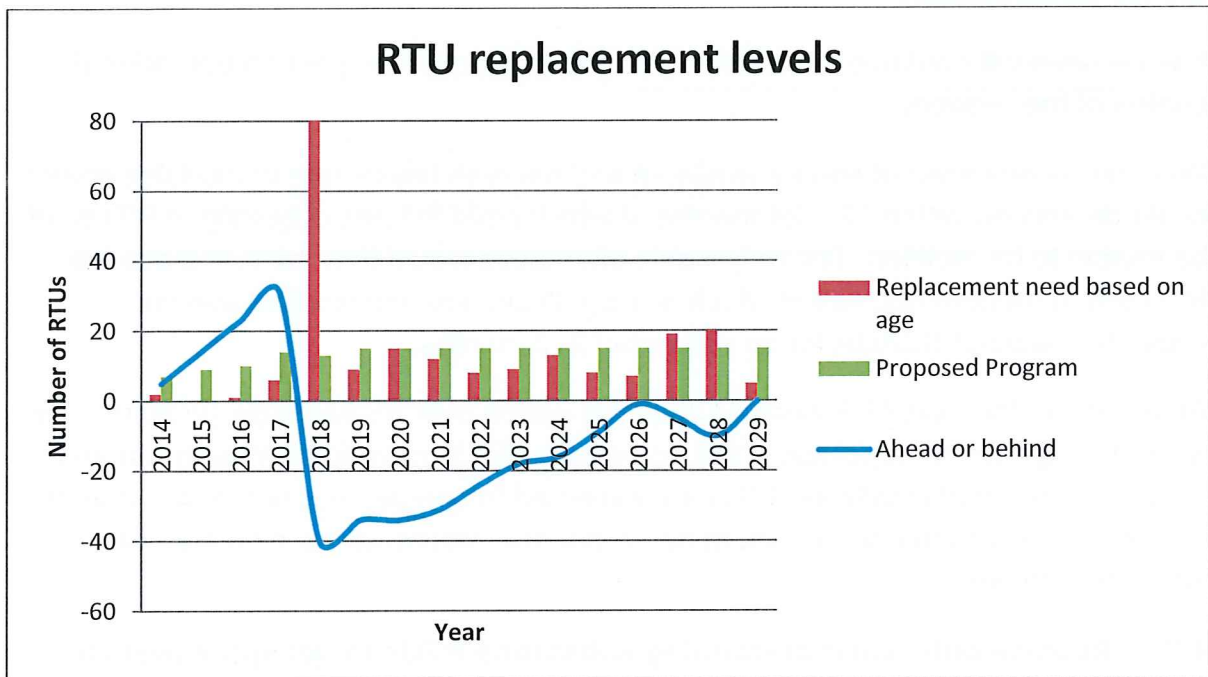
The life span for SCADA equipment is generally considered to be 15 years with the limiting factor typically components such as capacitors or batteries. As such with 219 RTUs if there was an even age profile of SCADA equipment approximately 15 RTUs would be required to be replaced each year due to age. Substations that are

upgraded for other reasons would normally require the SCADA RTU to be replaced or significantly refurbished at this time and would reduce this requirement.

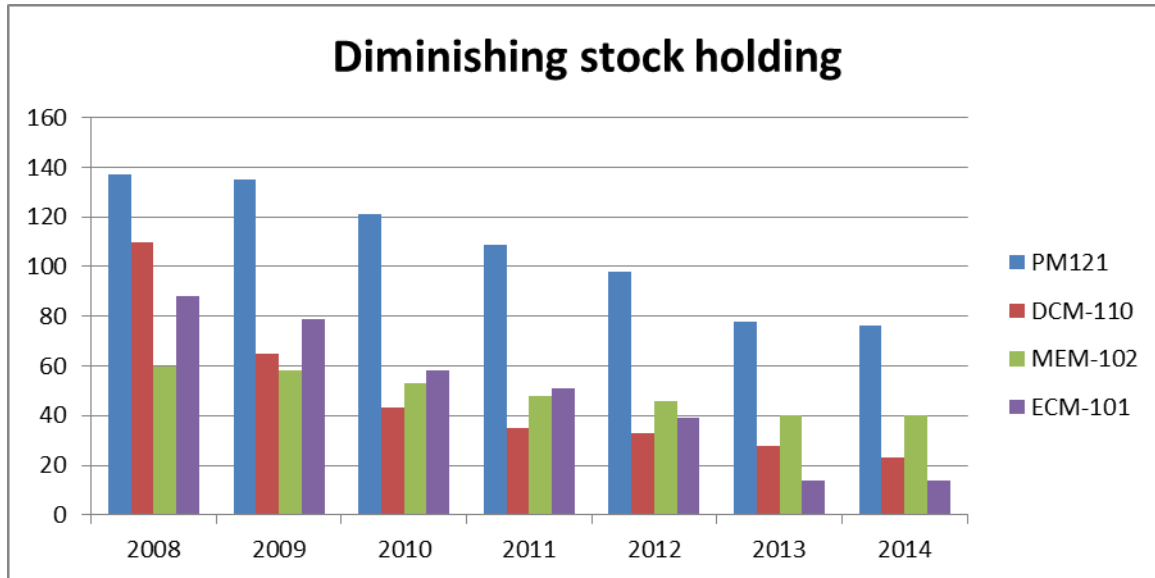
Figure 1: INVENTORY OF THE MD1000 RTU SPARE PARTS

Refer Figure 1 below which highlights the diminishing inventory of spare parts related to the MD1000 RTUs:

Current failure rates of MD1000 RTUs suggest that the existing stock levels will be consumed by 2015. However, components of RTUs that are replaced under the AU004 renewal program will be retained to boost the inventory to enable the remaining MD1000 units to be retained in service beyond 2015.

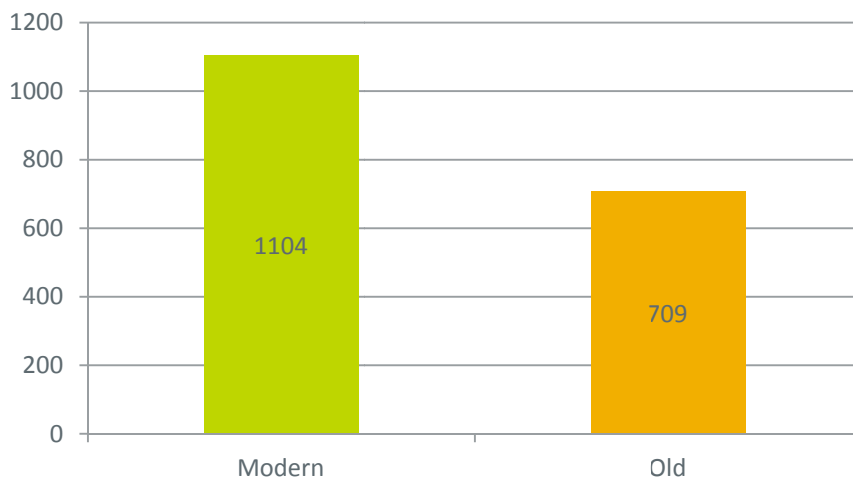
Relay types on distribution feeders

There are currently 1760 distribution feeder protection systems. 1104 of these feeders currently have modern protection systems, and 709 do not. The old systems include relays such as CDG, PBO, ITP, and CO relays, and this program will see the replacement of these older systems, which are not otherwise being replaced through other projects, as well as a small number of older modern systems which are not capable of being modified to achieve the benefits of this program.

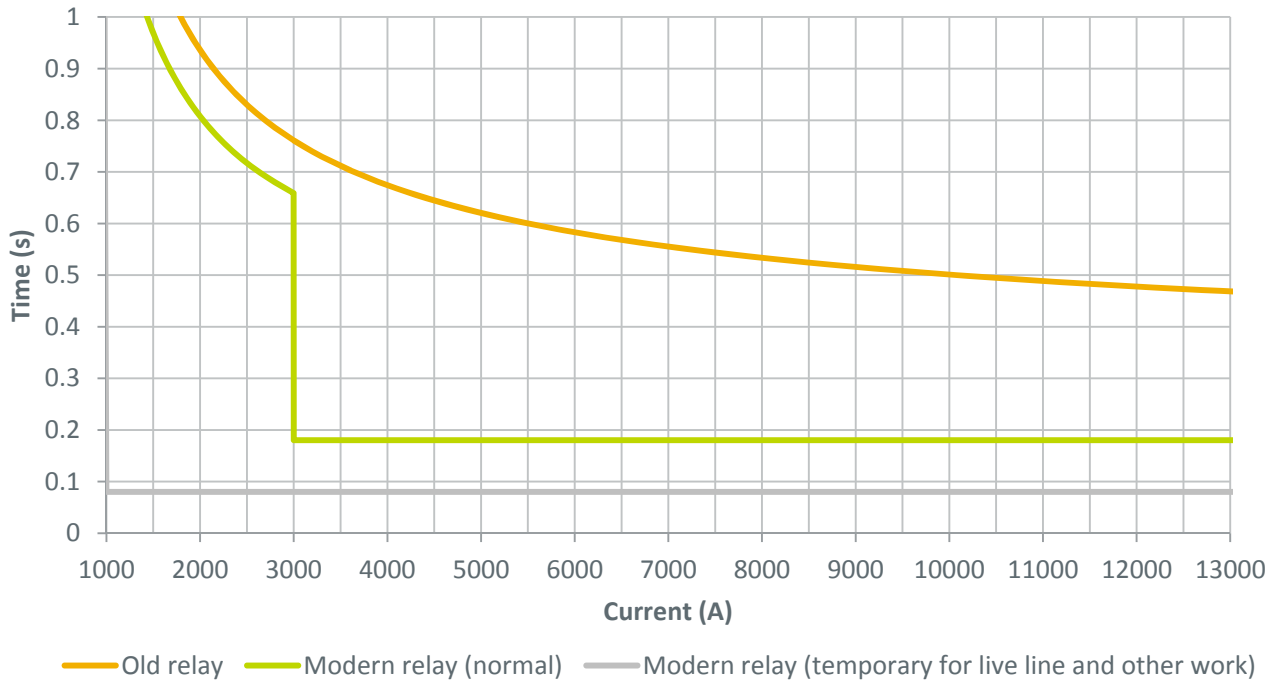
Typical fault clearance times

The graph below shows the substantial reduction in clearance time which can be achieved on a typical distribution feeder. Where the highset setting is included, the fault clearance time can typically be reduced by 60% to 85% for faults greater than 2-3kA. These higher fault levels, where the high-set is achievable correspond with our serious injury arc-flash accidents.

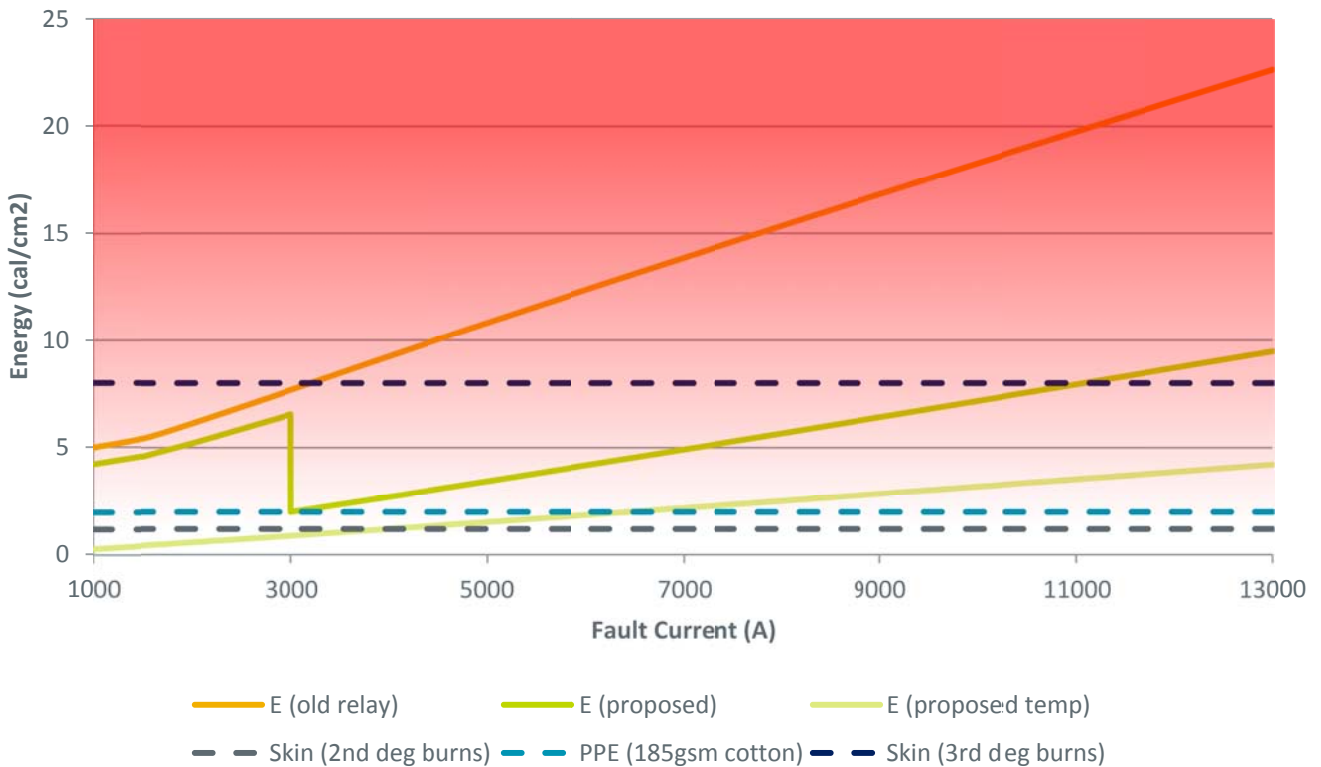
Typical arc flash energy levels at 0.5m
(IEEE 1584)

Experience and analysis shows that the majority of serious arc flash injuries are sustained at higher fault levels, say >3kA). It is at these higher fault levels where a substantial reduction in fault clearance times is normally available by way of a high-set (a higher speed fixed time protection element). The graph below illustrates the energy levels at 0.5m with and without a modern protection relay with typical ALARP settings. There is also a proposed temporary setting which is remotely controllable and results in very high speed clearance of electrical faults above 1kA. System operators can use this to reduce the risks to employees when work is being done, such as live line work, or switching high risk equipment.

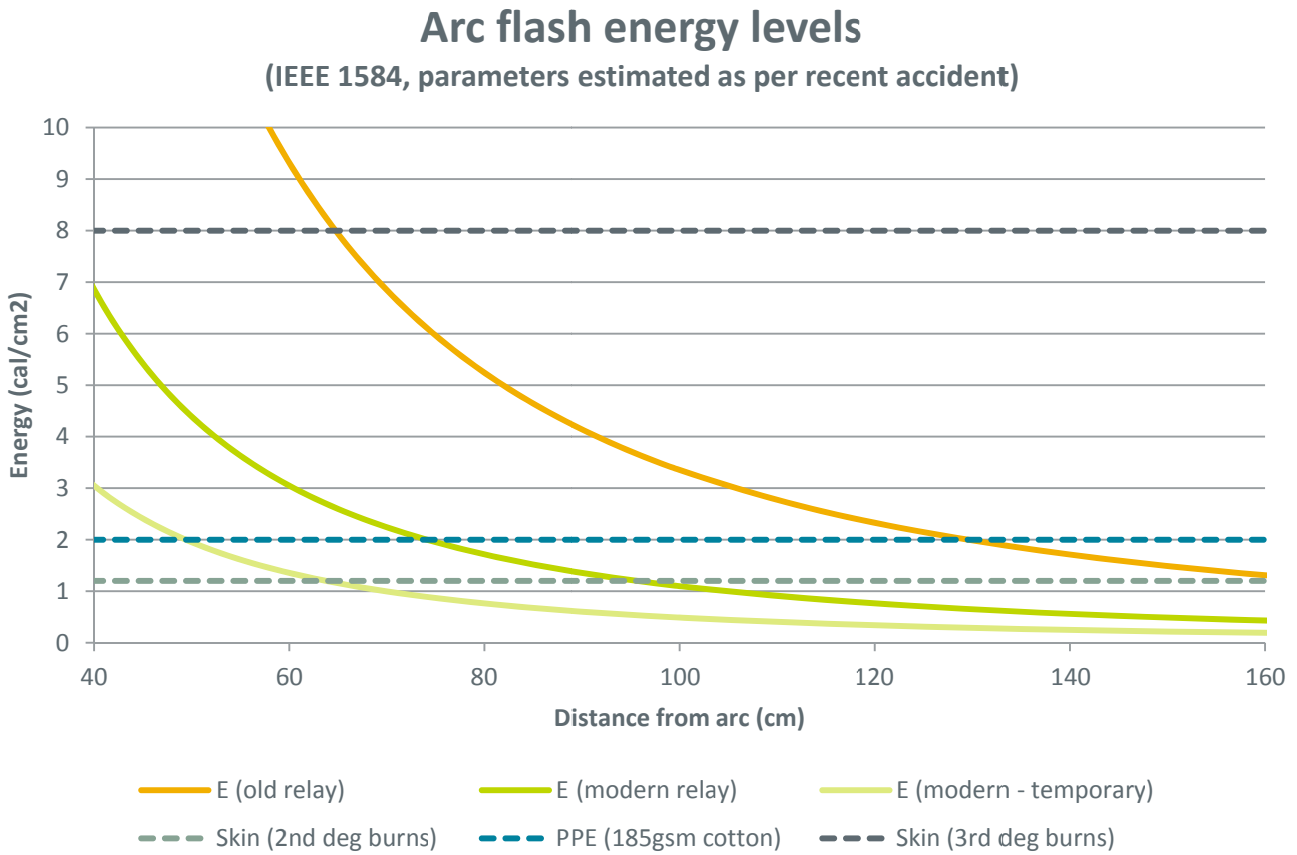
The following graph is applicable to one recent accident which resulted in serious burn injuries to an Endeavour Energy District Operator. A witness to the accident estimated our employee to be between 1 and 2 meters away from the padmount substation when the arc flash occurred.

The orange line illustrates the arc incident energy that is estimated to have occurred on the day of the incident. The dark green line represents the typical energy levels if modern relays and typical minimum practical settings were employed, and the light green line represents the level of energy which could be employed on a temporary basis by SCADA remote control for high risk activities such as live line work, and the switching back onto possible faults, the latter being applicable to this event.

It is clear that at a distance of 1m, the energy levels are substantially reduced, and it is reasonable to conclude that it is likely that our Employee would not have sustained any significant injuries had the temporary settings been employed at the time of the accident if the person was at a distance greater than 1m, as witness reports have stated.

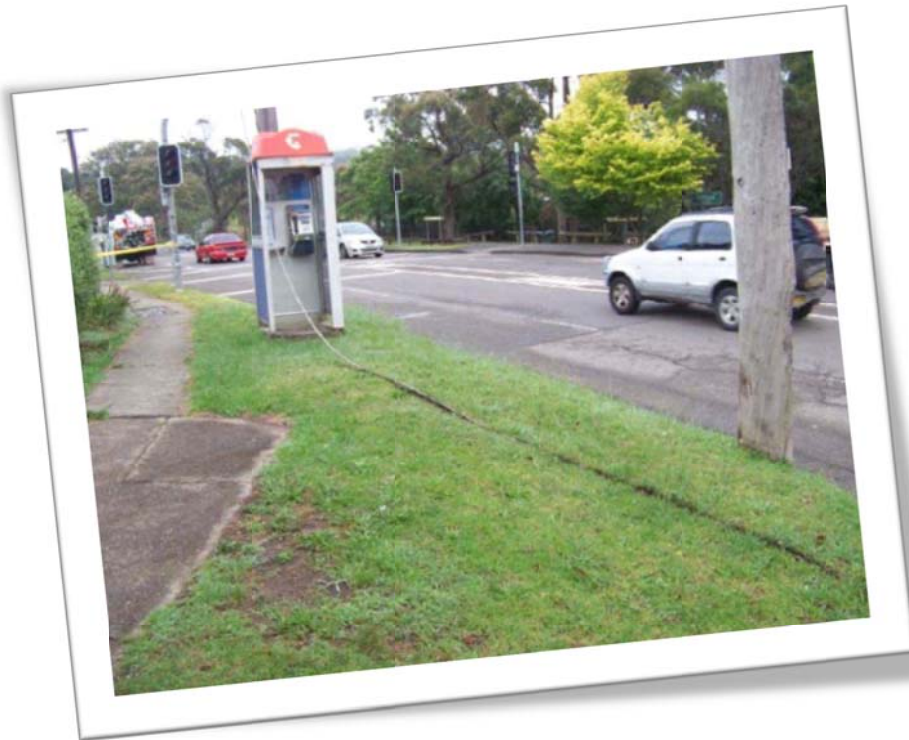
The following event occurred on the Endeavour Energy network a few years ago. Members of the public reported that lines were on the ground and witnesses saw arcing and smoking for 20 to 30 minutes before the fault was manually isolated from the supply. These types of events have a significant likelihood of fatal potential, and there is the precedence of a fatality via this means in the Endeavour Energy network.

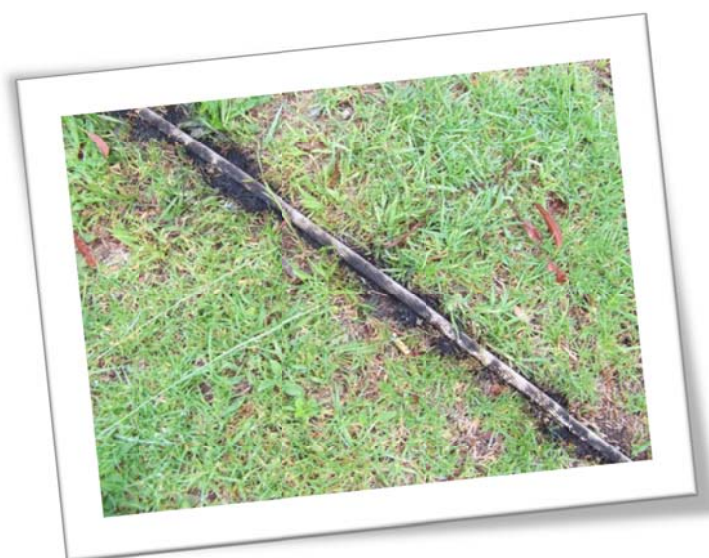
Assuming no fault resistance, the effect of the fault on the 3 phase winding voltages of a delta-star Dyn11 transformer is shown in the figures below. The voltage across the two windings that are connected to the fault will drop and change in angle. On the secondary side, the voltages will also drop and change in angle. The phases are at reduced voltages and are no longer 120 degrees apart. Some load will trip out, some load (e.g. constant power devices such as switch mode power supplies) will draw more current, and purely resistive loads keep the same impedance drawing less current. Embedded generation such as solar panels is likely to trip out resulting in an apparent decrease in impedance.

At the time of the incident, the estimated load current connected downstream of the fault was approximately 5A of primary current. Assuming no fault resistance and only constant impedance load, the calculated residual earth fault current in this case is 1.7A.

Pre-fault		Post-fault	
	Magnitude	Angle	Magnitude	Angle
IA (line)	5.00A	0°	4.41A	-19°
IB (line/fault)	5.00A	-120°	1.67A	-120°
IC (line)	5.00A	120°	4.41A	139°

It can be seen that the residual current (earthfault current) in this case is 1.67A compared to a pre-fault load current of 5A. This assumes star connected constant impedance load with a power factor of unity and a fault resistance of zero. Whilst there are several overly-simplistic assumptions in this analysis, it remains conceptually correct. In many cases of lines down, the fault will remain connected only through the windings of downstream distribution transformers, and in these cases the maximum residual current will be proportional (33% if all loads are constant impedance) to the downstream connected load current, which will usually be very small. A 1A or lower SEF pickup will increase the likelihood of these types of faults, as well as normally fed high impedance faults being detected.

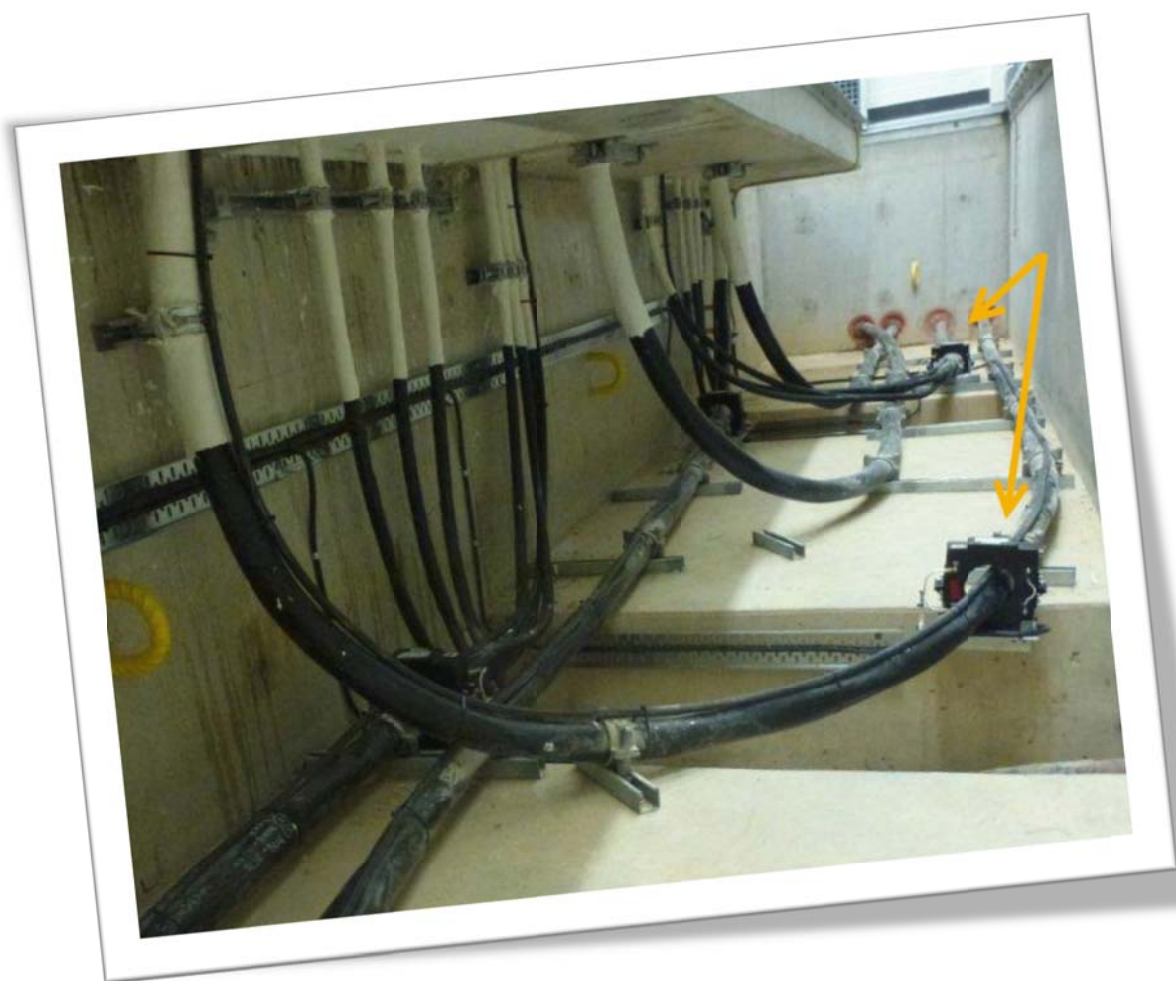
Core balance CT's installed at Blackheath Zone Substation

It is possible to retrofit this scheme to existing installations by installing a split core CT around the distribution cable (the cable screens have to be brought back through the CT to avoid measuring any

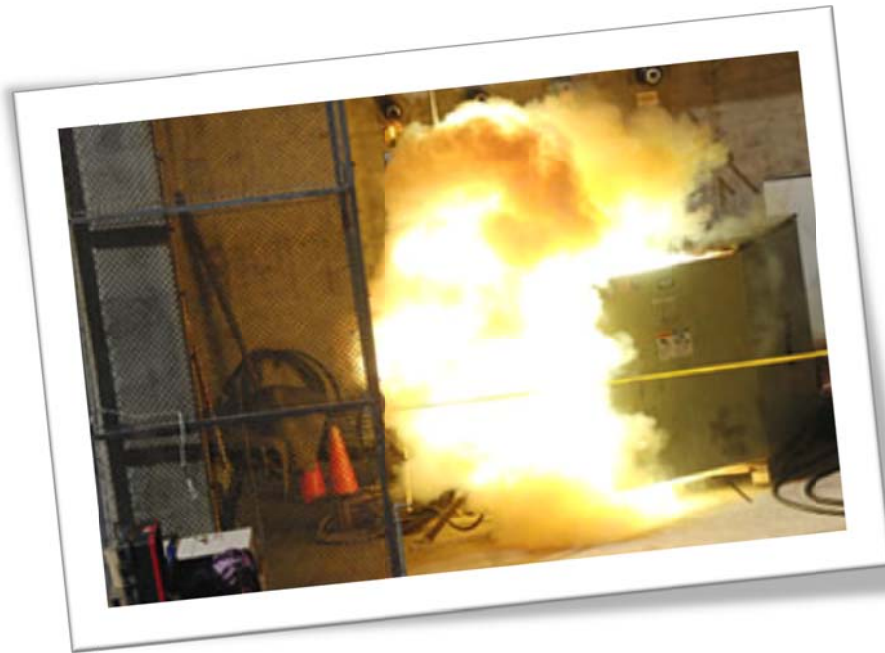
An arc flash explosion from a 21kV padmount switch ^[1]

An arc flash is the explosive release of heat and light energy as a result of an electrical fault where electrical current is partially or fully passing through air rather than a conductor. The temperature of an arc flash can exceed 19,000°C which is 4 times hotter than the surface of the sun. There are other dangers associated with arc flashes such as noise, pressure waves and solid particles such as molten copper which can be ejected at high velocity as a result of the blast.

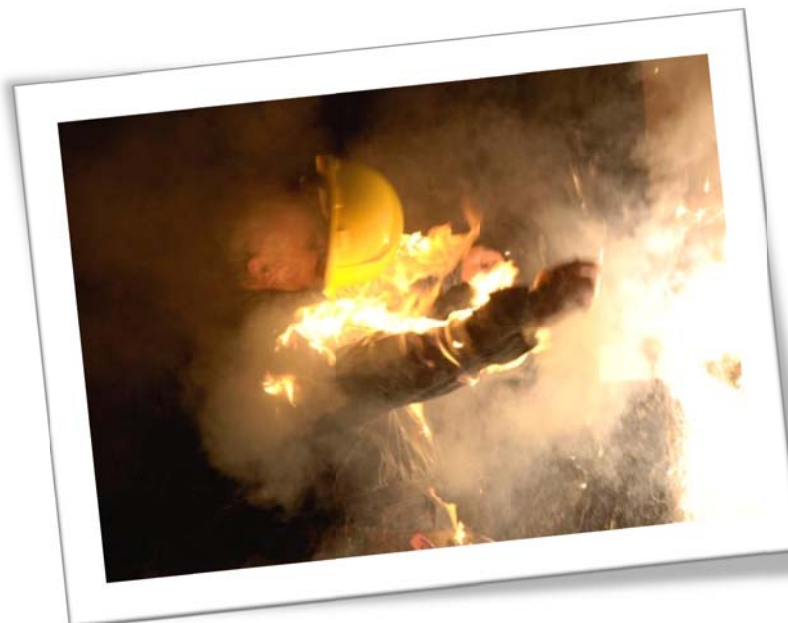
Aftermath of an arc flash explosion ^[2]

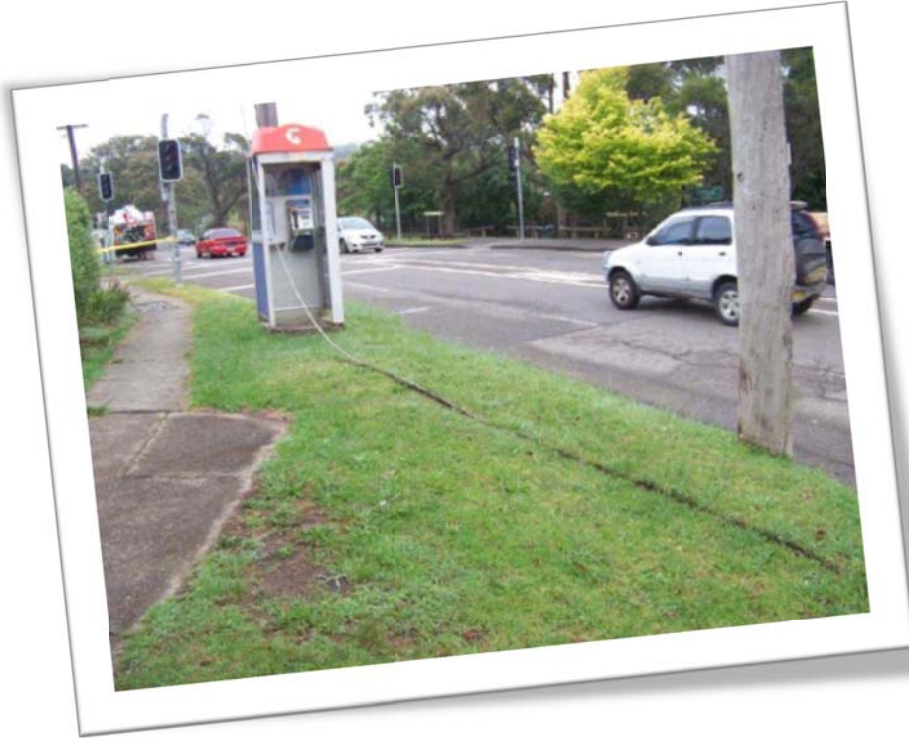
The following event occurred on the Endeavour Energy network a few years ago and this type of event is not uncommon. Members of the public reported that lines were on the ground and witnesses saw arcing and smoking for 20 to 30 minutes before the fault was manually isolated from the supply. These types of events have a significant likelihood of fatal potential, and there is the precedence of a fatality via this means in the Endeavour Energy network.

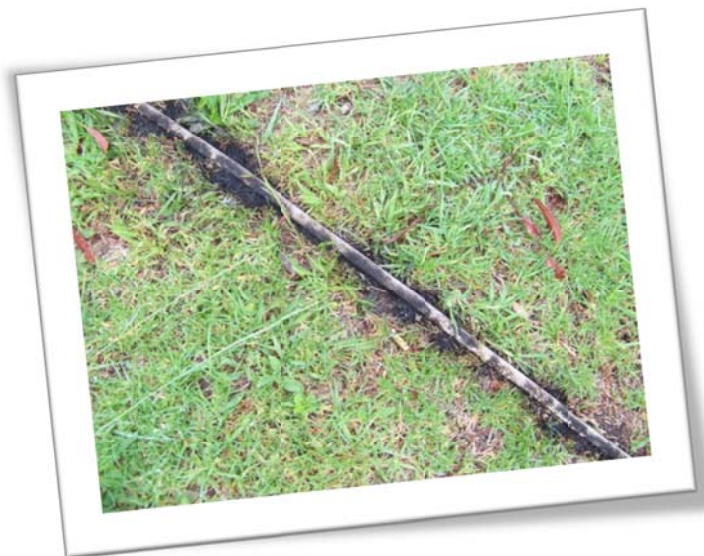
Assuming no fault resistance, the effect of the fault on the 3 phase winding voltages of a delta-star Dyn11 transformer is shown in the figures below. The voltage across the two windings that are connected to the fault will drop and change in angle. On the secondary side, the voltages will also drop and change in angle. The phases are at reduced voltages and are no longer 120 degrees apart. Some load will trip out, some load (e.g. constant power devices such as switch mode power supplies) will draw more current, and purely resistive loads keep the same impedance drawing less current. Embedded generation such as solar panels is likely to trip out resulting in an apparent decrease in impedance.

At the time of the incident, the estimated load current connected downstream of the fault was approximately 5A of primary current. Assuming no fault resistance and only constant impedance load, the calculated residual earth fault current in this case is 1.7A.

Pre-fault		Post-fault	
	Magnitude	Angle	Magnitude	Angle
VA	6351V	0°	6351V	0°
VB	6351V	-120°	0V	0°
VC	6351V	120°	6351V	120°
Va	240V	30°	139V	0°
Vb	240V	-90°	139V	-60°
Vc	240V	150°	240V	150°
Ia	132.3A	30°	76.4A	0°
Ib	132.3A	-90°	76.4A	-60°
Ic	132.3A	150°	132.3A	150°
IA (winding)	2.89A	210°	1.67A	180°
IB (winding)	2.89A	90°	1.67A	120°
IC (winding)	2.89A	-30°	2.89A	-30°
IA (line)	5.00A	0°	4.41A	-19°
IB (line/fault)	5.00A	-120°	1.67A	-120°
IC (line)	5.00A	120°	4.41A	139°

It can be seen that the residual current (earthfault current) in this case is 1.67A compared to a pre-fault load current of 5A. This assumes star connected constant impedance load with a power factor of unity and a fault resistance of zero. Whilst there are several overly-simplistic assumptions in this analysis, it remains conceptually correct. In many cases of lines down, the fault will remain connected only through
