Submission on the AER's public lighting supplementary draft decision

l. Process to date

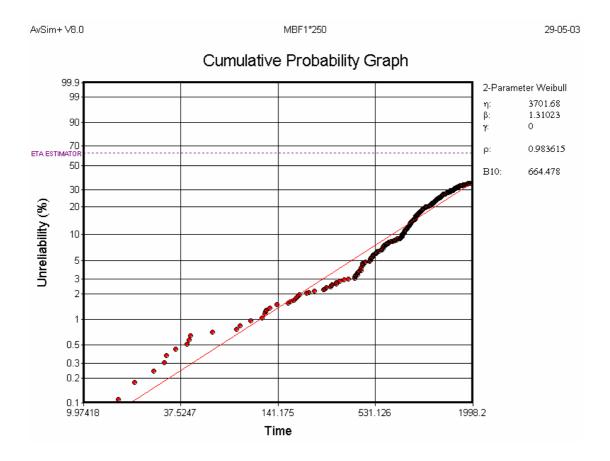
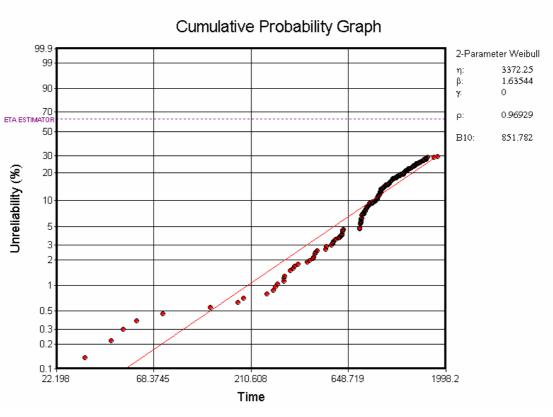
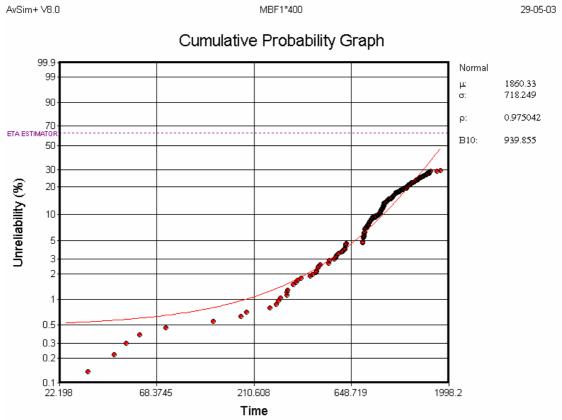
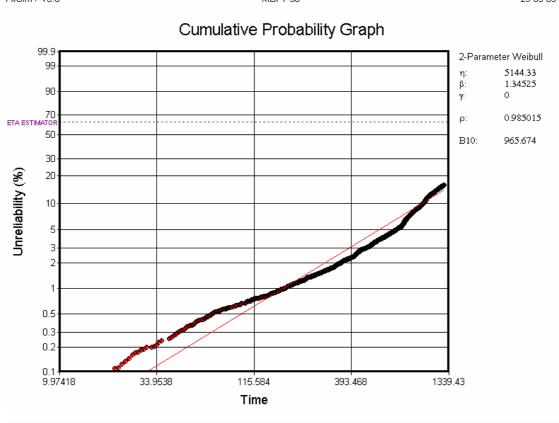
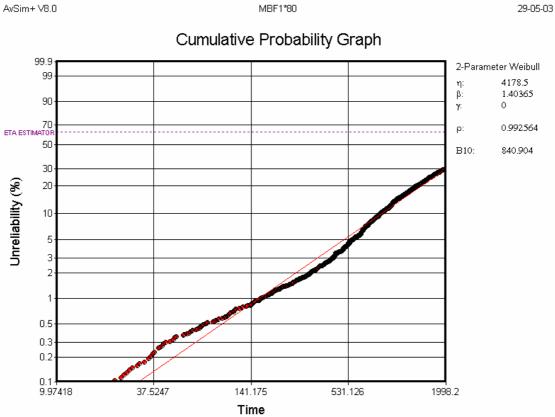
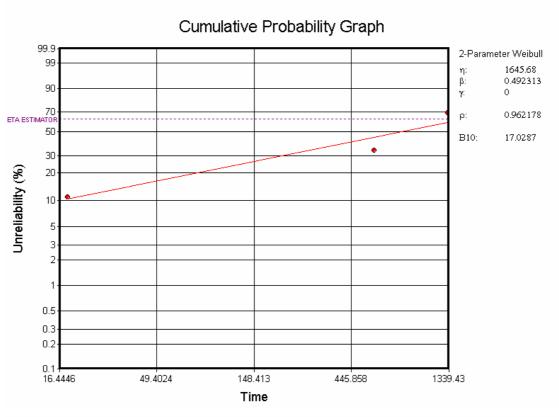
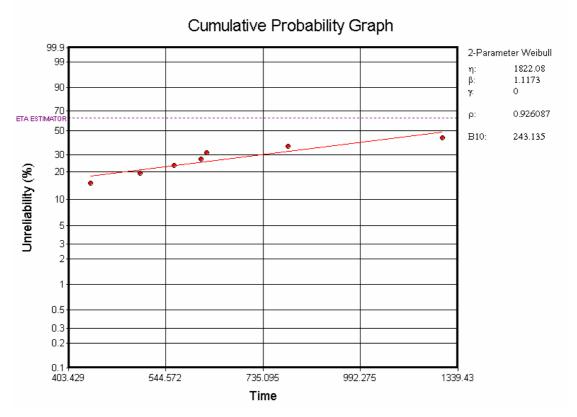
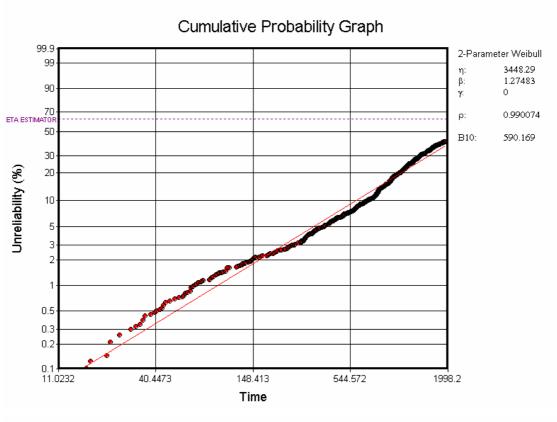
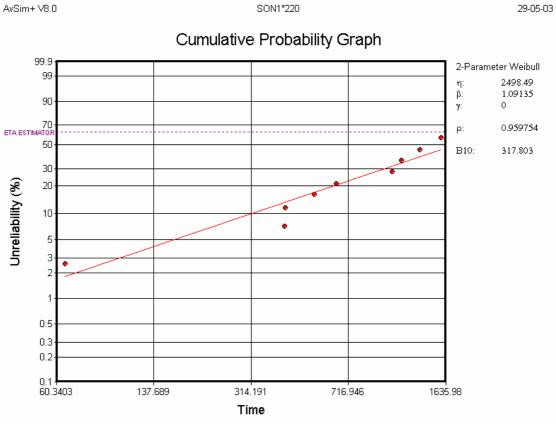
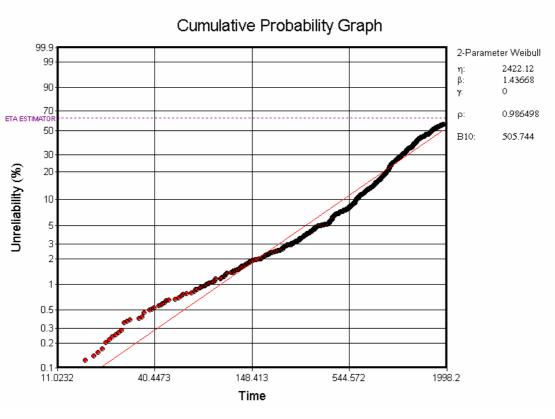
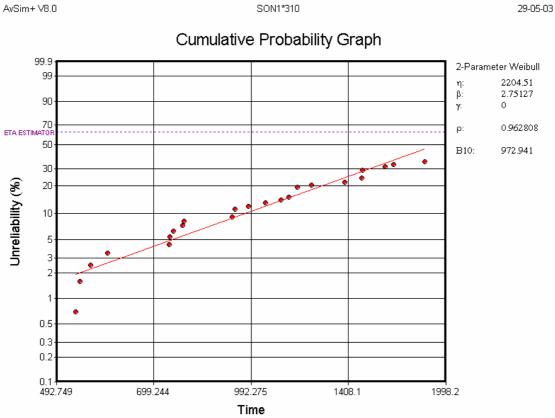
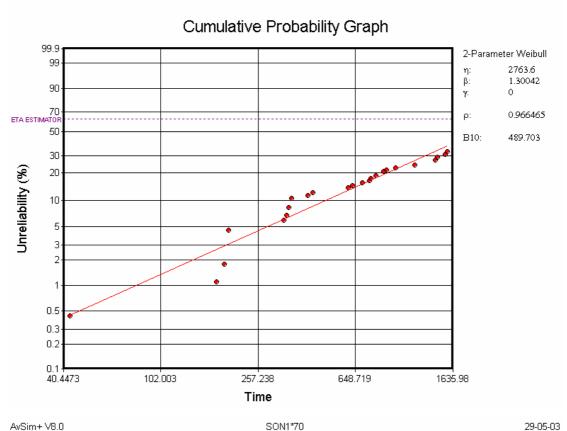
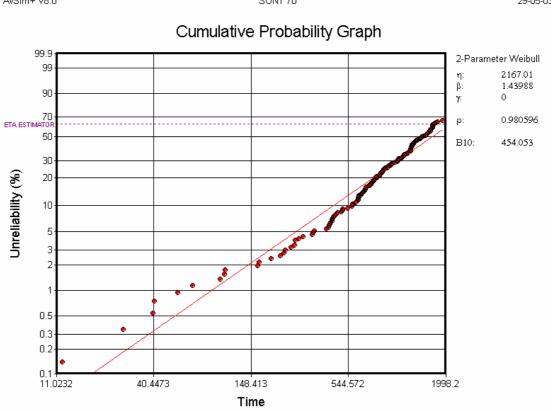
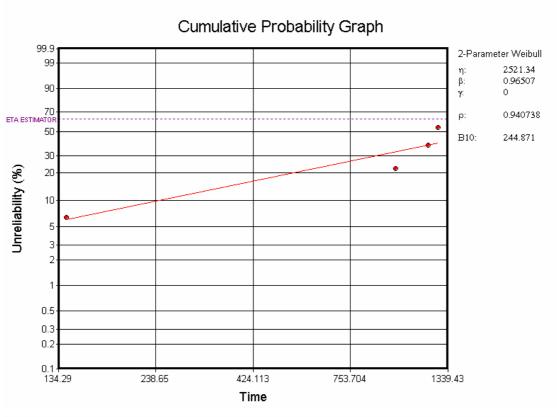
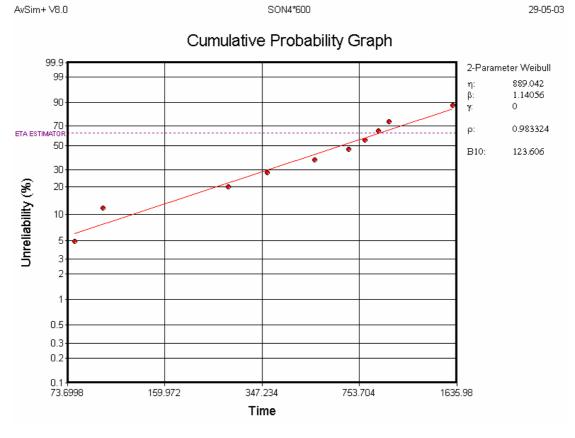
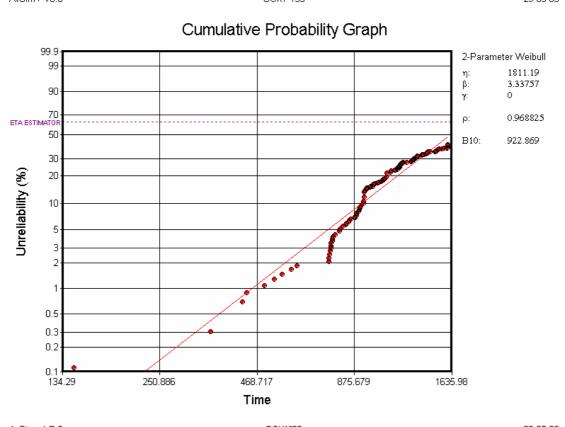
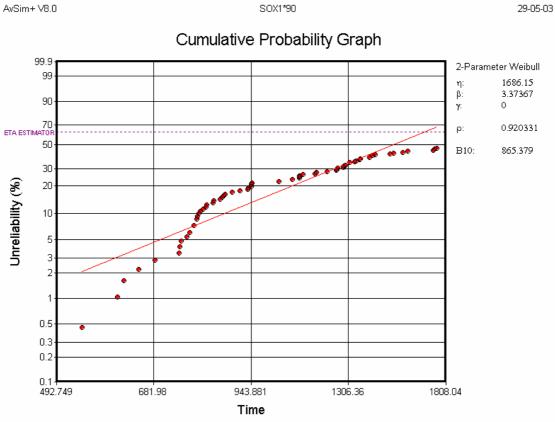
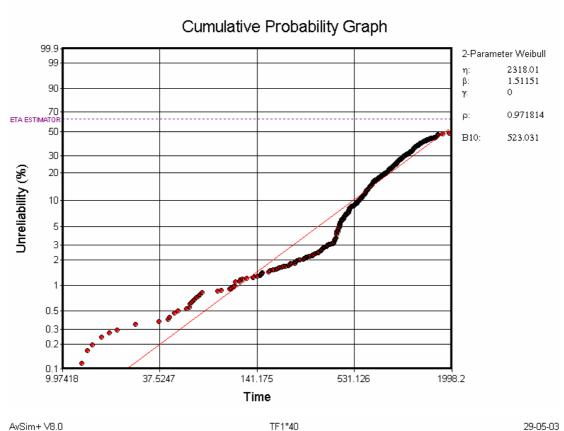
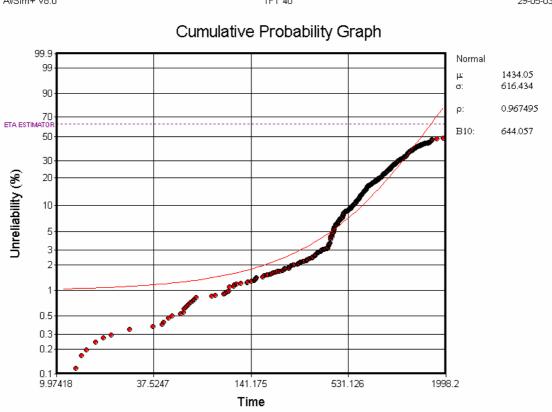
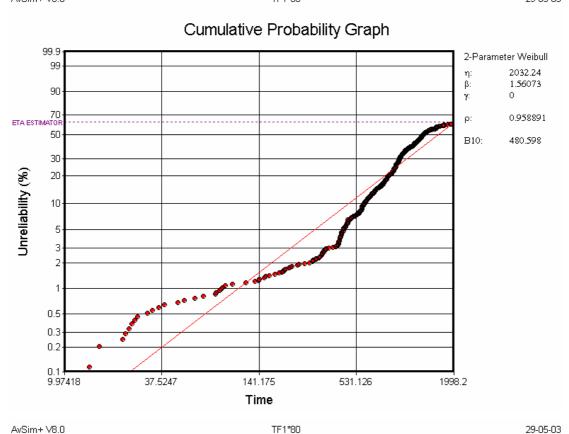
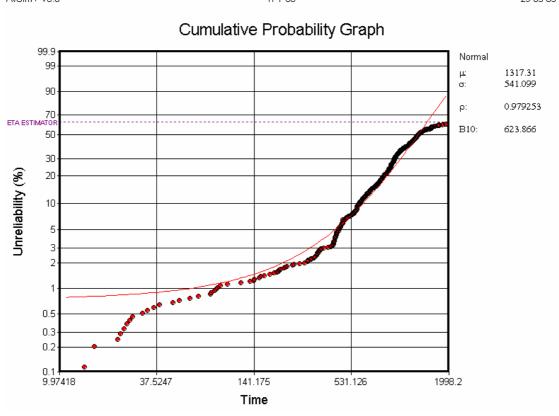
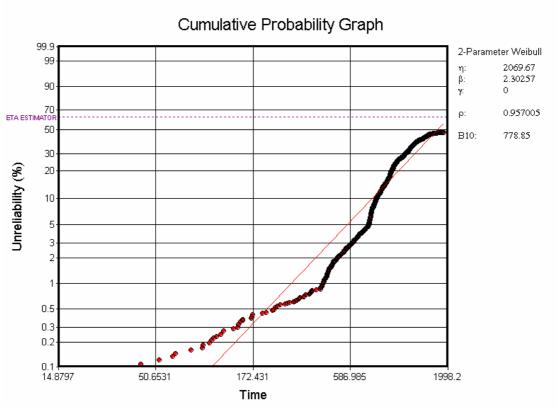
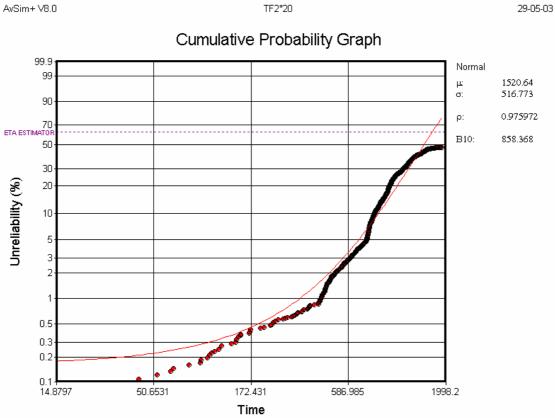
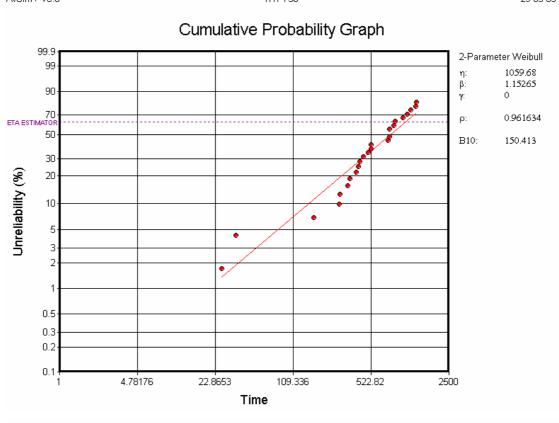
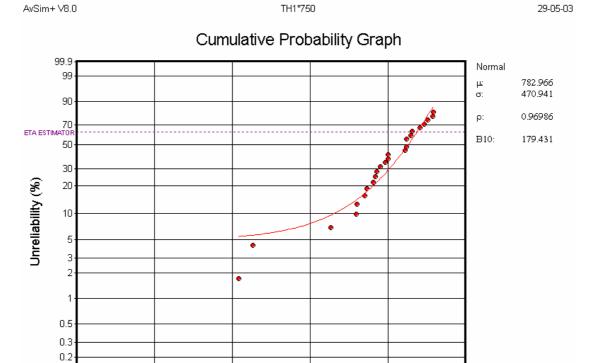
- Data for lamps with status of censored or in service from Newcastle database are considered as 'suspended' for the Weibull analysis
- B10 = days by which 10% of the population is expected to have failed
 - β = 1 = Random Failure
 - $\beta \sim 1.3 we arout$
 - β ~ 2.5 or more rapid wearout
- Some distributions may be closer to normal than weibull. In these cases two graphs for the same data set are presented on the same page
