## Building Condition Review and CAPEX Plan

**BGIS - TransGrid – Ultimo**

**Submission 1.0**

**Project No. EB1110**

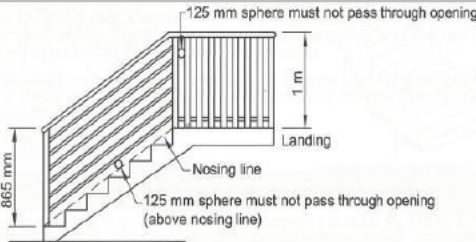
<p>Where the level of the surface below is 4m or more, a balustrade or other barrier must not facilitate climbing of horizontal elements between 150mm and 760mm above the floor.</p> <p>Climbable elements cannot be located within 900mm of the top rail of each balustrade where the fall is greater than 4m. This measurement is taken in an arc as seen in the extract below</p>

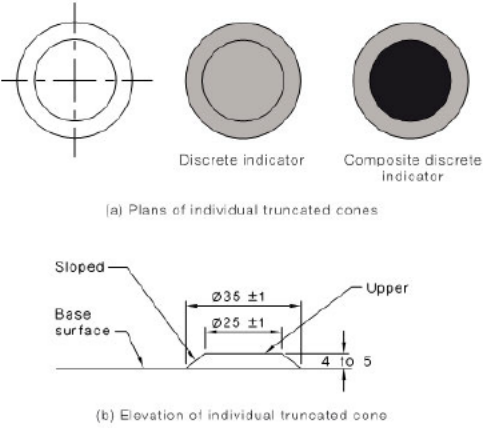
Clause	Description	Comment	Status
	<ul style="list-style-type: none"> <li>• an escalator, passenger conveyor or moving walk,</li> <li>• a ramp other than a fire-isolated ramp, step ramp, kerb ramp or swimming pool ramp, or</li> <li>• in the absence of a suitable barrier an overhead:               <ul style="list-style-type: none"> <li>○ obstruction less than 2 m above floor level, other than a doorway</li> <li>○ an access way meeting a vehicular way adjacent to any pedestrian entrance to a building, excluding a pedestrian entrance serving an area referred to in D3.4, if there is no kerb or kerb ramp at that point</li> </ul> </li> </ul> <p>Tactile ground surface indicators must comply with sections 1 and 2 of AS/NZS 1428.4.1</p>

<p>(a) Plans of individual truncated cones</p> <p>(b) Elevation of individual truncated cone</p>		
D3.9	<p><b>Wheelchair seating spaces in Class 9b assembly buildings</b></p> <p>Where fixed seating is provided in a Class 9b assembly building, wheelchair seating spaces comply with AS 1428.1 must be provided in accordance with Table D3.9.</p>		N/A
