# Program Business Need Identification

## Power and Water Corporation

**PRD33387**

## Transmission Tower Earthing System Refurbishment Program

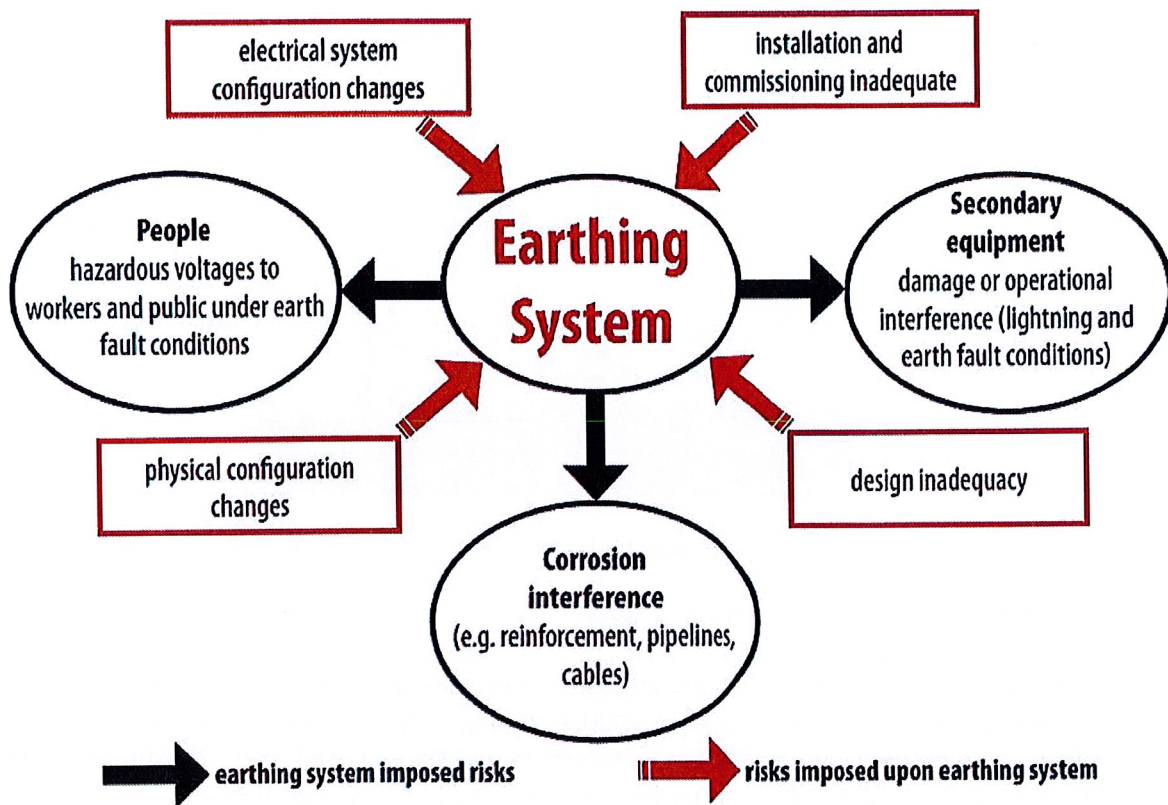
Figure 1 - Earthing System Risk Profile as defined in EG-0

as described by the Energy Networks Associations Power System Earthing Guide EG-0 risk profile in Figure 1 - Earthing System Risk Profile as defined in EG-0. As a consequence, the performance requirements for the earthing system design may differ from one tower to the next along the length of a transmission feeder depending on the environmental conditions at each site, such as soil type and population density.

In the context of Darwin, the urban areas where much of the original transmission system was constructed in the 1970's and 1980's has changed considerably, increasing the uncertainty associated with the risk factors defined in the EG-0 risk profile. What has become apparent during the current period is that the performance of existing tower earthing is inadequate as described further in this section. A report by specialist earthing consultants was commissioned in 2017<sup>1</sup> to provide a review of the historical and current performance and provide guidance on the management of this emerging risk. The report concluded that remediation of towers with the poorest performance was prudent and that further development of routine testing practices was also required to effectively manage these risks.

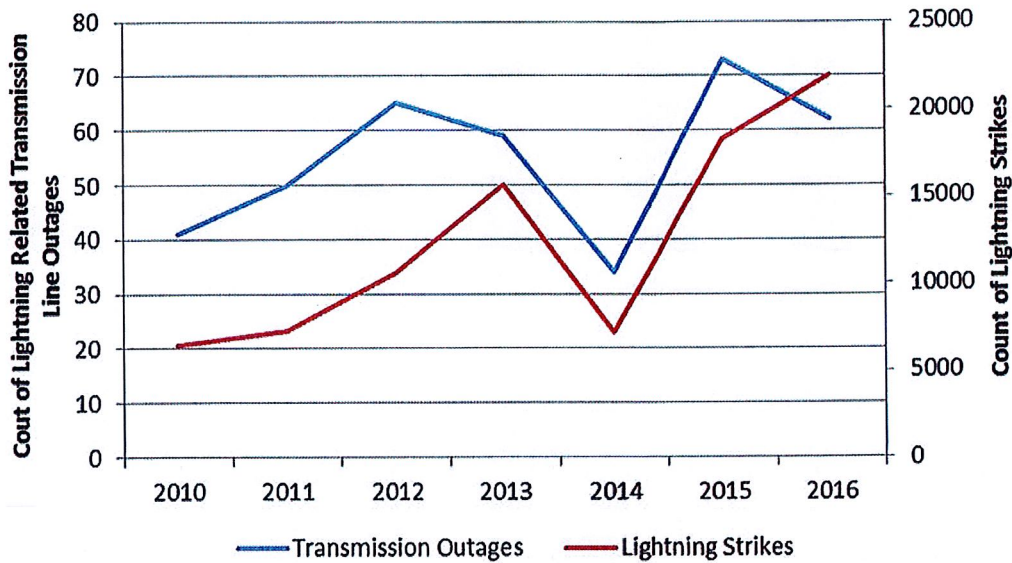
Figure 4 Transmission Line Outages and Recorded Lightning Strikes In Darwin Area

The correlation between annual lightning strikes<sup>5</sup> and transmission line outage rates is also demonstrated in Figure 4 Transmission Line Outages and Recorded Lightning Strikes In Darwin Area below. This data shows a strong correlation between lightning and lightning related transmission outages. Note the growth in lightning sensors in the north of Australia will continue to improve the accuracy of lightning data, and additional focus on recording transmission line outages may partially explain the increasing trend in both series.

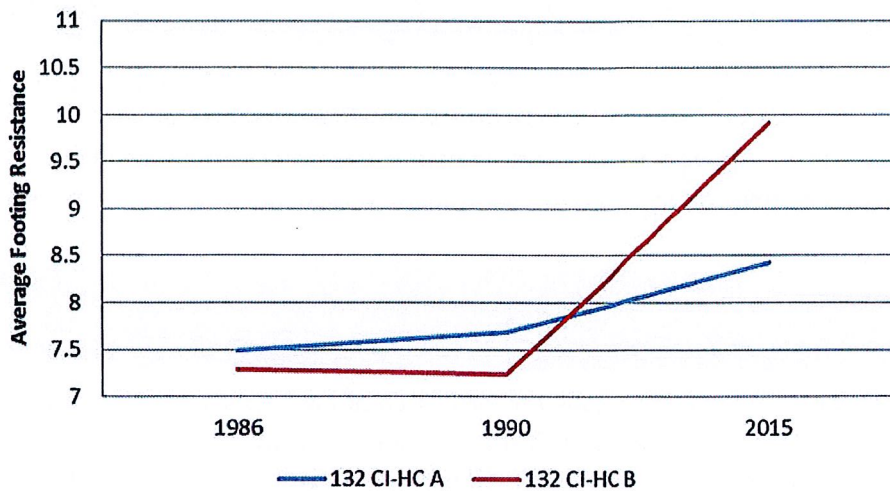
Figure 6 - Available 132kV CI-HC Lines Historical Test Results

Further investigations triggered by the 2014 System Black event determined that particular feeders, specifically the 132 kV Channel Island to Hudson Creek (132 CI-HC) transmission line had 25% of its earthing systems exceed 10Ω, which is PWC’s current pass criteria in lieu of tower specific assessments. The investigation also found that connections to the OHEW may have been compromised at some installations impacting on the effective fault return path and corrective action has been performed to address this issue. It is worth noting that both the 2010 and 2014 Darwin-Katherine “System Black” events were initiated by lightning strikes on the 132 CI-HC line. It is not clear

whether this was due to a back-flash occurring. A report commissioned by the System Operator as a result of System Black investigation findings recommended corrective action associated with earthing connections, which have been resolved, and further consideration of earthing system improvements to mitigate possible future back-flash caused by lightning strikes. Figure 6 below demonstrates the increase in average footing resistance for these two lines.

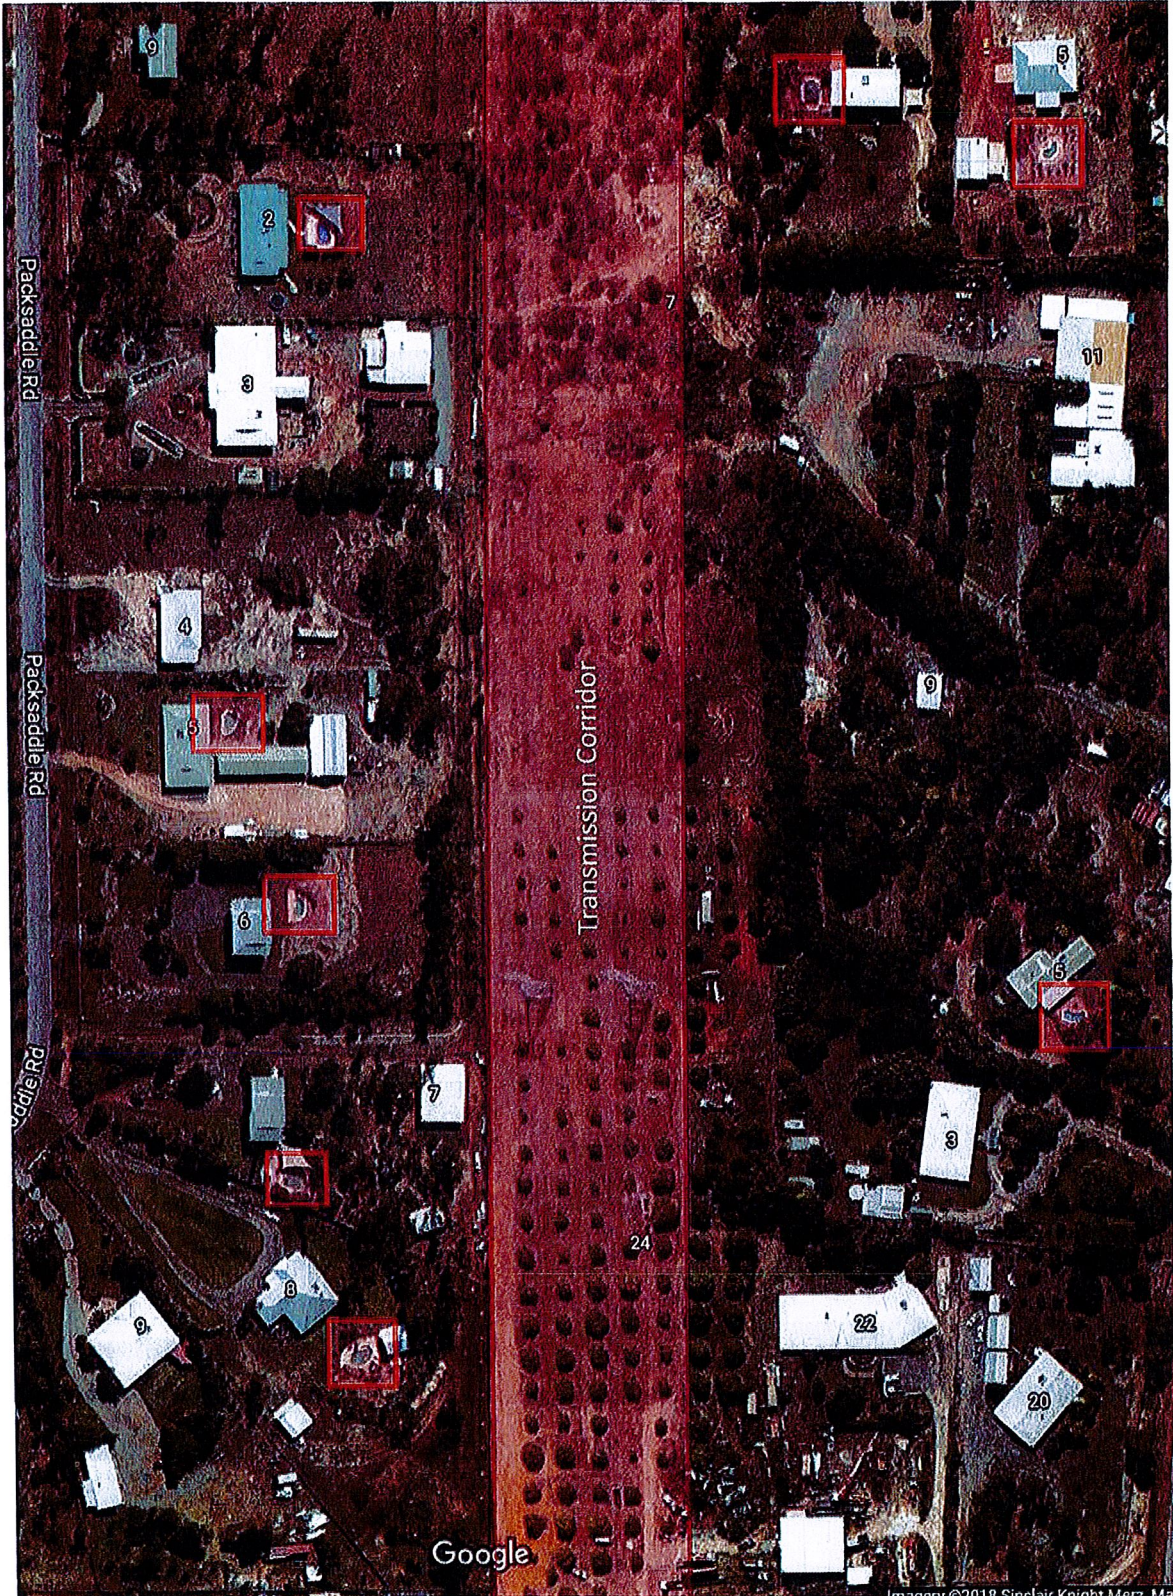
Figure 7 Example of Urban Infill Along 132kV and 66kV Line Corridor including houses, sheds, swimming pools
