Evaluation of Low Energy Lights for Minor Road Lighting

**Twin 14 & 24W T5
32 & 42W CF
50W HPS**

Produced by the *Victorian Sustainable Public Lighting Action Group (VSPLAG) – Technical Reference Group.*

Final Report, Revision 1: 2nd April 2009

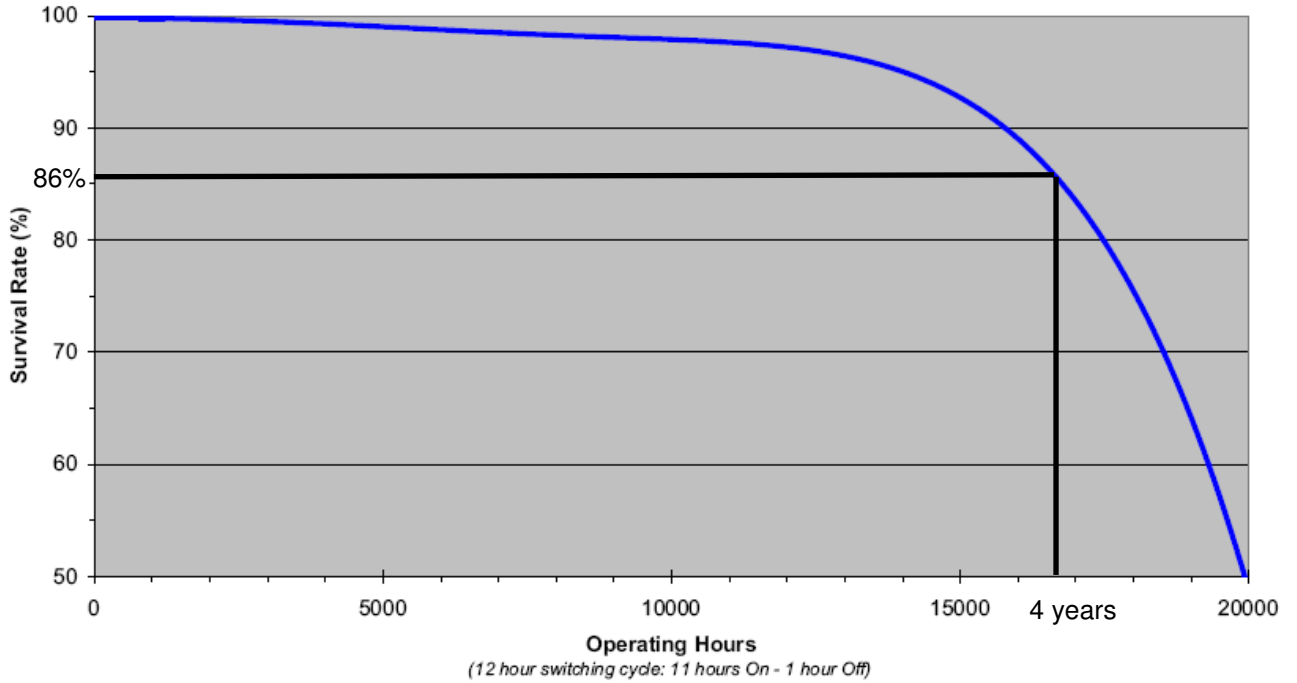
Lamp Survival - Lynx 26W, 32W & 42W CFTE

Calculation of lamp life expectancy:

From the figure above, at 4 years (16644 hours), the survival rate of a CF lamp based on a 11 hr switching cycle is 85% or 15% failure rate (or $15/4 = 3.75\%$ per year average).

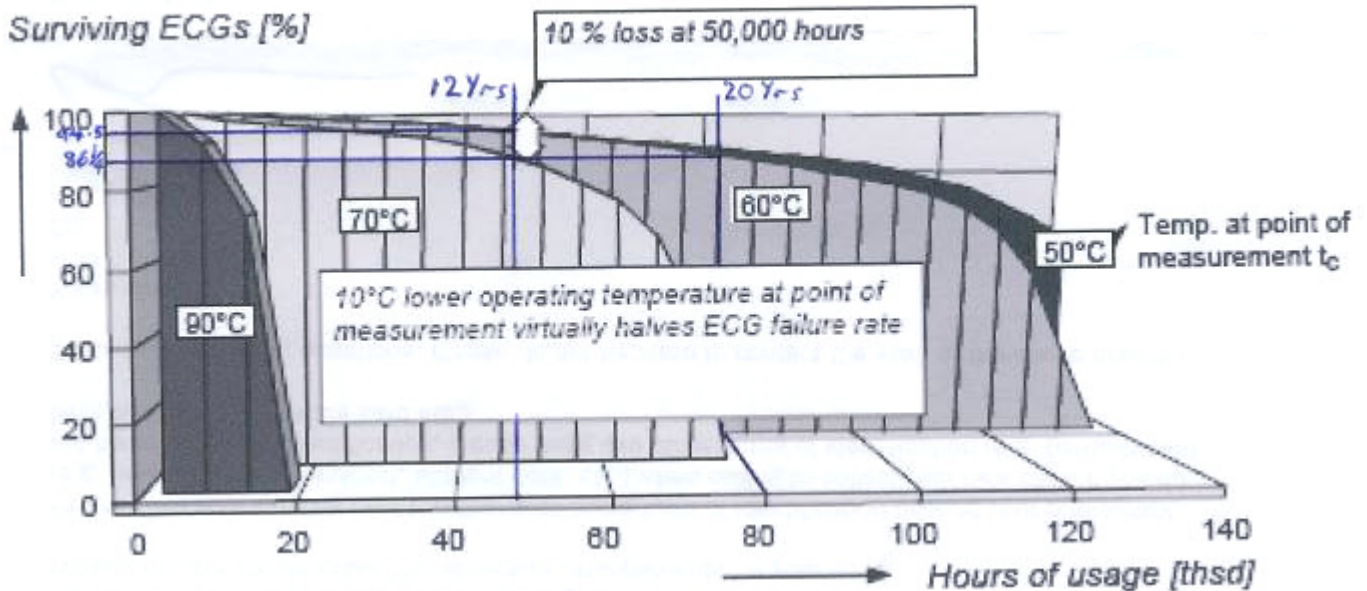
Appendix 3 : Electronic (Ballast) Control Gear (ECG) Failures Rates

Life expectancy curve below².

Calculation of ECG life expectancy:

The table below summarises the expected life of the ECG at different maximum temperatures at the T_c point. Note that this is conservatively based on 3 hour switching cycle. It is expected that there will be increased life for 11 hr switching cycle (for lamps the life is increased by 17%). ECG life is dependent on maximum temperature.

From the T5 ballast life expectancy curve in *Appendix 3*, over 8 years the failure rate is approximately linear at about 0.7% failure per year (based on a 70 degrees C curve).

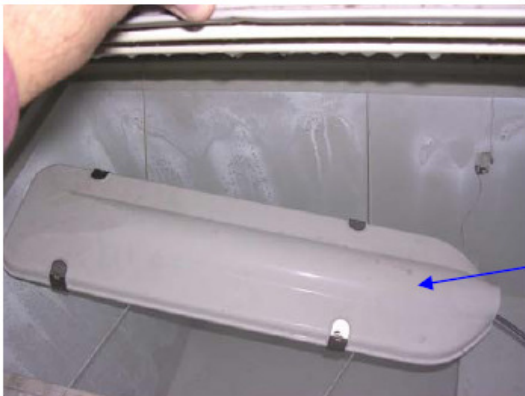
the test ended at -15C were the freezer could not drop the ambient any further.

Photo of Green Street in freezer
After testing.
