Asset Management Plan

Conductors and Hardware – Distribution

Info Zone Record Number: R260427

Version Number: 3.0

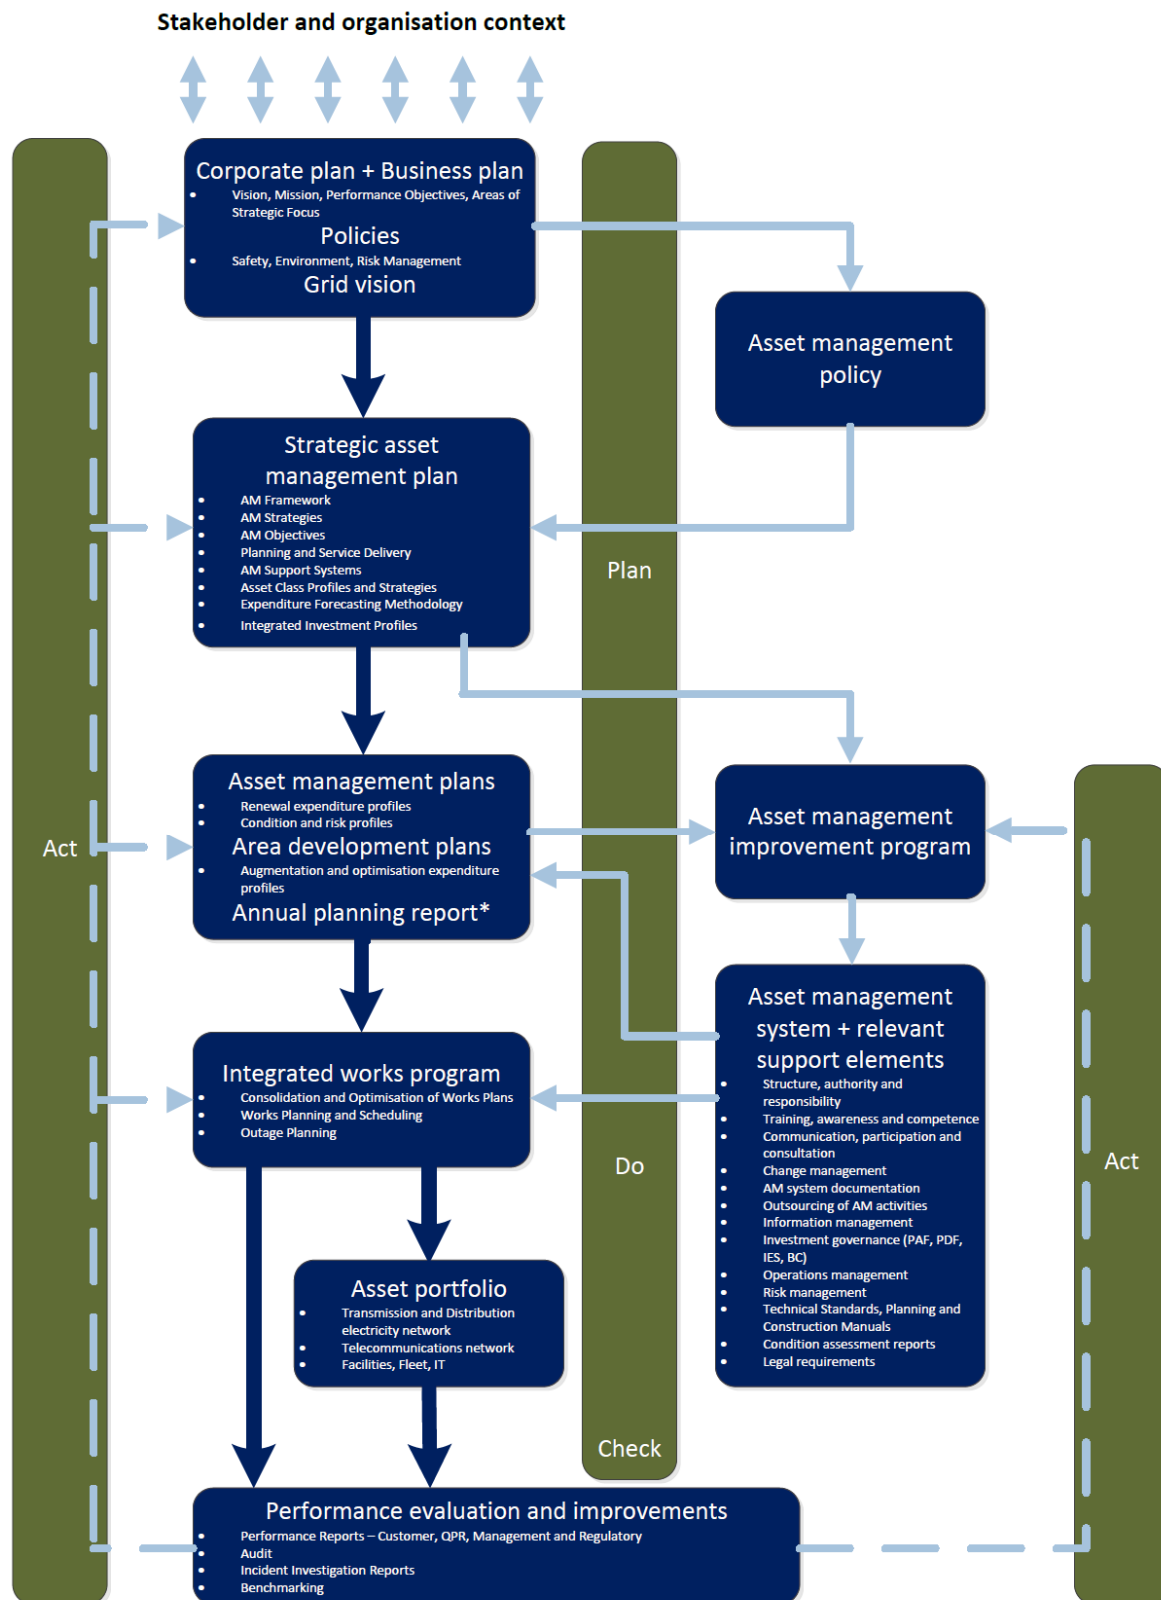
The asset management policy and strategic objectives are outlined within the Strategic Asset Management Plan. Figure 1, from the Strategic Asset Management Plan, represents TasNetworks documents that support the asset management framework. The diagram highlights the existence of, and interdependence between, the Plan, Do, Check, Act components of good asset management practice.

Figure 1: TasNetworks Asset Management Documentation Framework

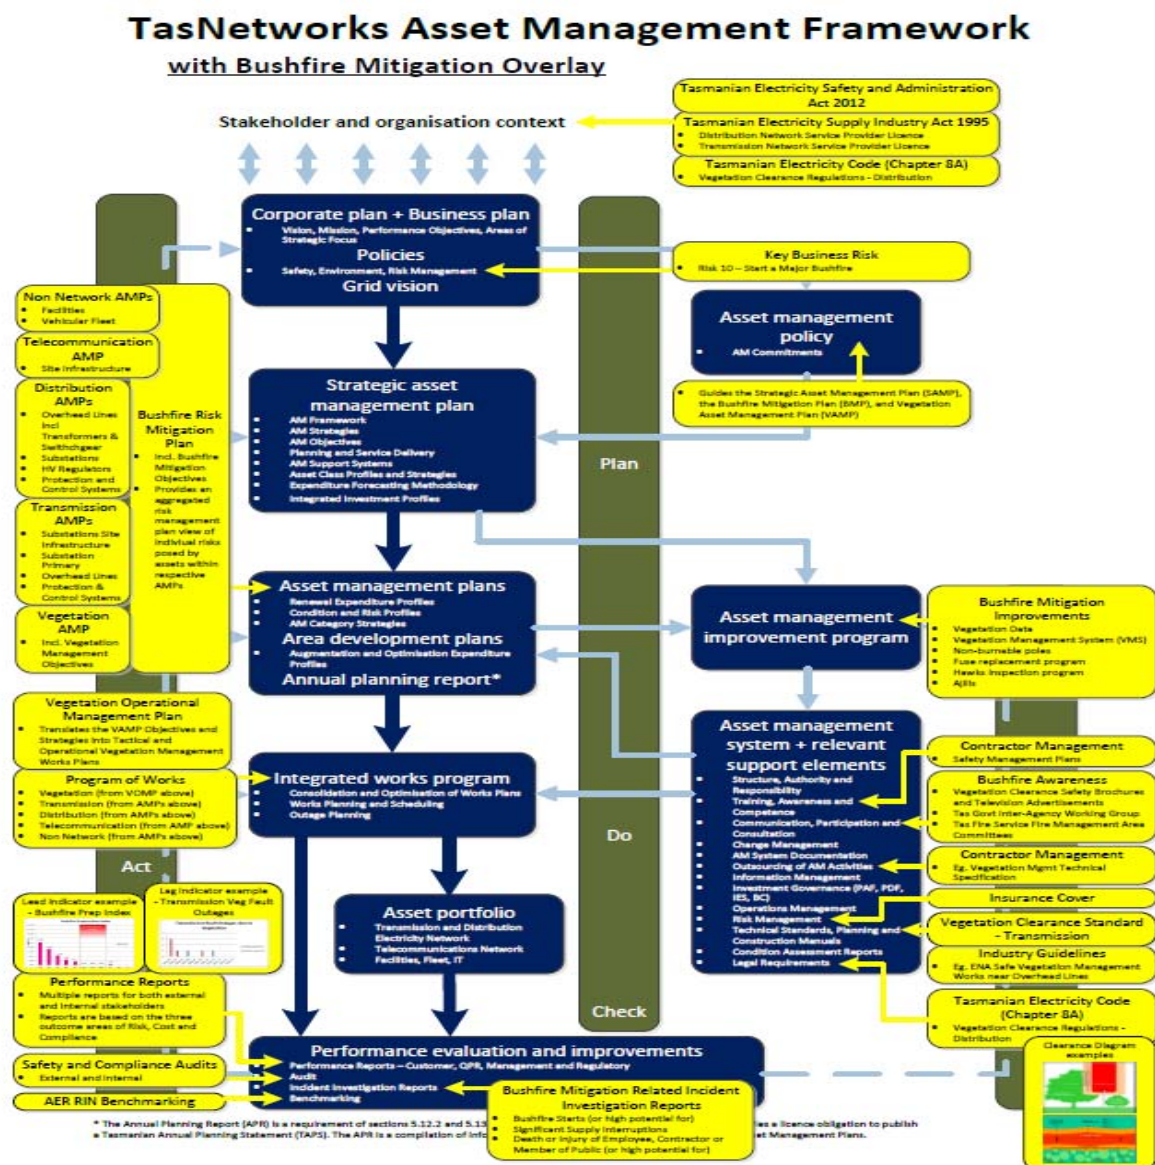
Figure 2: TasNetworks Asset Management Documentation Framework with Bushfire Mitigation Framework Overlay

Many TasNetworks assets, including distribution conductors and poletop hardware are located within areas of the state affected by bushfire. TasNetworks' bushfire mitigation framework has been overlaid onto the TasNetworks Asset Management framework to show the direct relationship between the two, and is shown in Figure 2. The Bushfire Mitigation Asset Management Plan provides guidance to other stakeholders in the preparation of asset management plans, ensuring effective bushfire risk mitigation outcomes are achieved, while also summarising some key bushfire risk mitigation outcomes and commitments made within those asset management plans.

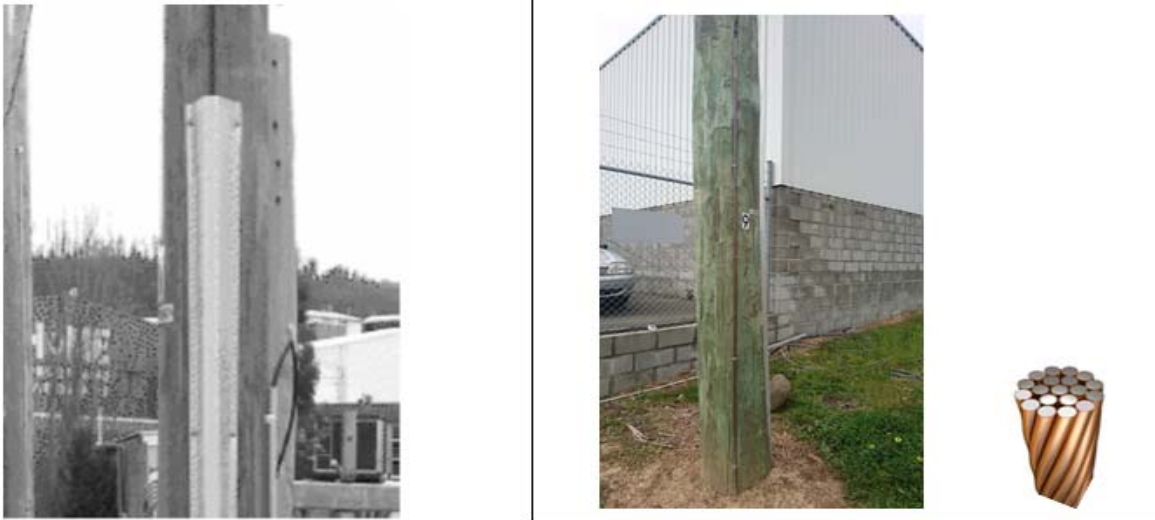
Figure 3: Pole earth copper theft is resisted by steel covers or using copper clad steel

Pole copper earth theft is persistent, but vandalism and theft risk is reduced by use of steel covers or using copper clad steel earthing conductors.

In the 64 SWER systems the HV SWER pole earth is also a load current carrying conductor, and any breakage or copper theft deliberate cut of the HV earth conductor can immediately impose 12.7kV ac open circuit voltage to earth on the break gap as a shock hazard risk and a gap current flow resistive heating wood risk of pole fire.

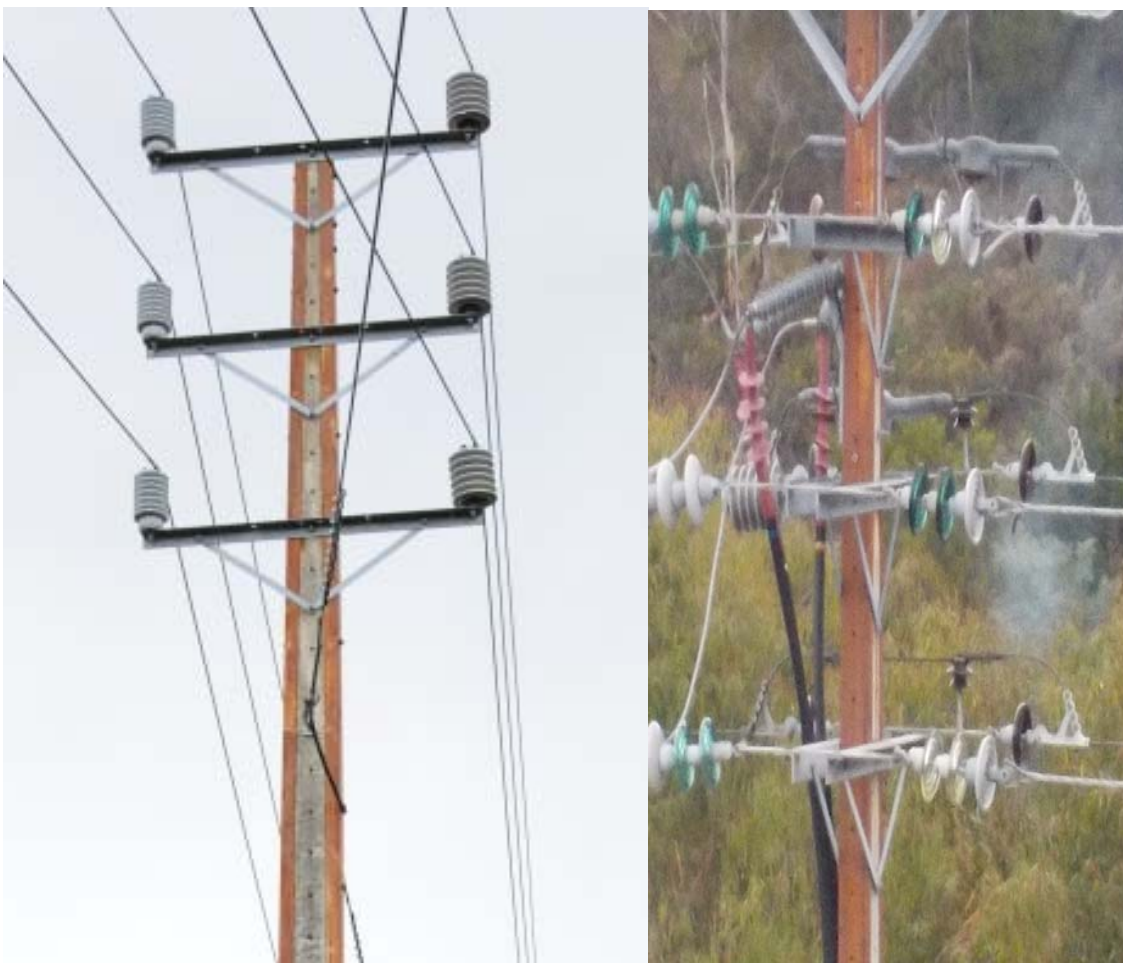
Figure 4: Steel HV cross arms and insulators on dual circuit 33kV and 33 kV and 11kV circuits on a stobie pole

Steel HV cross arms are used because they provide the structural integrity to withstand high conductor load tensions and associated loads imposed (see Figure 8). ENA industry feedback indicates these have the lowest failure rate of all crossarms at 1.6 per 100,000 crossarms installed.

Generally surge arresters are installed on specific higher replacement cost equipment, such as pole mounted cable risers or transformers. Figure 4 shows red weathershed metal oxide surge diverters also used as angled nearly horizontal support insulators for cable riser termination. However, the surge arresters may also be placed in the overhead system at strategic locations prone to lightning strike. Appendix L illustrates lightning risk is higher in the north and northwest.

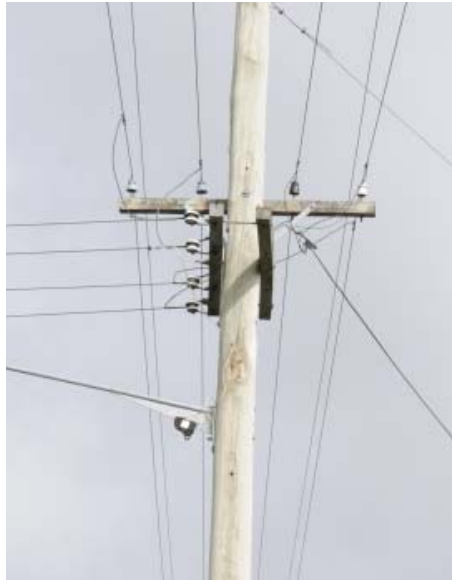
Figure 5: Wooden LV cross arms

LV cross arms are predominantly manufactured from sawn timber as this medium is cost effective and offers insulation qualities to allow live line activities to be performed safely. Sawn wood LV crossarms as are shown in Figure 9 and have a relatively short service life (≈20 years). ENA industry feedback indicates the untreated wood cross arms mostly fail by fungal decay, and at rate of 258 per 100,000 crossarms installed.

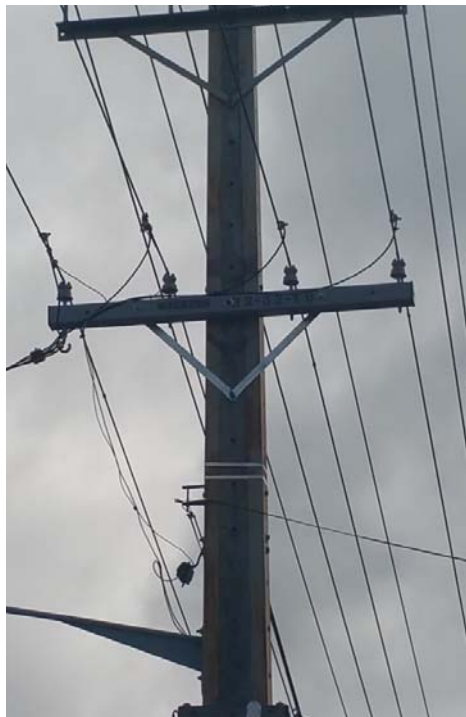
Figure 6: Fibreglass (FRP) LV cross arm in trial

In 2016/17, a cross arm trial recommended in its Final Report (reference 17) replacing LV cross arms with more than 15 years service life with Fibreglass crossarms. An 18 months change period has been proposed and a further trial involving alternative HV cross arms was recommended, primarily for improved lighter weight lift ergonomics, increased insulation for reliability and endangered species flashover risk mitigation. The LV crossarm trial concluded that the fibreglass crossarms offered safer handling, an improved asset lifecycle cost and improved insulation for reliability (see references 12,17 and the summary in Appendix P).

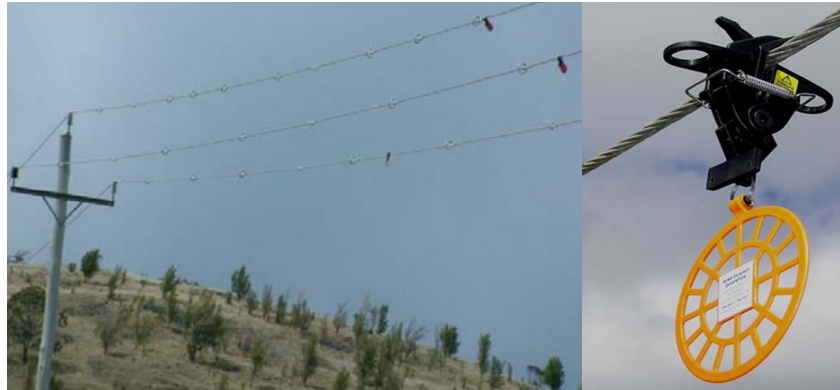
Figure 8: Bird diverters installed on conductor (but not on substandard conductors)

Swans, geese, waterfowl and other large birds commonly collide with conductors. Bird diverters are installed in problematic locations to make conductors more visible to birds (Figure 17) but are not installed on substandard conductor that display red rust or have insufficient strength. Birds are the cause over 400 outages a year on TasNetworks' distribution system.

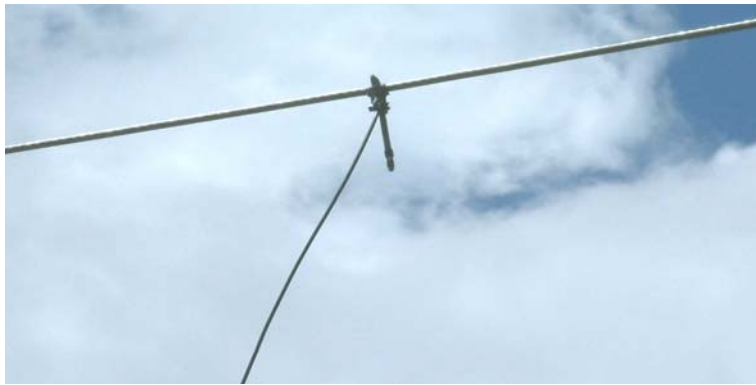
Figure 9: Live line clamp directly connected

In the past, live line clamps were used to connect new transformers directly to HV feeders without requiring an outage as in Figure 10. This connection was intended to be a temporary connection and to be changed to a 'D-loop' at the next planned outage. Records were poorly kept of installations connected using live line clamps and many were not changed to D-clamps. It is estimated that there are approximately 10,000 live line clamps still connected (by the WASP defect pool).

The connection of a live line clamp directly onto a live tensioned conductor can result in arcing, eroding individual strands of the conductor and greatly reducing its strength. The risk is greater for Galvanised Iron (GI) conductor as this arcing can remove the galvanising, which exposes the iron to moisture build up underneath the clamp. This results in corrosion of the conductor, which will lead to conductor failure or the fusing of the conductor to the clamp. Priority will be given to the HBCA for this program to remove live line clamps.

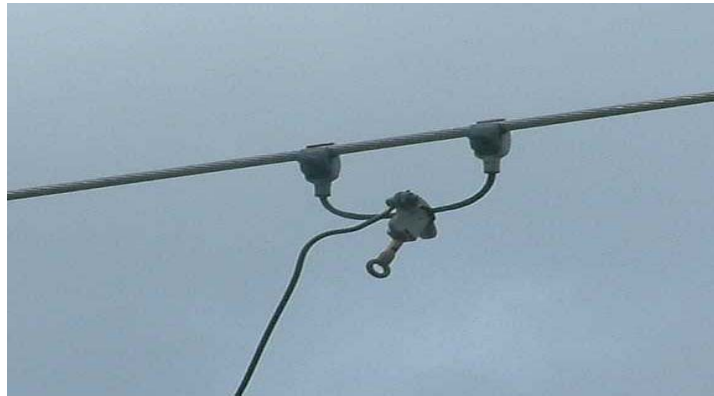
Figure 10: Live line clamp connected via D-clamp

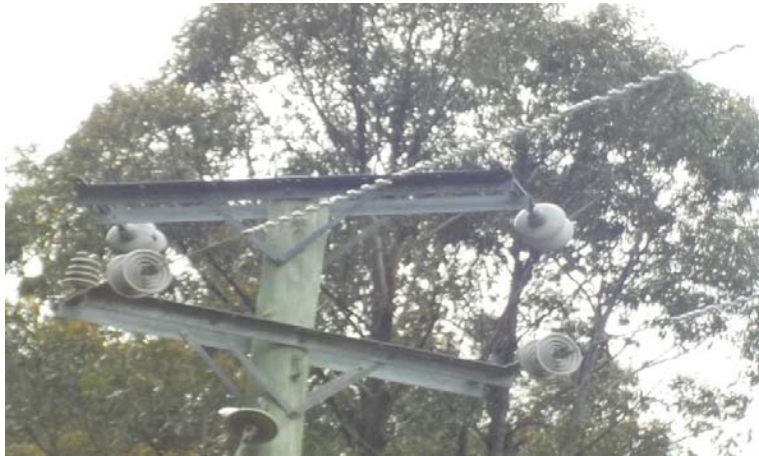
Figure 11: Three in series HV spiral dampers per conductor on a long span

Spiral vibration dampers are a relatively simple device used to minimise the effects of wind-induced vibration on HV power lines. Sustained vibration can lead to wearing and abrasion of a conductor and the ties near the connection point. It is for this reason that dampers are normally installed within a hand's width of where the conductor finishes at a pole. Dampers are helically wound around the outside of the conductor and clamped at one end. As the vibrating conductor hits the inside of the damper coil the coil disturbs the build-up of natural frequency, thereby reducing vibration. Figure 11 shows a series of three spiral dampers per phase in a long span.

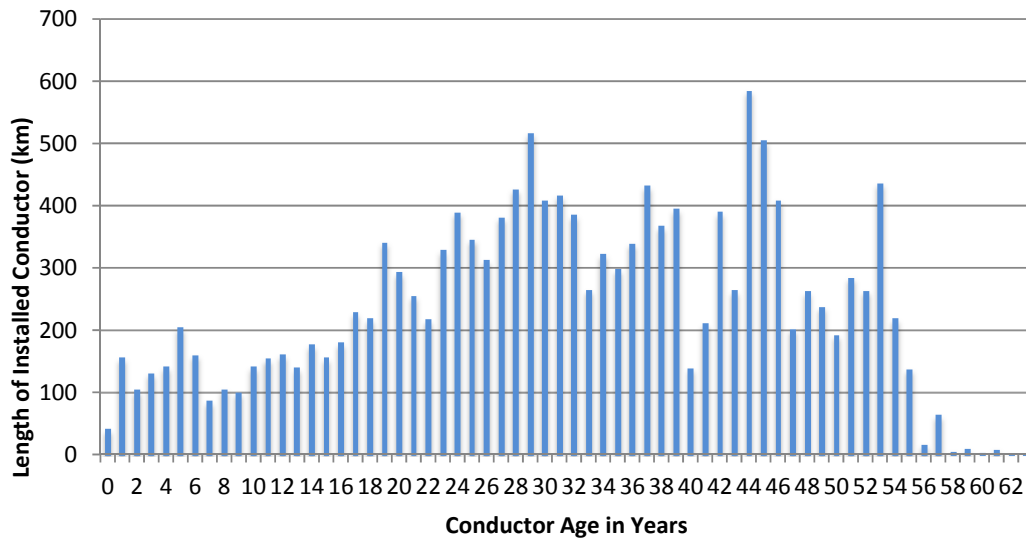
Figure 12: Estimated Age Profile for all HV Conductor in the Network

The age profile of all HV overhead conductors is indicated in Figure12. Copper and galvanised iron conductors being the majority of the older conductors.

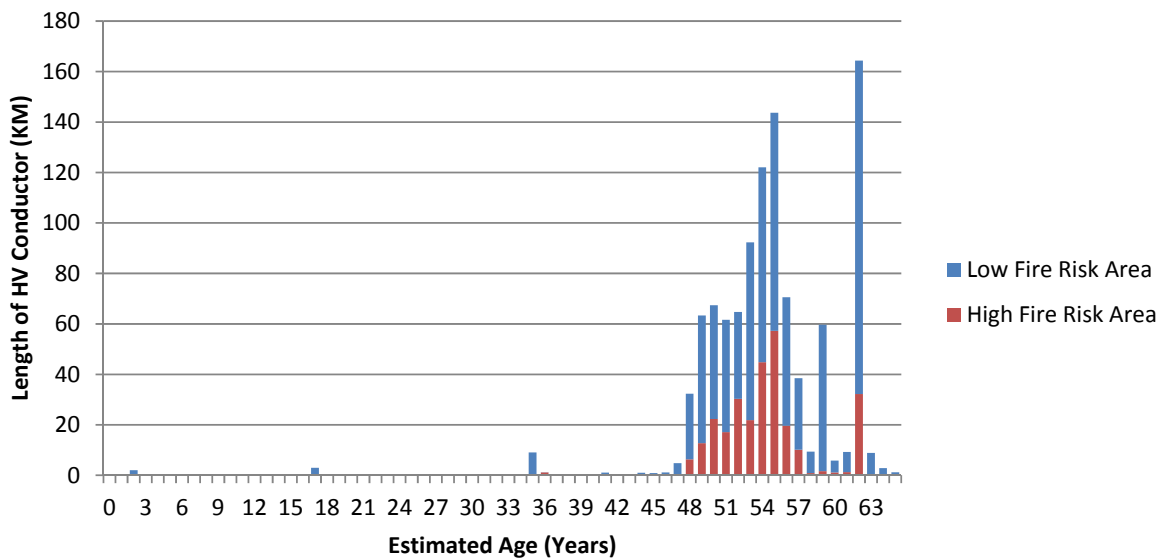
Figure 13 Copper HV Conductor Estimated Age Profile

Figure 13 gives the age profile of copper conductor. As the majority of copper conductor in the LV and HV system was installed prior to 1964 it will be in excess of 55 years old by the start of the current determination period in 2019.

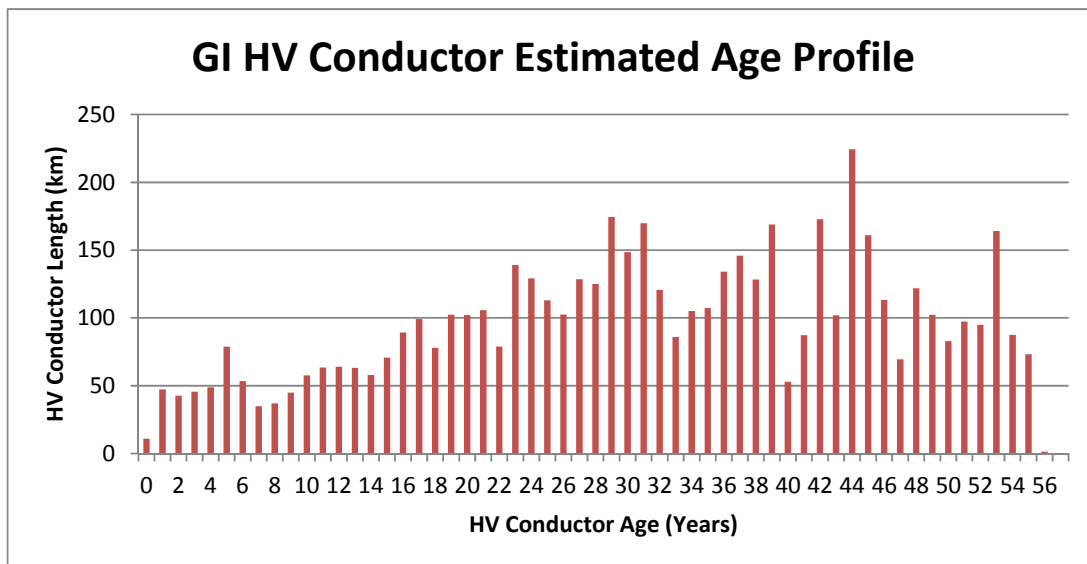
Figure 14: GI HV overhead conductor estimated age profile.

Figure 14 shows the estimated age profile for GI HV overhead conductor.

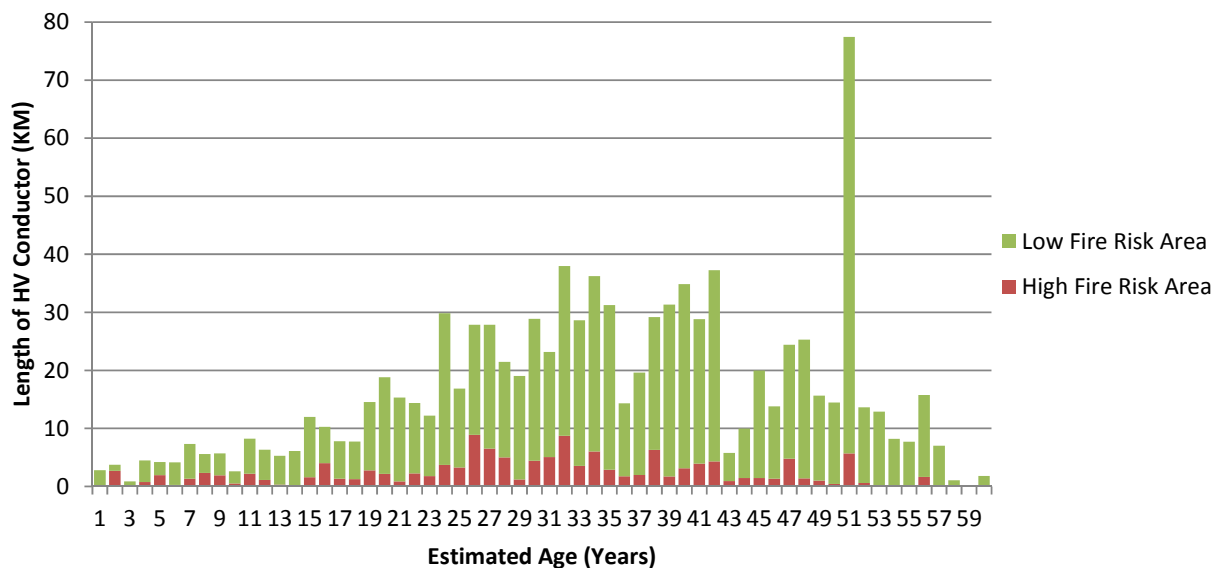
Figure 15: GI Conductor estimated age profile within 2km of the coast

Figure 15 shows the age profile of the most at risk GI HV conductors, those within 2km of the coast. The large age spike of GI conductor currently at 51 years of age can be attributed to the work carried out in the aftermath of the 1967 bushfires and the older is mostly rural electrification not otherwise destroyed in bushfires.

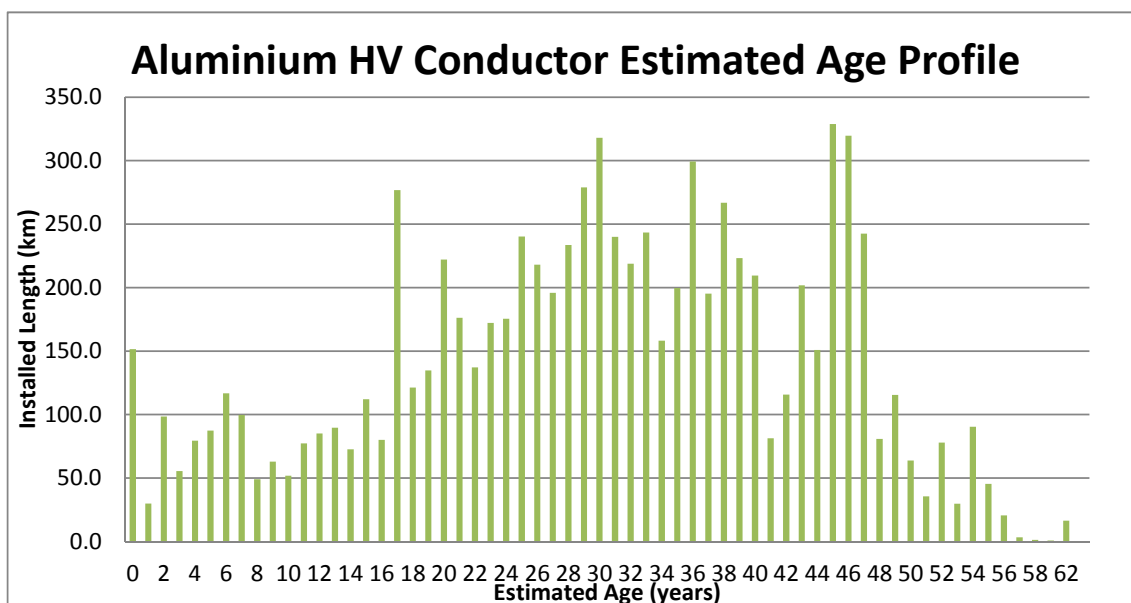
Figure 16: Aluminium HV conductor estimated age profile.

Figure 16 illustrates the age profile of aluminium conductors in TasNetworks distribution system. The majority of aluminium conductor in the LV and HV system was installed from 1963 and will average in age from new to 53 years by the end of the current determination period (2016/2017). Smaller cross section stranded AA conductor is more surface area to diameter prone to corrosion earlier, and to creep by fatigue if at high mechanical tensions likely in rural lines.

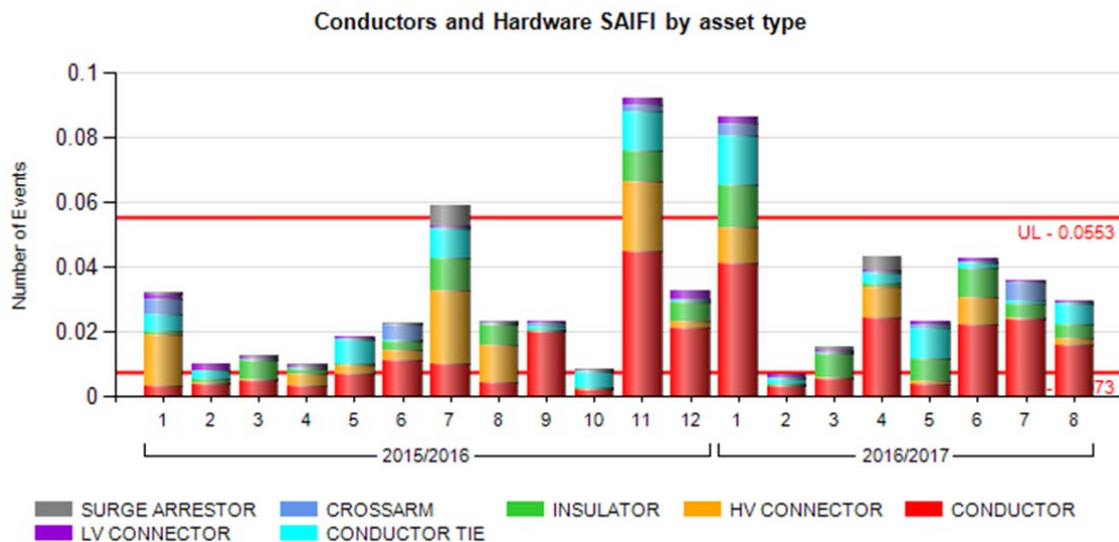
Figure 13: Asset Failure SAIFI contribution – Conductors and Hardware

Figure 17 identifies conductor and hardware asset failure contribution to SAIFI 2015/2016 and 2016/2017

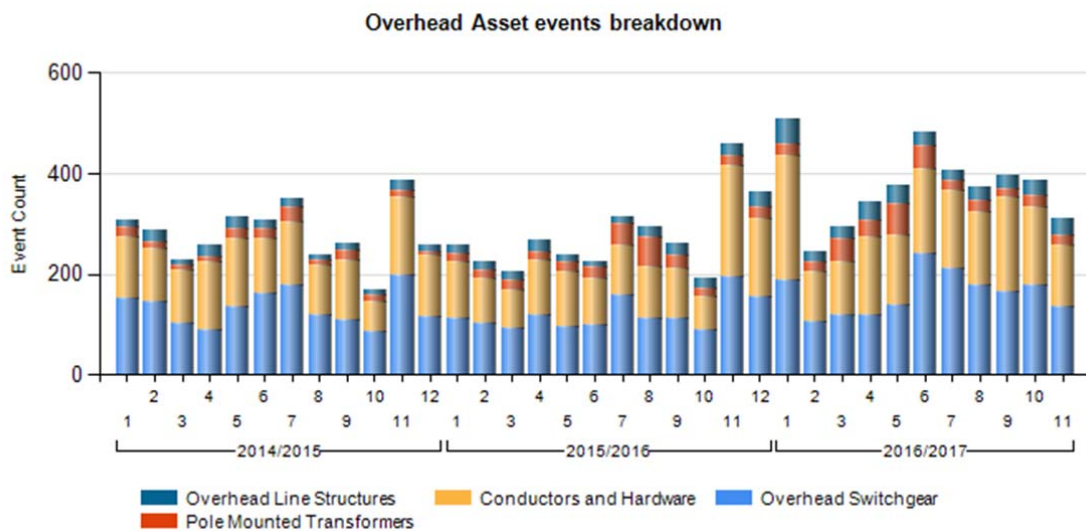
Figure 18: Conductor and hardware as a proportion of all overall Overhead Asset events breakdown (June 2017)

Figure 18 identifies conductor and hardware asset events as a proportion of all overhead asset events.

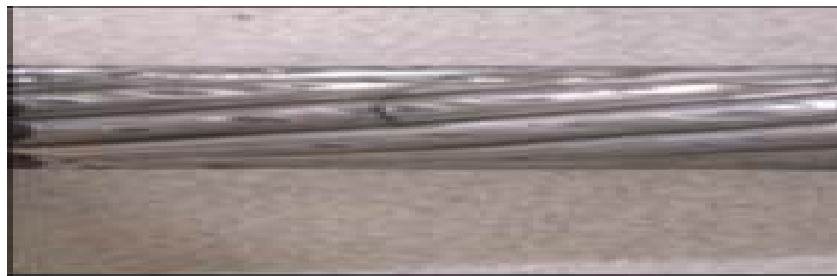
Figure 22 shows example of fretting conductor fatigue failure risk in AA or ACSR conductor

Figure 22 shows fretting fatigue failure that can become a cause of strand failures in both outer and inner strands. Interstrand microslip amplitude increases, small cracks are generated, and some propagate to strand failures (reference 11)

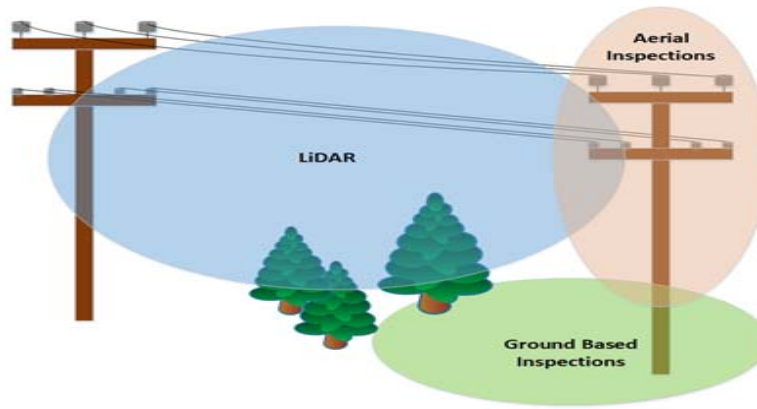
Figure 14: Synergy between Distribution Inspections

A combination of LiDAR, aerial and ground based inspections allows best use of available technologies to better risk assess the network and manage risks associated with potential failures.

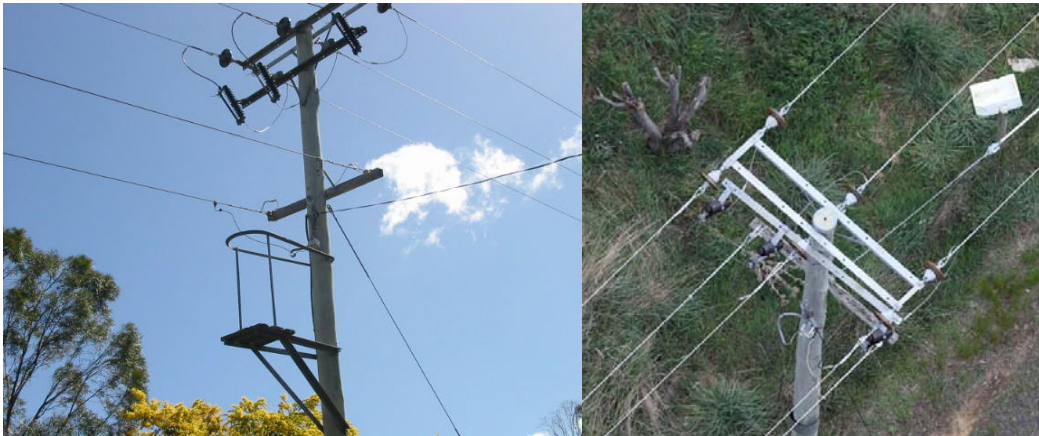
Figure 24: The same pole as seen from the ground and from the air

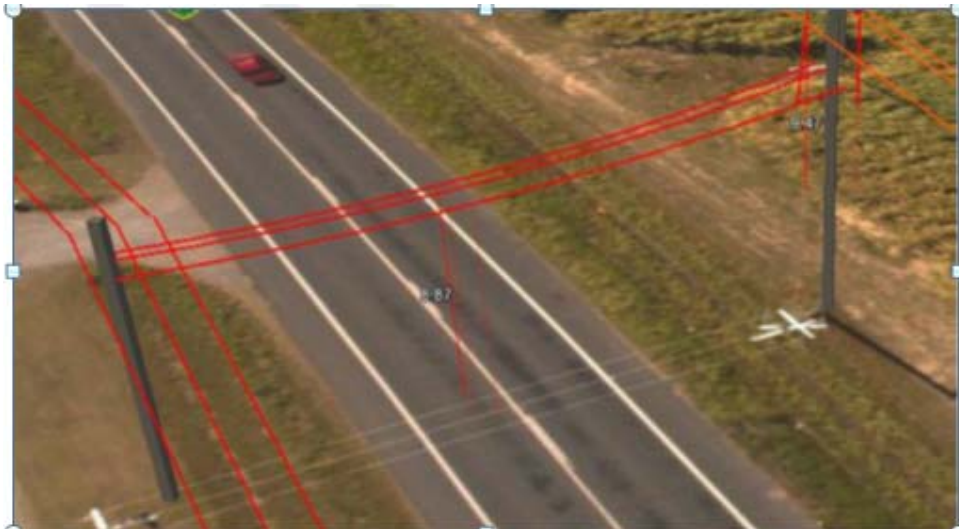
Figure 15: 3D image example of a LiDAR survey identified a line span conductor clearance risk.

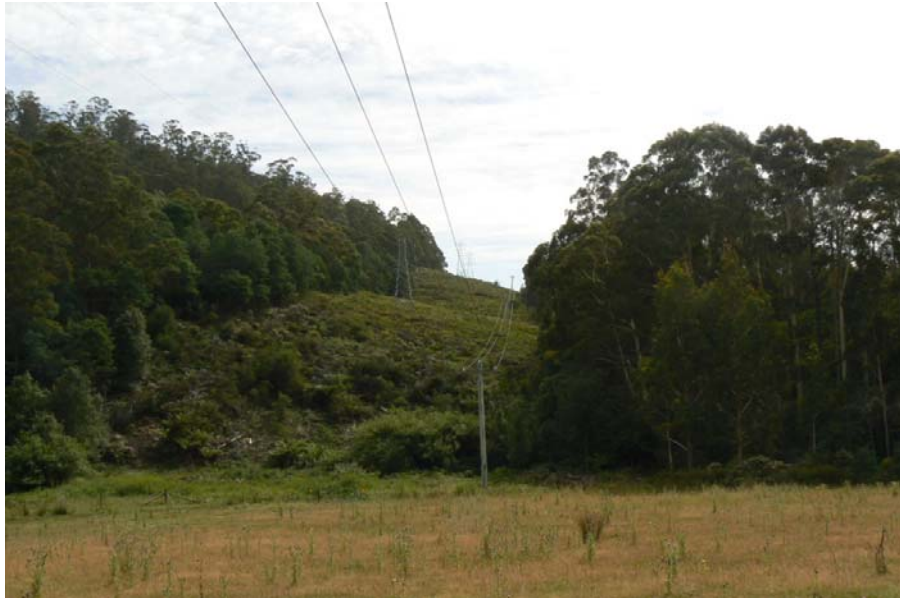
Figure 26: shared corridor for a distribution line in this Transmission line for LiDAR survey

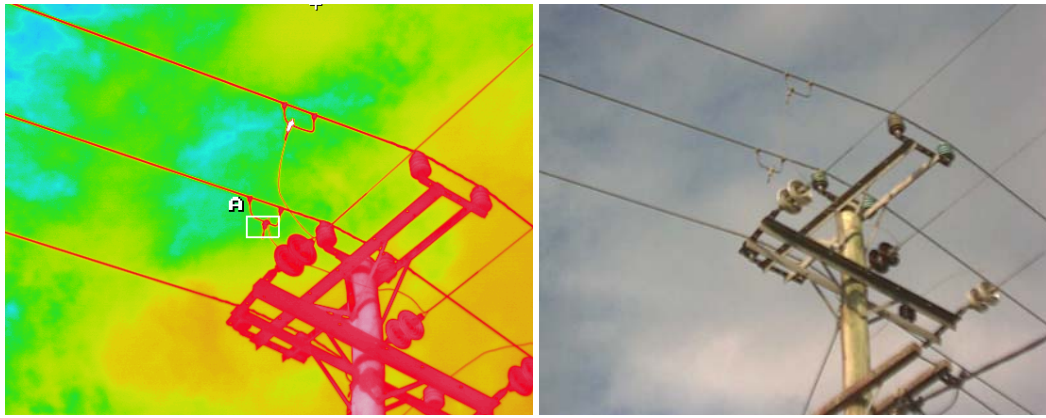
Figure 27: A Live Line Clamp through a thermal imaging camera and a normal camera

In April 2015 a review of this program was undertaken (see AIOTI Strategy Review, reference 6) which identified a number of opportunities for improving the program's effectiveness and efficiency. This resulted in a more targeted approach and co-ordinating the inspection so feeders are inspected at times when they are more heavily loaded. From 2015/2016 onwards in particular areas of the network such as the high bushfire consequence area and on the seven worst performing feeders, the 1,000 kVA threshold will be maintained. For all other areas of the network it is the inspection threshold will be raised to 4,000 kVA to maximise the likelihood of finding asset defects.

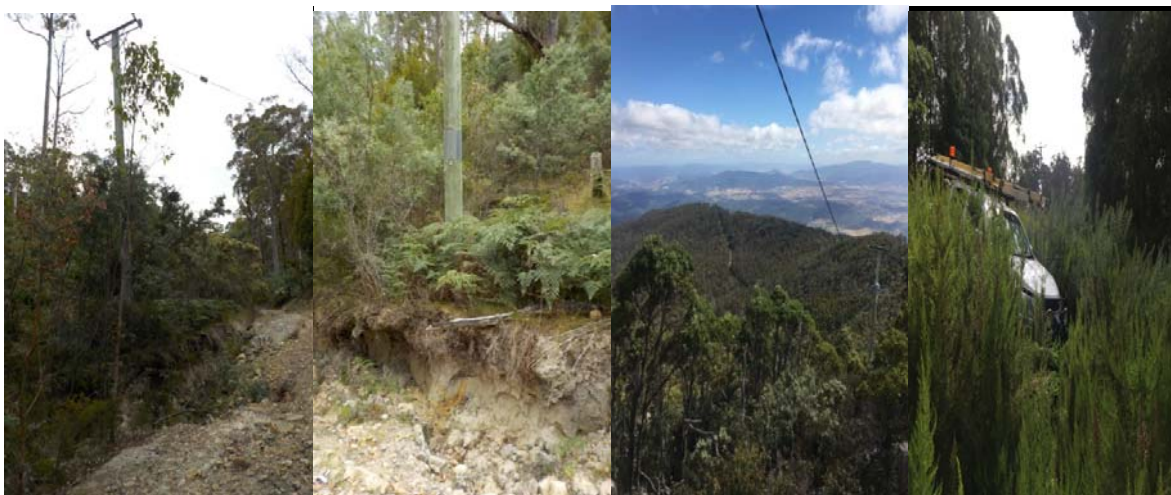
Figure 28 Examples of high slope access tracks & track washout near pole footing

Experience within TasNetworks has shown existing access tracks need to be maintained approximately every four years for optimum cost versus benefit and to stop them degrading to the stage where they require extensive works.

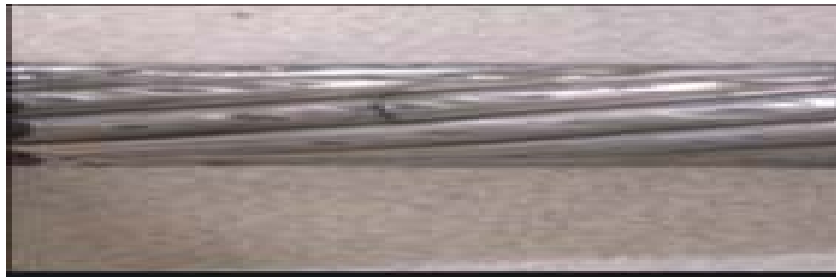
Figure 31 shows example of fretting conductor fatigue failure risk in AA or ACSR conductor

Figure 31 shows fretting fatigue failure that can become a cause of strand failures in both outer and inner strands. Interstrand microslip amplitude increases, small cracks are generated, and some propagate to strand failures (reference 11)

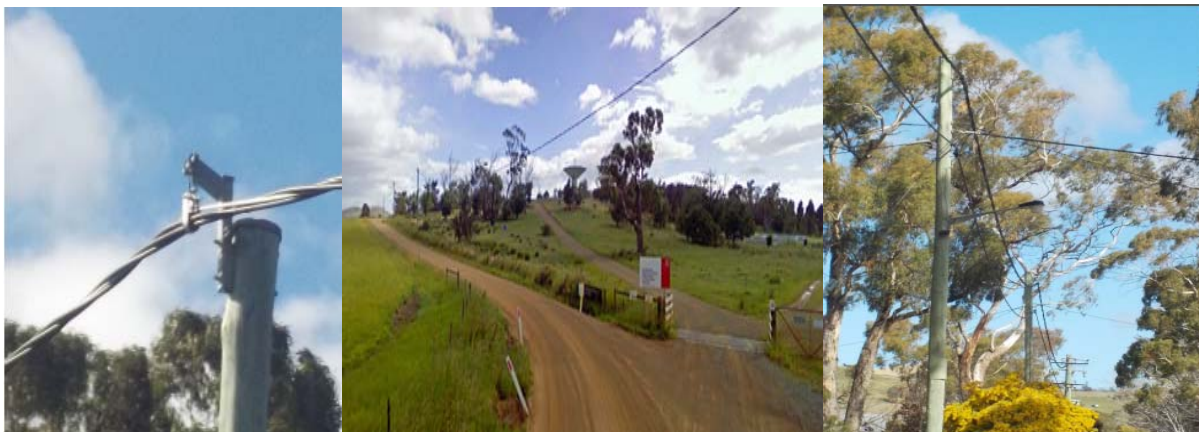
Figure 32 existing non-metallic screened (NMS) HV ABC conductor

The 2017/2018 POW approach is to risk review the insulation wear on 27 km of non-metallic screened (NMS) HV ABC based on in service life and condition assessment for planned replacement based on risk, noting reference 32 illustrates findings of a Victorian Utility.
