Asset Management Plan

High Voltage Switchgear

Record Number: R32659

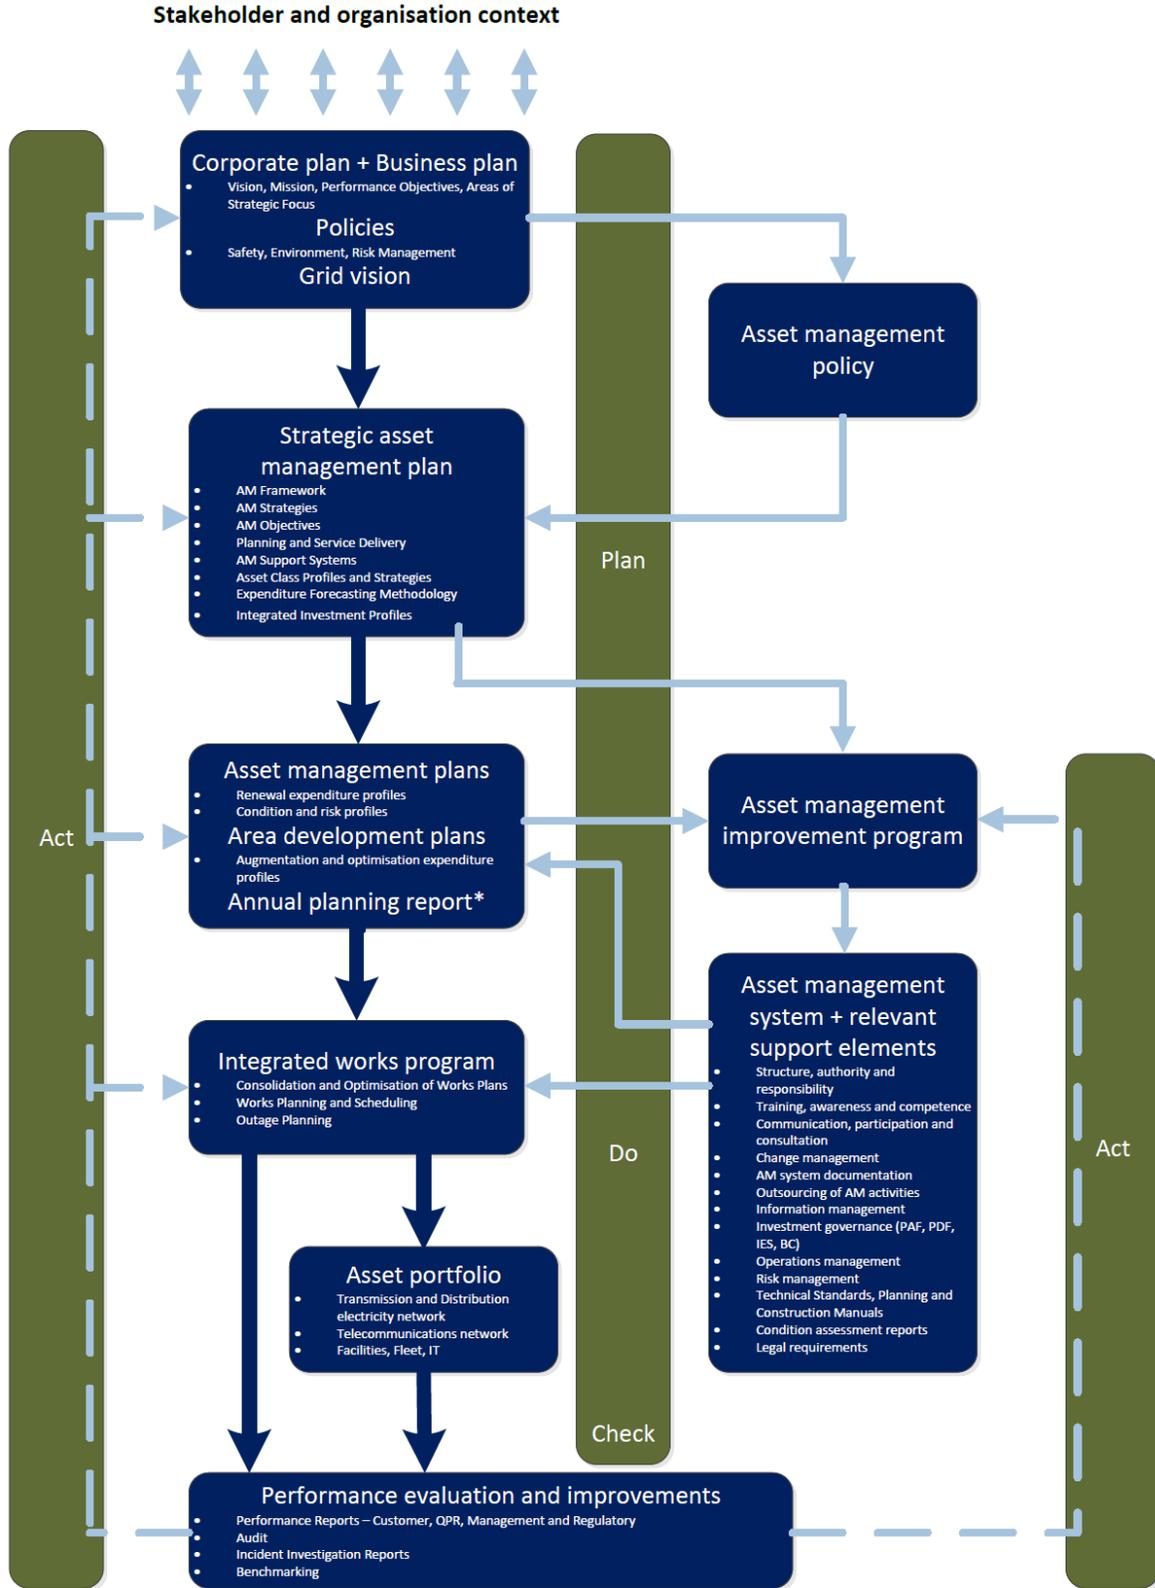
Figure 1: TasNetworks asset management documentation framework

The asset management policy and strategic objectives are outlined within the Strategic Asset Management Plan. Figure 1, from the Strategic Asset Management Plan, represents TasNetworks documents that support the asset management framework. The diagram highlights the existence of, and interdependence between the, Plan, Do, Check, Act components of good asset management practice.

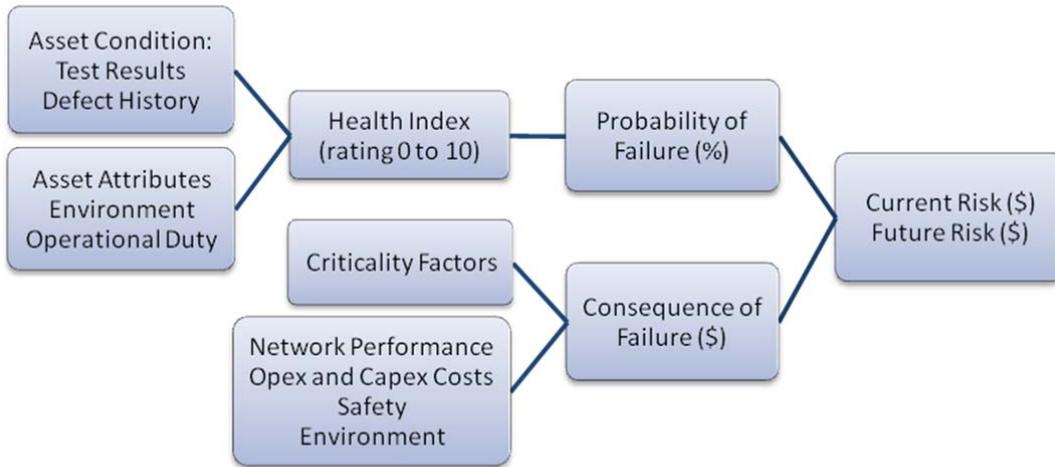
Figure 2: Asset Risk Framework

Condition based asset risk is the product of probability of failure, consequence and circuit criticality as details in Figure 2.

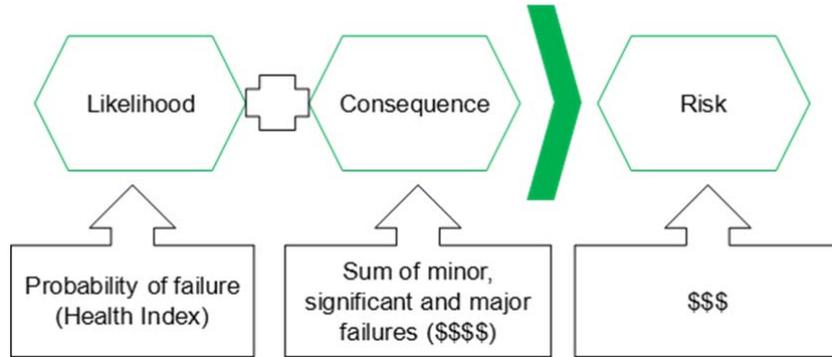
Figure 3: Risk derivation for CBRM

As with every risk decision, there are two main inputs, being likelihood and consequence. Figure 3 shows what CBRM considers as the two risk inputs.

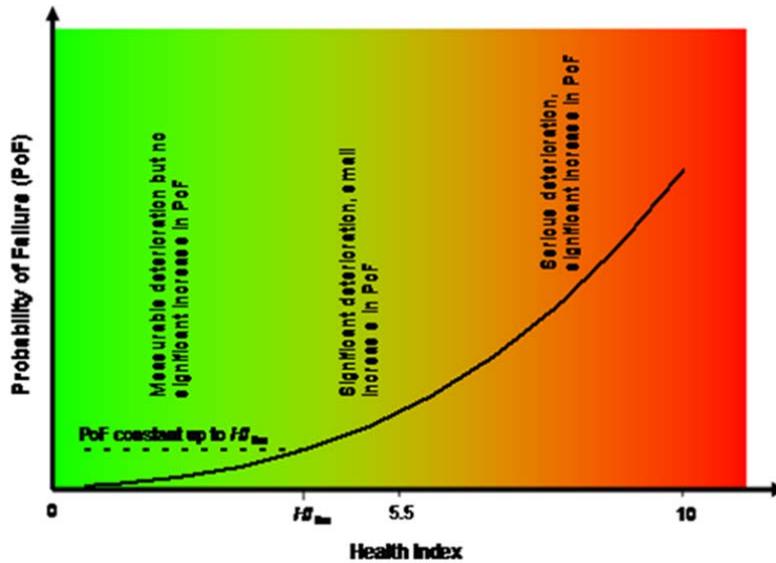
Figure 4: Deriving a probability of failure

CBRM calculates the likelihood, or the probability, of failure of an asset by deriving a Health Index (HI). The HI of an asset is a means of combining information that relates to its age, environment and duty, as well as specific condition and performance information to give a comparable measure of condition for individual assets in terms of proximity to End of Life (EOL) and Probability of Failure (POF).

Once a HI for an asset is derived, a POF can be found. Notionally, the POF is an exponential function as shown in Figure 4 and Figure 5.

Assets with a low HI, even up to five, have quite a low probability of failure, but that increases dramatically at higher HIs. The equation and steepness of this curve is calculated independently for each asset based on input data.

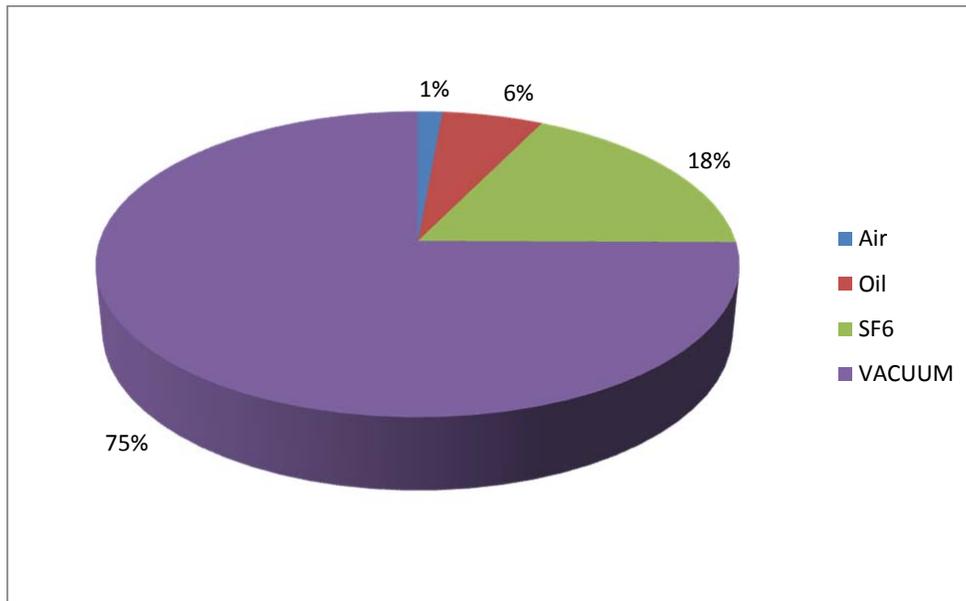
Figure 6: High voltage switchgear population by type of insulant

The population of HV switchgear includes units constructed by 13 different manufacturers comprising 46 different types. Condition monitoring results for each of the types can vary as different design and construction methods are used for each type. The differences in physical design and construction characteristics between types, increases the complexity of contingency planning and spares management. Figure 6 illustrates the percentage of each type of switchgear within the population, which also indicates that around 93 per cent of TasNetworks HV switchgear population comprises either vacuum or SF6 insulated switchgear.

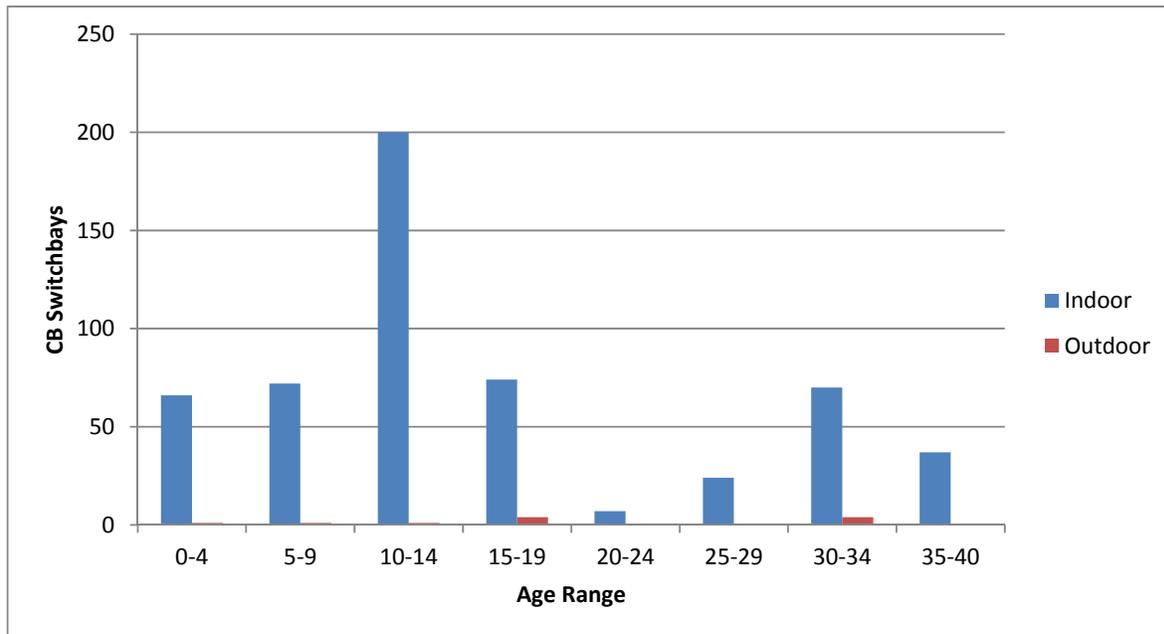
Figure 7: Age profile of high voltage switchgear (as at October 2017)

HV switchgear is considered to have an average service life of 45 years. The average age of TasNetworks' indoor and outdoor HV switchgear population is 15.9 years and 20.6 years respectively as at 2017. The overall average age of the entire HV switchgear population is 16 years. This relatively low average age profile is largely as a result of TasNetworks' HV switchgear replacement program, which has resulted in many of the outdoor installations replaced with modern indoor metal-clad switchgear and the establishment of new connection sites.

Given the relatively low average age of TasNetworks' HV switchgear, overall performance levels of the population should not be adversely affected by age-related issues. The age profile (from manufacture) for TasNetworks HV switchgear population is shown in Figure 7.

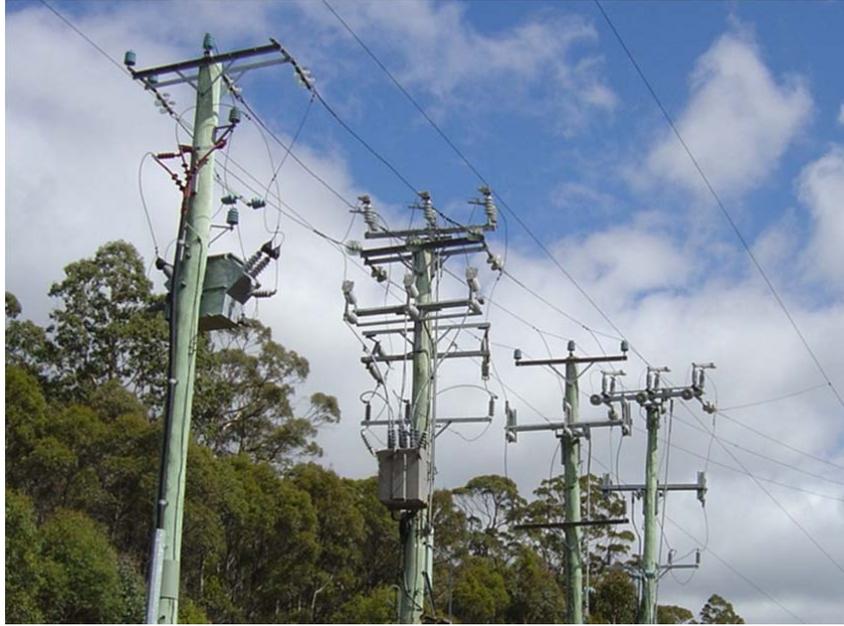
Figure 9: Pole mounted 22 kV switchgear at Derwent Bridge Substation

Asset	Manufacturer	Type	Voltage	Devices	Year	Age [years]	Number of units
Circuit breaker	Nulec	N24-150	22 kV	A252	2008	9	1
Disconnecter	ABB	S-Series	22 kV	A229A, A229B, A229D	1975	42	3
Current transformer	Mounted inside CB (re-closer)			-			
Voltage transformer	Modern Products	VT238	22 kV	A597	1996	21	1
Combined voltage & current transformer	TWS	SBH90	22 kV	A296/97	2003	14	1

All 22 kV switchgear at Derwent Bridge Substation is in an acceptable electrical condition. Nulec circuit breaker with auto-reclose facility was replaced in 2008 during supply transformer replacement following a failure of the previous Nulec recloser control card.

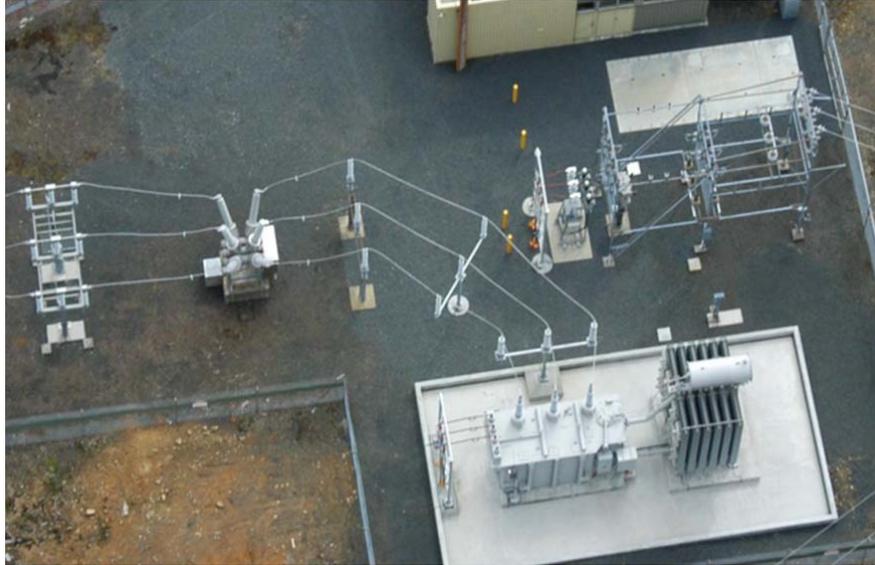
Figure 10: 22 kV switchgear at Que Substation

At Que Substation there is only one circuit breaker, a 22 kV Magrini Galileo, manufactured in 1997. Also there are two disconnectors, two current transformers, three VTs and a combined CT/VT. These 22 kV switchgear are generally in acceptable electrical condition. There have been a number of 22 kV current transformer failures and protection related incidents at Que Substation - more recently in January 2007, April 2007, and February 2008 and in April 2008.
