Asset Management Plan

Pole Mounted Transformers

Record Number: R260428

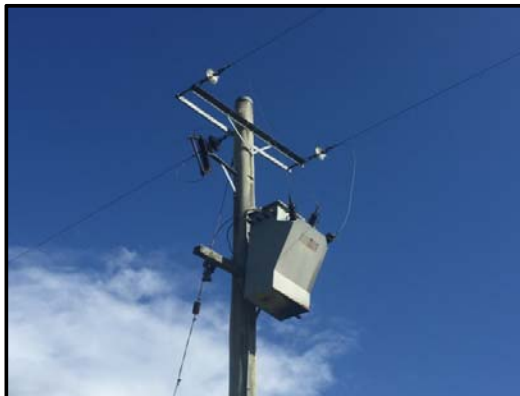
Figure 2: A SWER isolating transformer with 6/20 EDO SWER fuselink

The isolating transformer isolates the earth currents (zero sequence currents) of the SWER system from the three-phase main supply feeder. This limits the exposure to telephone interference and allows the main supply feeder to maintain its sensitive earth fault detection protection.

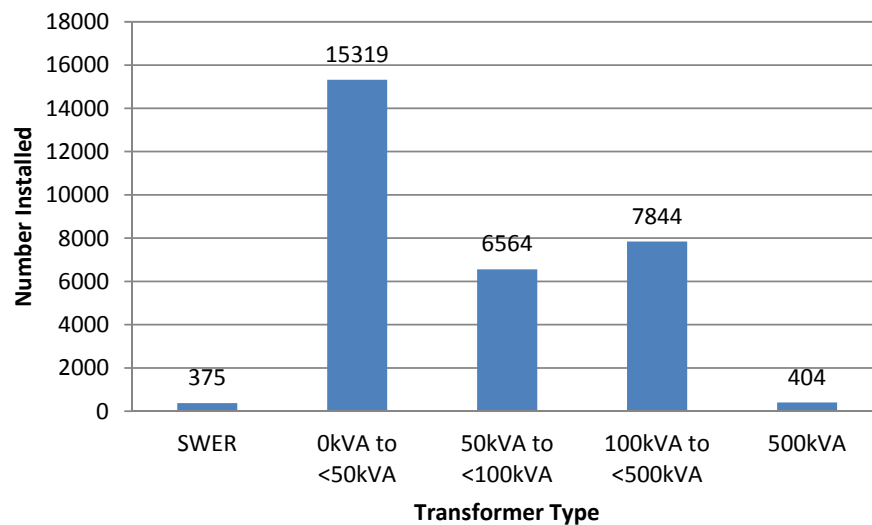
Figure 3: Pole mounted distribution transformer types

Table 1 and Figure 3Figure 1 show the pole mounted transformer population by type, voltage, and size.

Transformer Size	22kV	11kV	6.6kV	12.7kV SWER	LV Isolating	Number Installed
0kVA to <50kVA	11222	4093	2	0	2	15319
50kVA to <100kVA	4638	1926	0	0	0	6564
100kVA to <500kVA	5988	1850	2	0	0	7844
500kVA	316	88	0	0	0	404
SWER	0	0	0	375	0	375
Isolating transformers				64	2	66
Total	22164	7957	4	439	2	30506

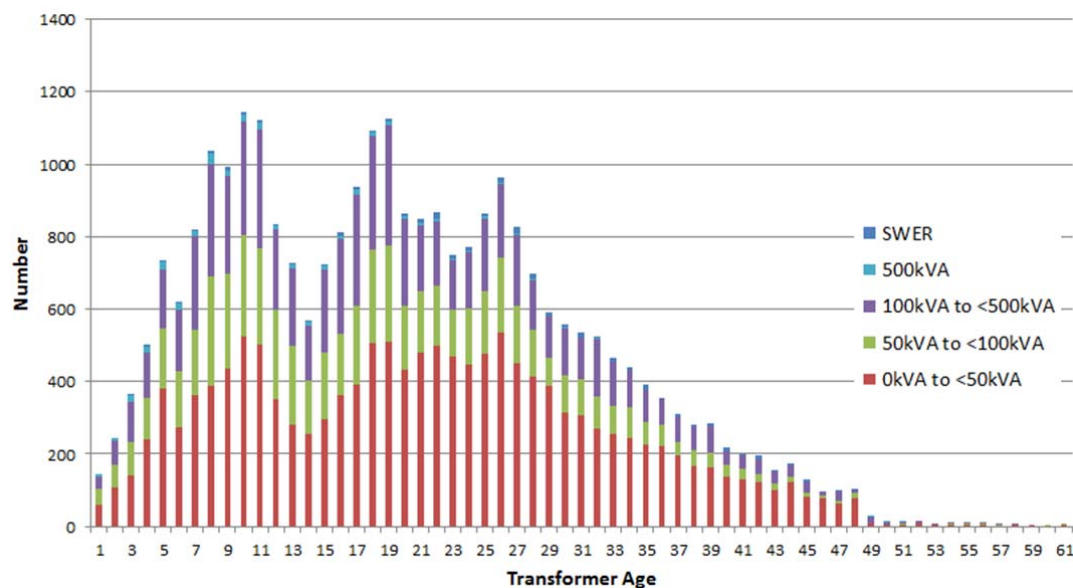
Figure 4: Transformer age profile

The transformer age population profile is shown by transformer capacity in Figure 4.

In Figure 4, the typical distribution transformer asset service life is showing indicative 50 years, but that can be location- limited by uprating needs, such as site load capacity growth or decline. Also

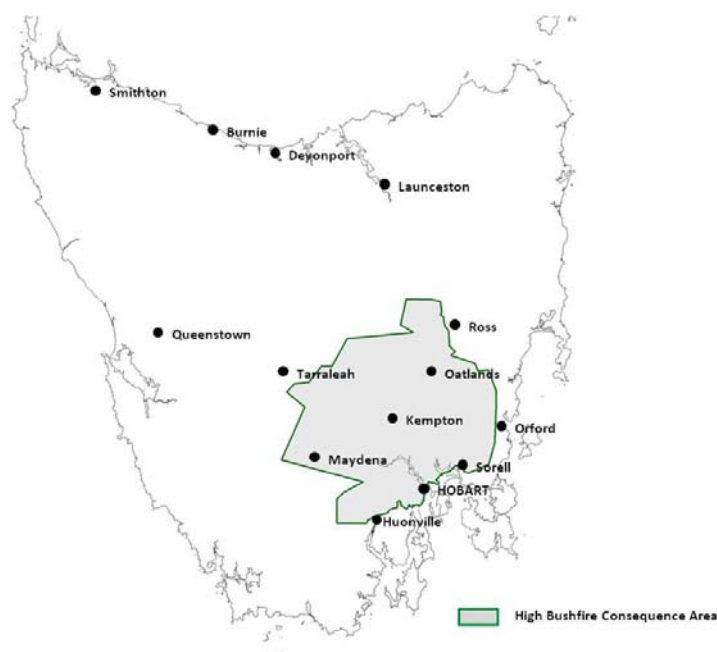
Figure 5: Current High Bushfire Consequence Areas

The definition of the High Bushfire Consequence Area is flexible, however, and can change between years, in that TasNetworks has the option of extending the area covered by its pre-summer inspection and cutting program if conditions leading into the bushfire season pose sufficient risk to warrant additional work being undertaken. Such risks and additions to the program are developed in consultation with the Tasmania Fire Service and the Bureau of Meteorology.

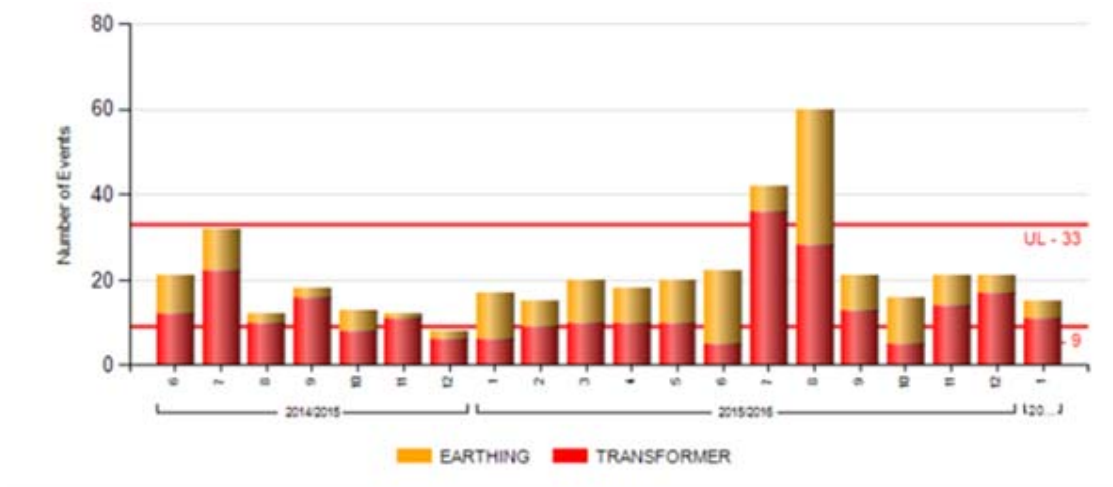
Figure 6: Pole mounted transformers failure events by asset type

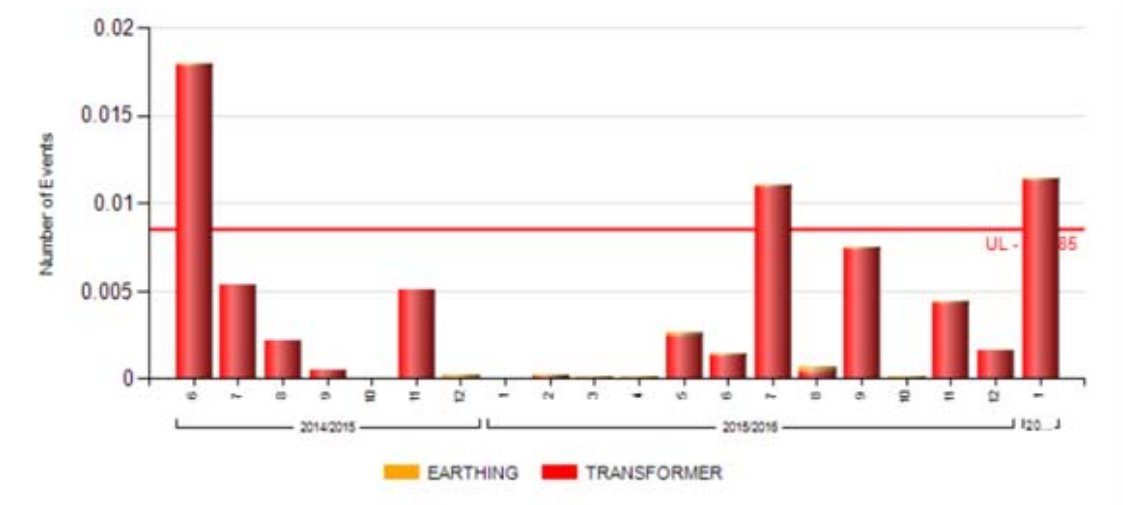
Figure 7: Asset Failure SAIFI contribution by pole mounted transformers

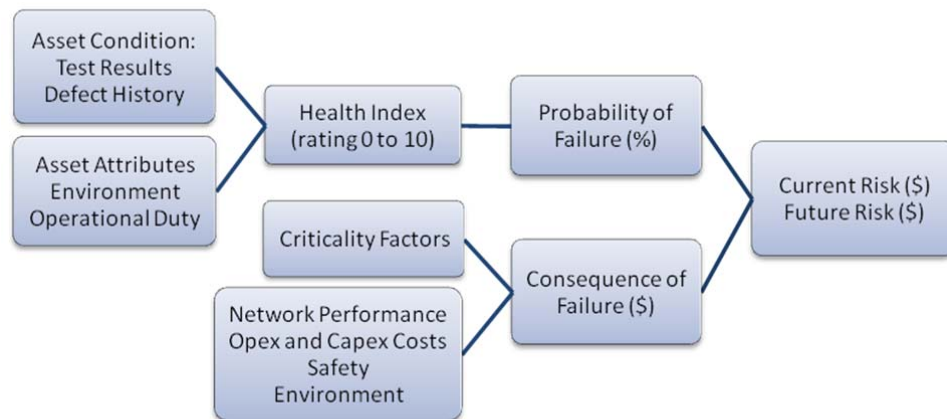
Figure 9: Asset risk framework

CBRM is a tool designed to analyse a fleet of assets and determine the effects of risk and cost trade-offs when considering asset replace and refurbish type decisions. By using a tool to quantify the asset risk, a better overall view of the asset class can be achieved ensuring replacement programs effectively target assets that are the highest risk to the distribution system. TasNetworks plans to introduce this methodology as part of its asset information improvement initiative as described in Section 4.2. Figure 9 shows the CBRM framework that will be employed to improve investment decision making.

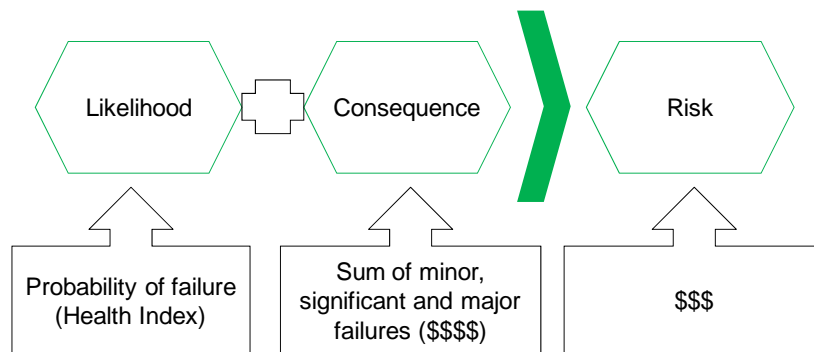
Figure 10: Risk derivation for CBRM

Figure 10 shows what CBRM considers as the two risk inputs.

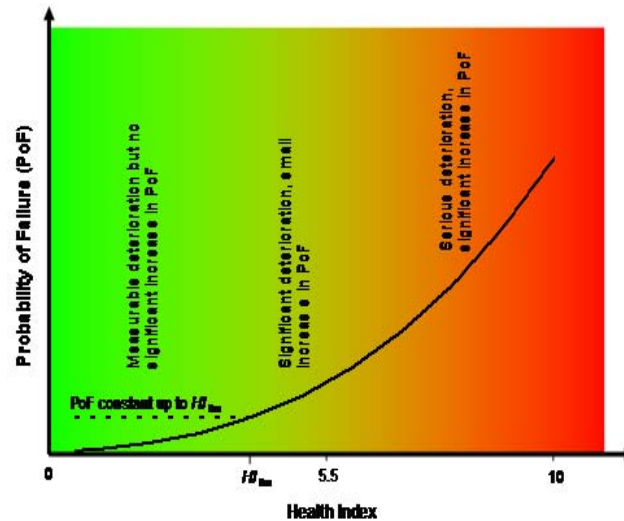
Figure 12: Deriving a probability of failure

Once a health index for an asset is derived, a probability of failure can be found. Notionally, the POF is an exponential function as shown in Figure 12.

It can be seen that assets with a low health index, even up to five, have quite low probabilities of failure, but this increases dramatically at higher health indices. The equation and steepness of this curve is calculated independently for each asset based on input data.

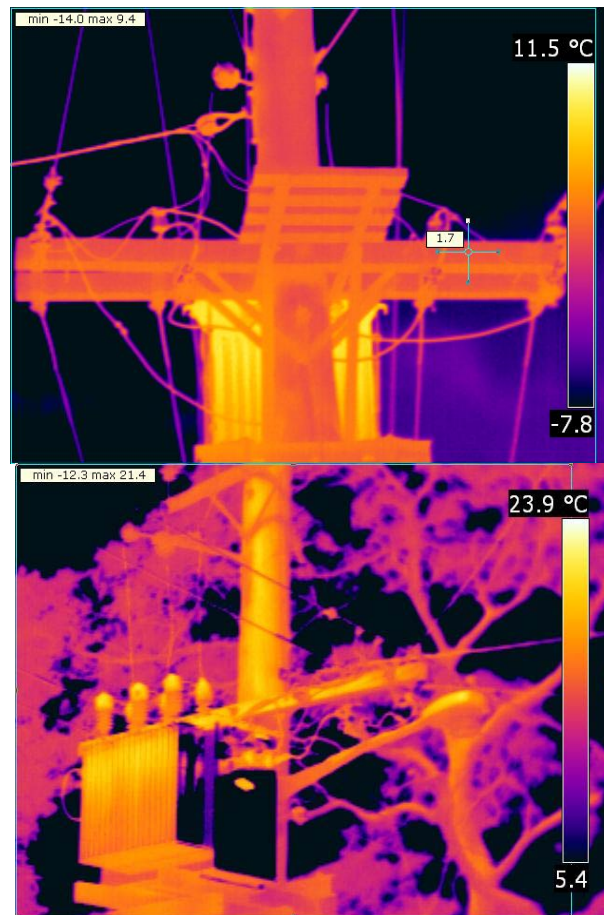
Figure 13: Thermal images showing warm transformer radiators and no hot spot defects

The frequency of inspection remains at three years which included the thermal inspection of distribution pole mounted transformer terminal bushing and overhead line connections.

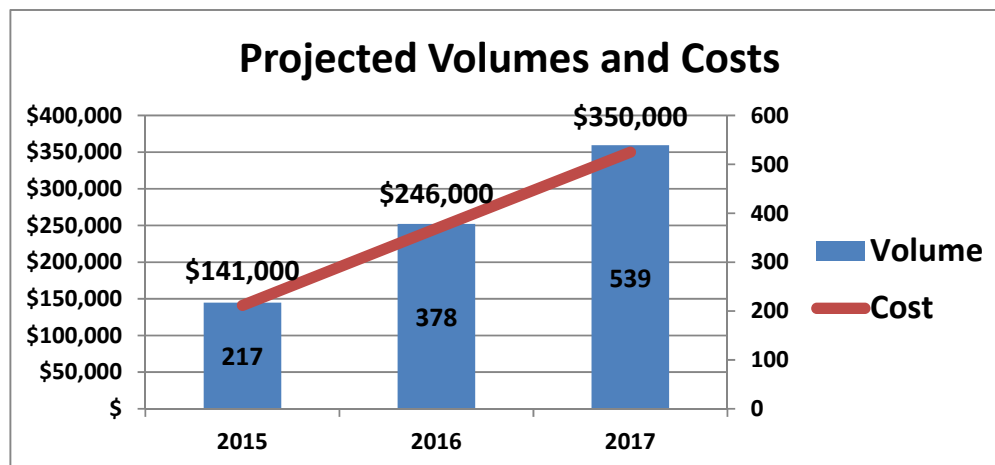
Figure 14: Projected volumes and costs for pole copper theft by year

Copper earthing conductor is a target for theft as the salvage prices for copper is high. Records of copper theft from previous years are variable however as data improves TasNetworks will assess to better target risk areas. Vandalism theft is presently a regular reoccurrence, in some locality sites, and can increase the risk of electrical shock to workers, public, and first responders.

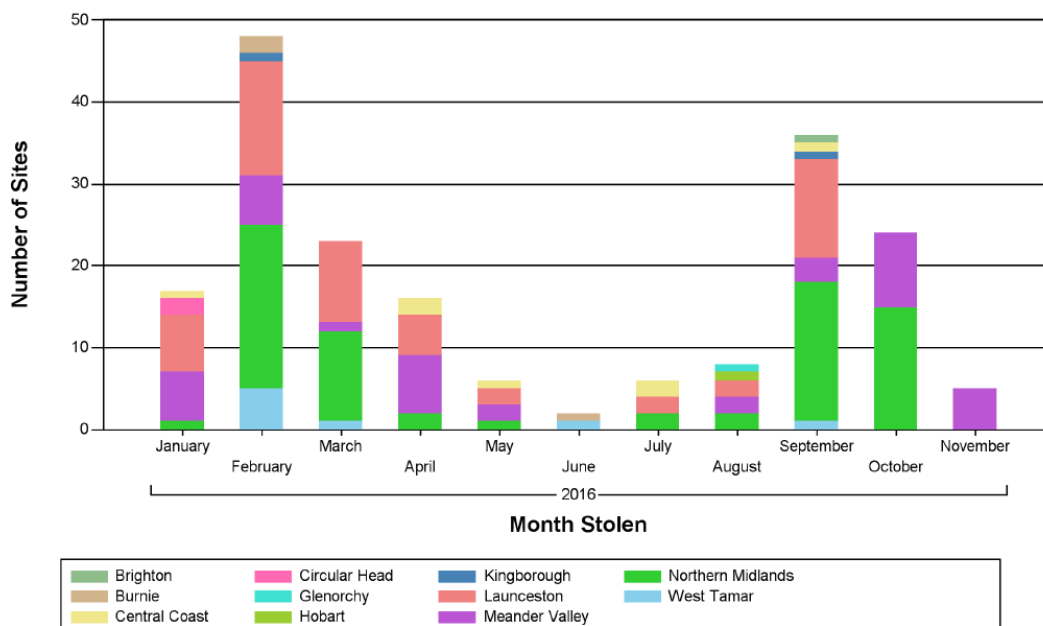
Figure 15: Example of a weekly report on stolen pole earths based on Local Govt. areas

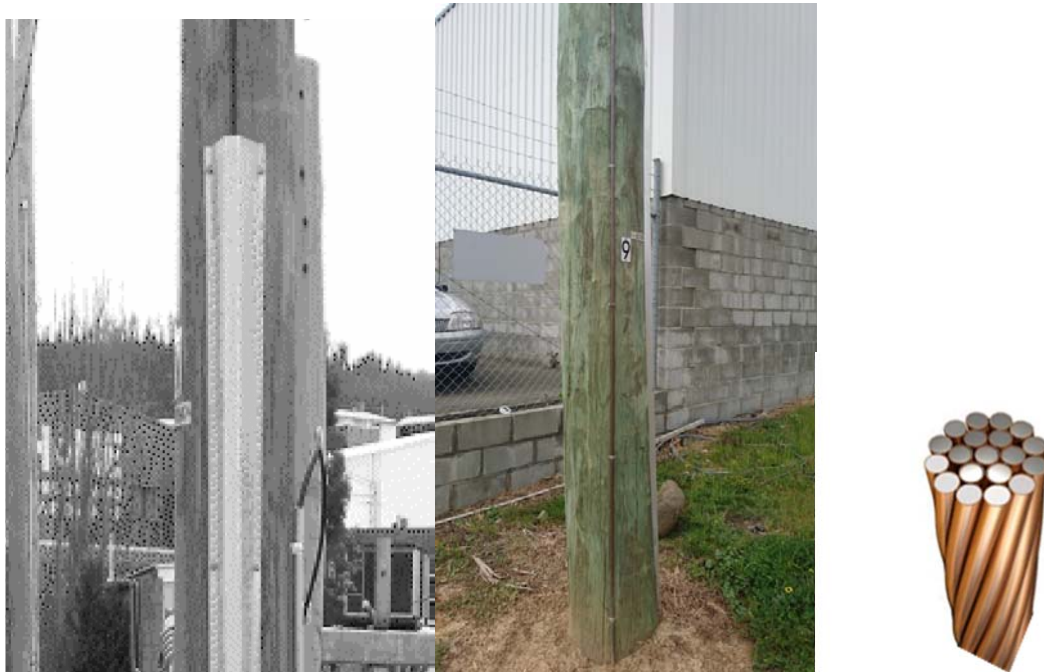
Figure 16: Pole copper earthing conductor with steel security guard to drawing D-OH1-1.8/30 and the new alternative copper clad steel rod kit used now in repeat theft locations.

Standard practice for TasNetworks has been to have the earths covered and stapled to the pole when they are replaced at sites targeted by copper thieves. Where pole copper thefts of earths on poles have been ongoing a new heavier duty steel cover had been deployed in 2015/16 to try to reduce theft repetition (See Figure 16). However after thefts in 2016/17, by unscrewing these

steel guards, a trial using copper clad steel electrode kit was undertaken. It is now standard practice to install copper clad steel earth rods when replacing stolen earths.

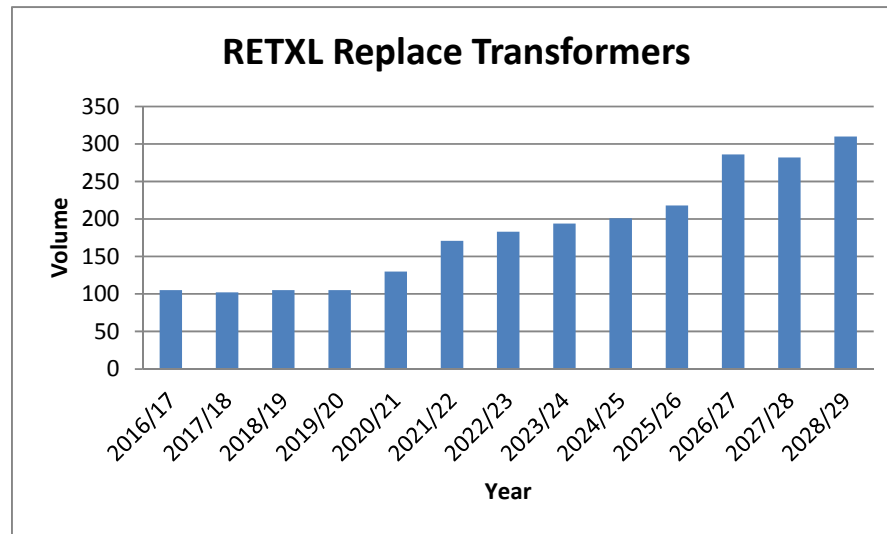
Figure 18: Forecast of volumes for replace transformers (RETXL)

Most of the transformer replacements in the distribution networks are done under fault. There is an average of 65 outages per year caused by transformer failure, due to condition, overload, internal and external failure of the transformer, break down of insulation, extreme weather events or third party collision with support structures. Transformer failures account for around 7% of outages by outage duration or around 550 hours of outages per year on average. An outage caused by a transformer failure lasts for an average of 9.3 hours. Volumes for this program are based on historical failure numbers with taking into account the age profile of transformers, assuming that transformers are more likely to fail once they reach end of asset life. Figure 18 shows the forecast volume for transformer replacements going forward.

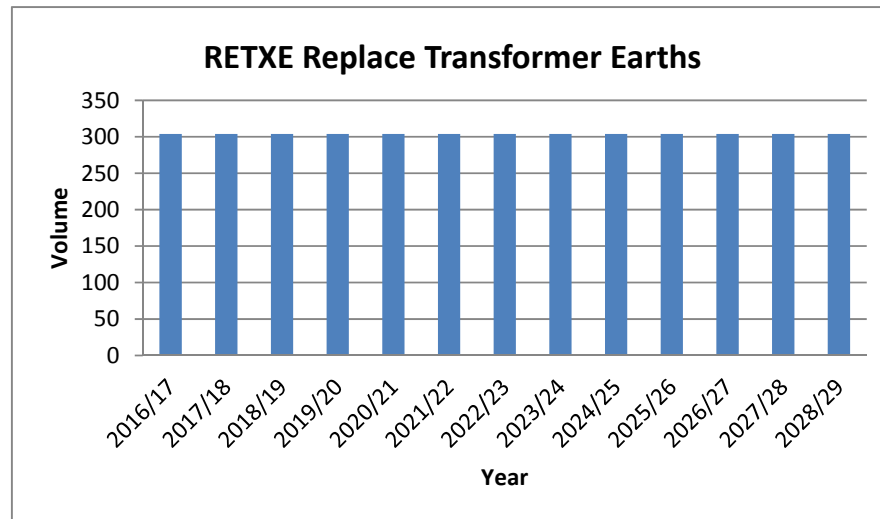
Figure 19: Forecast of volume of transformer earth replacements (RETXE)

This program has existed for some years but only in response to chance reporting of missing or obviously damaged earths picked up by the asset inspectors as part of the pole inspection program. With the Overhead Transformer Inspection & Monitoring (Earthing) AIOTX program which commenced in 2014/15, this program is set to increase in volume and complexity.

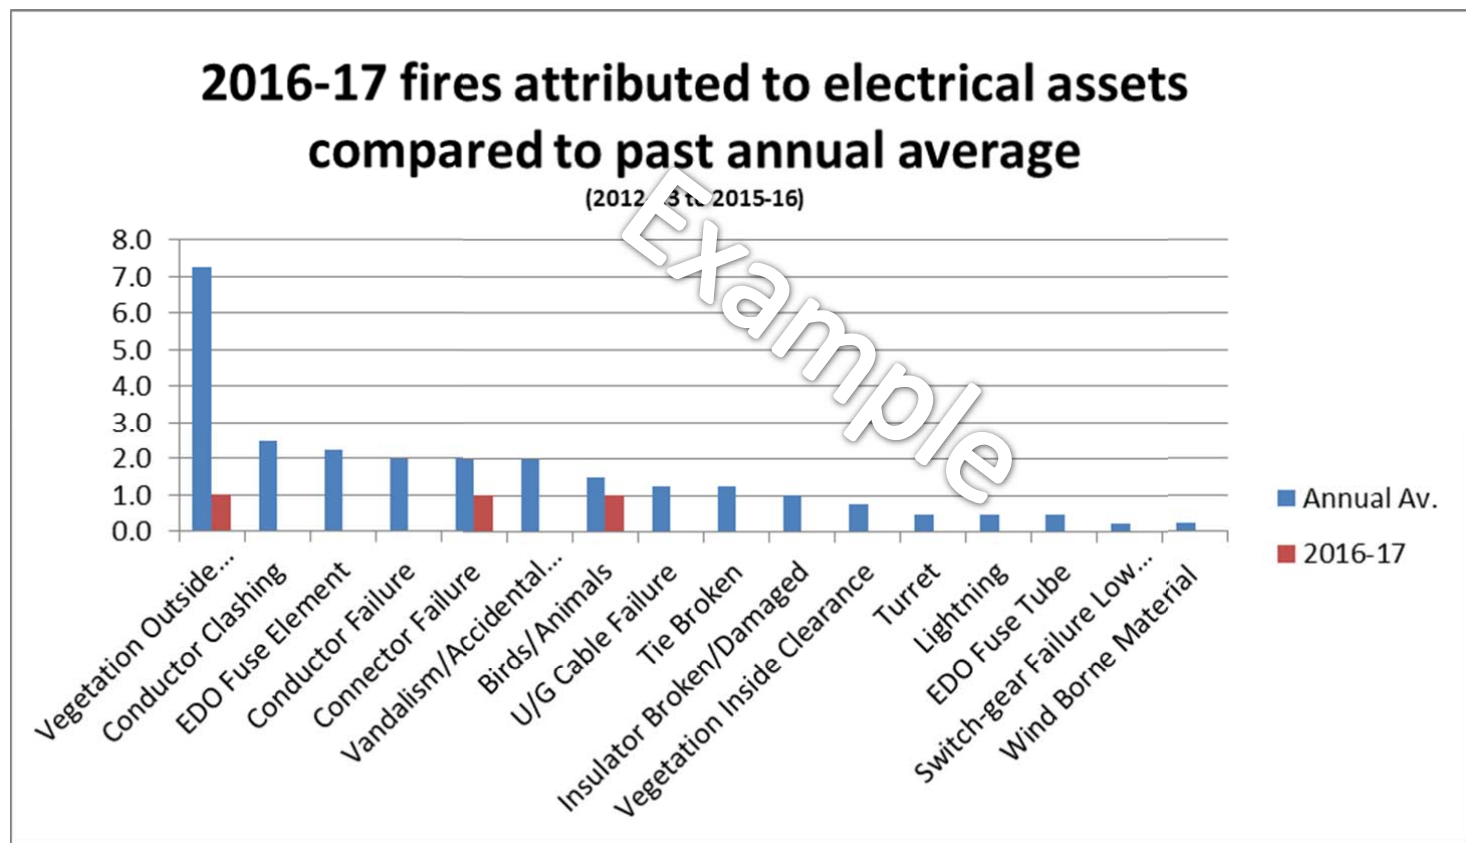
2016-17 Fires Compared to Past Annual Average
