Asset Management Plan

Overhead Line Structures - Distribution

Record Number: R260425

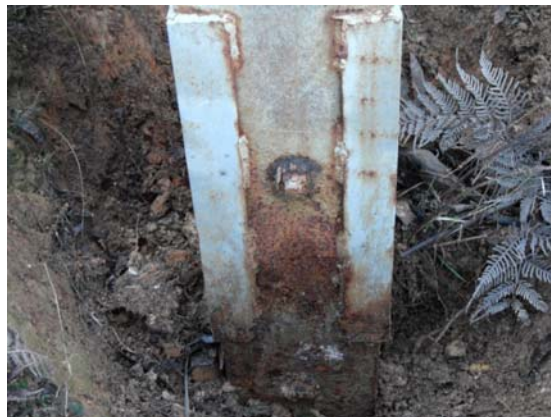
Figure 20: Poor condition steel and concrete (Stobie) pole

The driver for this program is managing business operating risks (safety). The program involves maintaining steel and Stobie structures in serviceable condition by repairing components found to be defective through the various inspection programs.

Repairing the below section of direct buried Steel and Concrete poles is cost effective as it will extend their lives by 15 to 20 years.

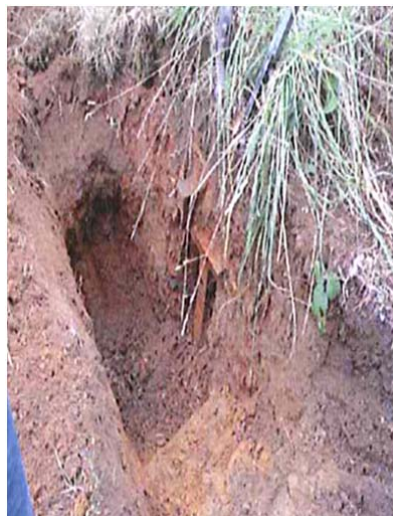
Figure 31: Corrosion on surfaces of underground portion of Steel Tower Leg

The aim of this program is to undertake major remedial works on the below ground portion of TasNetworks' distribution line steel towers. As with wood poles, steel towers deteriorate below ground at a faster rate than above ground.

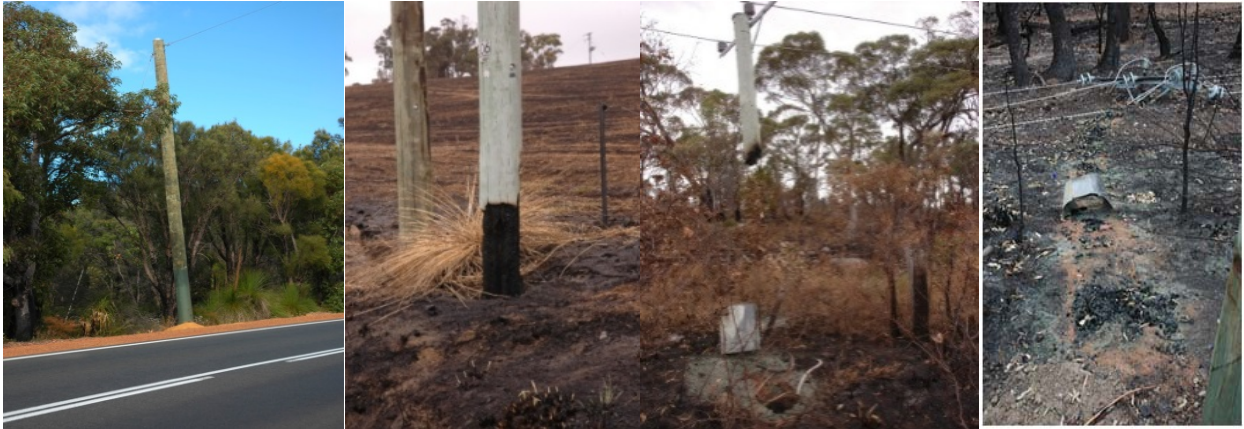
Figure 10: An intumescent coated wood pole and poles lost to reduce risk of CCA afterburn

TasNetworks wood poles are vulnerable to both bushfires and lower level preventative fuel reduction burns especially in button grass heath and scrub. As in Western Power, WA, CCA Wood poles can be given increased bushfire resilience/resistance by an Intumescent paint coating from below the ground line to 2.5 metres above ground. A trial on bushfire risk located TasNetworks' wood poles to reduce incidence of CCA

afterburn charring and candling burn failures of poles impacted by bushfires or fuel reduction burns is proposed. Figure 10 shows a bushfire resilient / intumescent coated wood pole base and examples of CCA Wood poles lost to CCA afterburn after fuel firing pole base, fire darts to splits and /or candling in the 2014 Dunalley Bushfire.

Where an existing TN wood pole exists with significant remaining service life expectation, the retrofitting of an intumescent coating for first 2.5 metres of pole height above ground level offers added resilience from fuel reduction burns and low level scrub or razor grass bushfire.

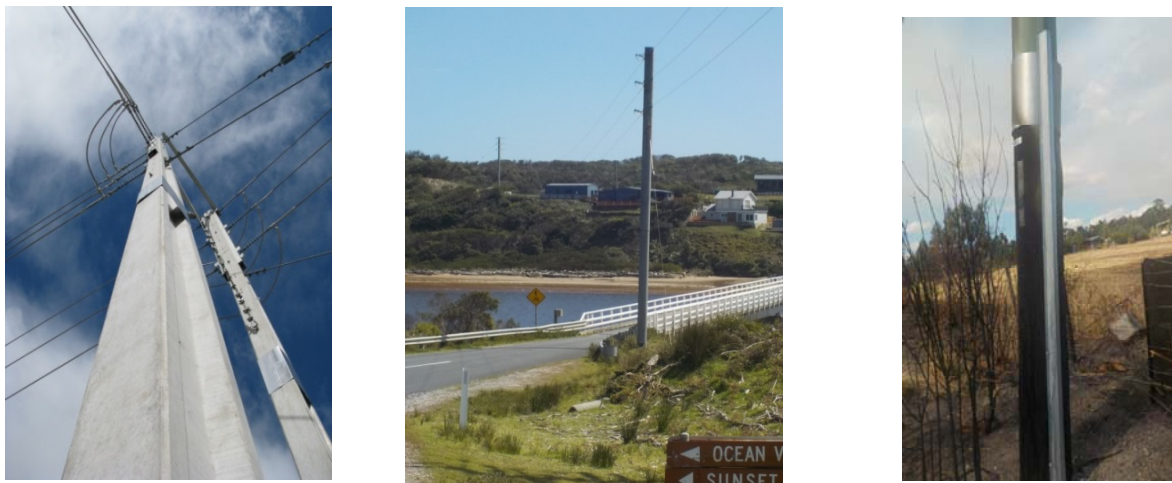
TasNetworks is trialling “Alternative” non-wood poles, called Titan poles by supplier Dulhunty Engineering, that are already CSIRO bushfire tested to be bushfire resilient. These poles are also electrically insulated, and capable of higher stress loading in critical structure roles. The trial field tests bushfire risk mitigation and feeder supply restoration resilience as use of electrically insulated TITAN poles to support higher replacement cost roles for equipment poles and highly mechanical stress loaded structure poles. Other alternative conductive poles as already used in TasNetworks network include Busck cast reinforced concrete, Bluescope hot dipped galvanised steel, and lattice steel poles. References for Bushfire Testing are AS 1530.1 and Energy Network Association (ENA) Pole Fire Test (reference 17).

Figure 11: alternative line support structures

These Alternative Support Structures for Equipment and other High Stress Risk Structures are detailed in Reference 14. They are alternative pole structures for where Chromated Copper Arsenate (CCA) TasNetworks wood poles do not survive in Net Present Value (NPV) terms for service life duty of 50 years. These alternative structures/poles are for use in the following conditions, prioritised as

- Structures located in bushfire prone locations, that need to withstand bushfires

- Equipment structures that are required to support transformers, reclosers and other equipment and
- Structures subject to high stress such as strain structures or structures subject to high wind.

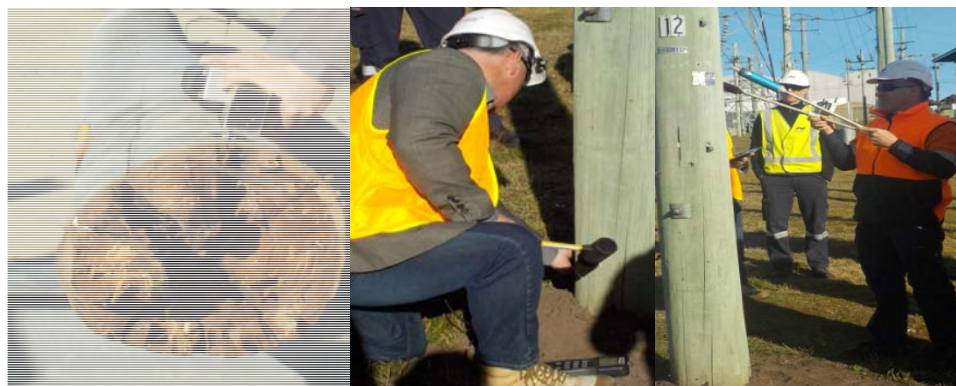
The University of Tasmania, UTas, has been contracted to laboratory test samples of drilled wood shavings to support Asset Inspectors Pole Inspection DNA analysis diagnosis for identifying presence of carroty rot (a form of soft rot) to improve detection in suspect aged poles. Improved detection of carroty rot will reduce the number of unassisted pole failures per annum, later forensically identified as undetected carroty rot. An explanation of this trial is provided in Appendix G, and the 2016/17 Final Report is included in reference 19. As a result of UTas as test reported in Reference 19, it's noted a number of different fungi with bacteria symbiotic communities have been identified as 'soft rot' and it's even been found in new delivered poles. The soft rot rate of growth in the wood is directly related to the moisture levels present and so poles with increasing splits and pole wood drillings are at greater risk, especially with pole aging. Aged poles acquire more splits with windage, adding moisture and spore access to aged wood. The worldwide R&D knowledge of soft rot growth and its feeding is negligible, and more research is recommended for detection and developing biocontrols. UTas recommended use of Non Destructive Testing pole inspection methods to minimise drilled holes and to help identify rot by density differences, and better correlate density differences to specific rot behaviour by UTas DNA sample tests to better diagnose and scan to monitor poles for presence of internal soft rot, the rot extent, the rot rate in progress and utilise Non Destructive Testing (NDT) to assess periodic progressive deterioration risk and optimal remediations.

Figure 12 Non-Destructive Testing Methods for minimising need for wood drilling
