Asset Management Plan

Substation Site Infrastructure

Record Number: R40523

Date: October 2017

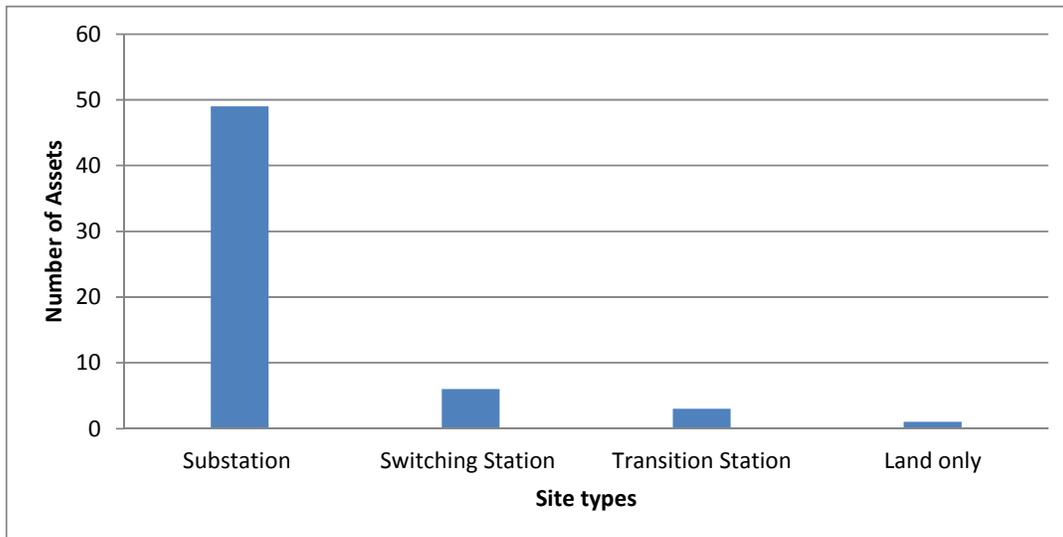
Figure 2 – Substation site types (as at October 2016)

- Land only – vacant sites that are owned by TasNetworks for future development.
- Substation sites – sites that supply customers and typically contain power transformers.
- Switching stations – sites that contain switchgear to interconnect the network but do not supply customers directly.
- Transition stations – sites that contain equipment to transition from an overhead transmission line to an underground cable.

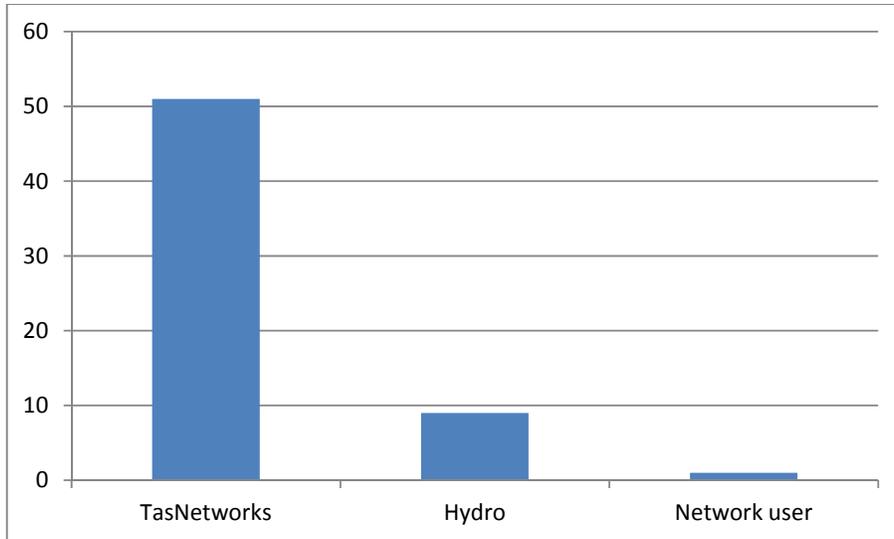
Figure 3 – Number of sites shared with customers or wholly TasNetworks occupied

Some TasNetworks owned and operated sites share common infrastructure with other connected customers. Figure 3 shows how the 58 sites are shared and with whom.

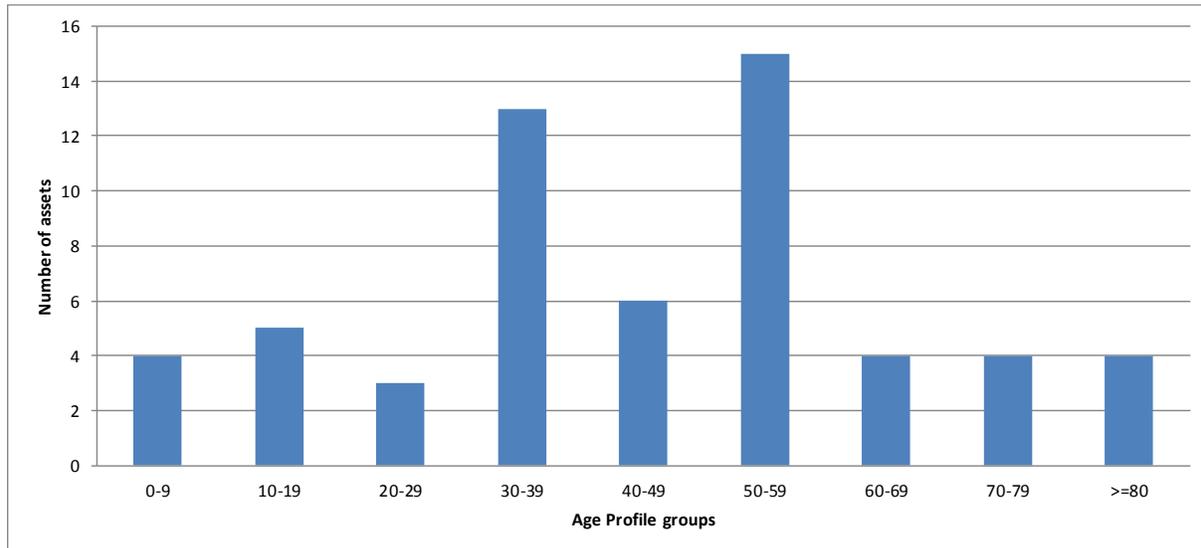
Figure 4 – TasNetworks owned substation age profile from initial establishment (as at October 2017)

The average age of TasNetworks owned substation sites, from initial establishment is 46 years. Figure 4 presents the age profile of substation sites.

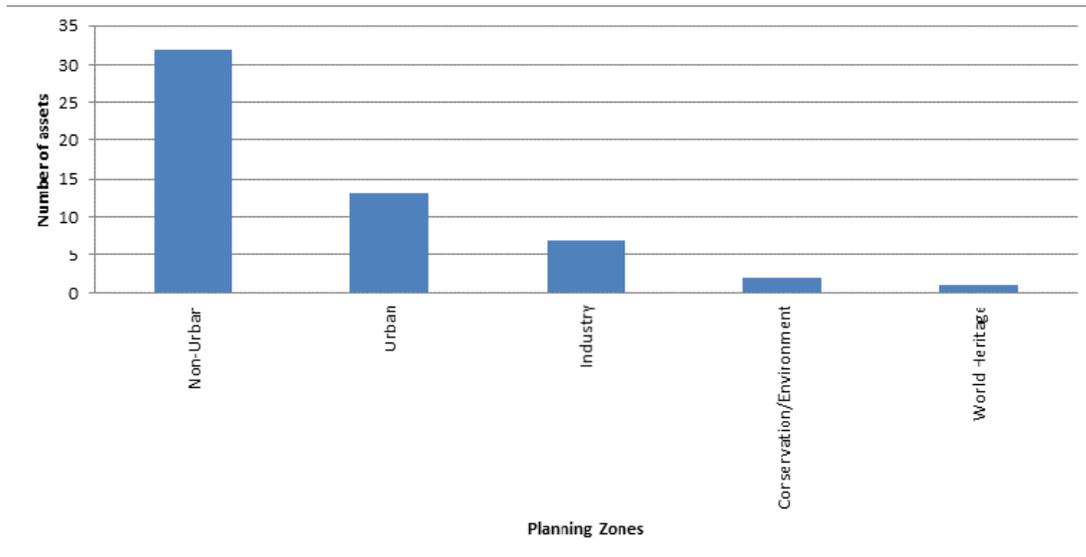
Figure 5 – TasNetworks owned sites by zone type

TasNetworks substation sites can be broken down into the types of locations they are installed and what the site is used for.

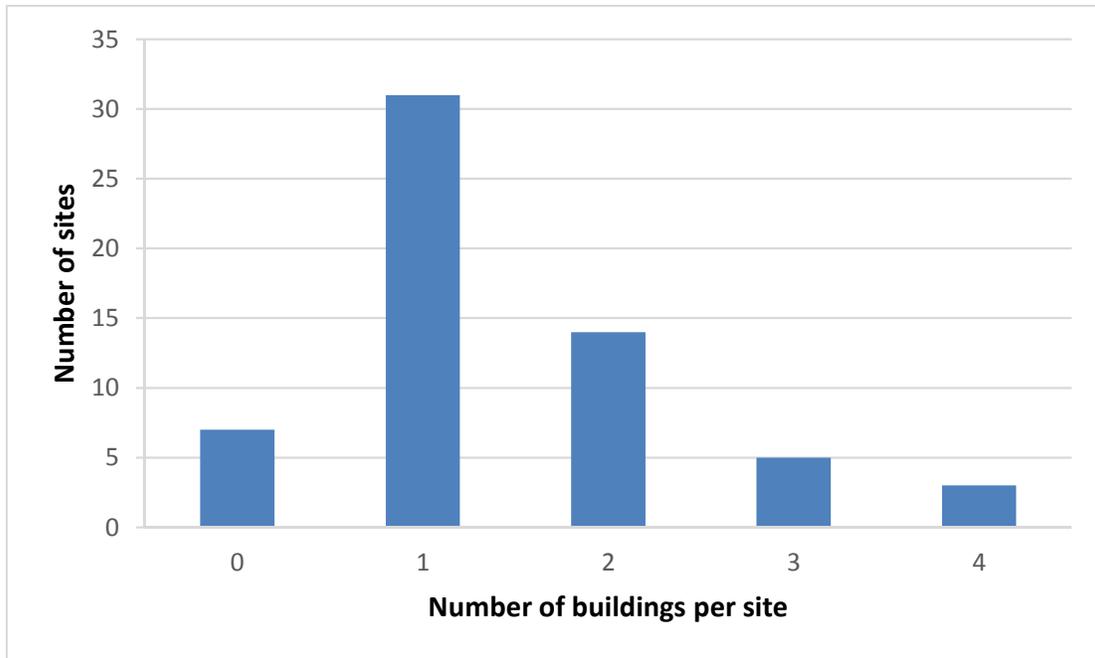
Figure 6 – Number of sites by number of buildings per site

TasNetworks owns 86 different substation buildings. Of the 86 buildings, 13 are multi story buildings. Figure 6 shows the number of sites broken down by number of buildings on site.

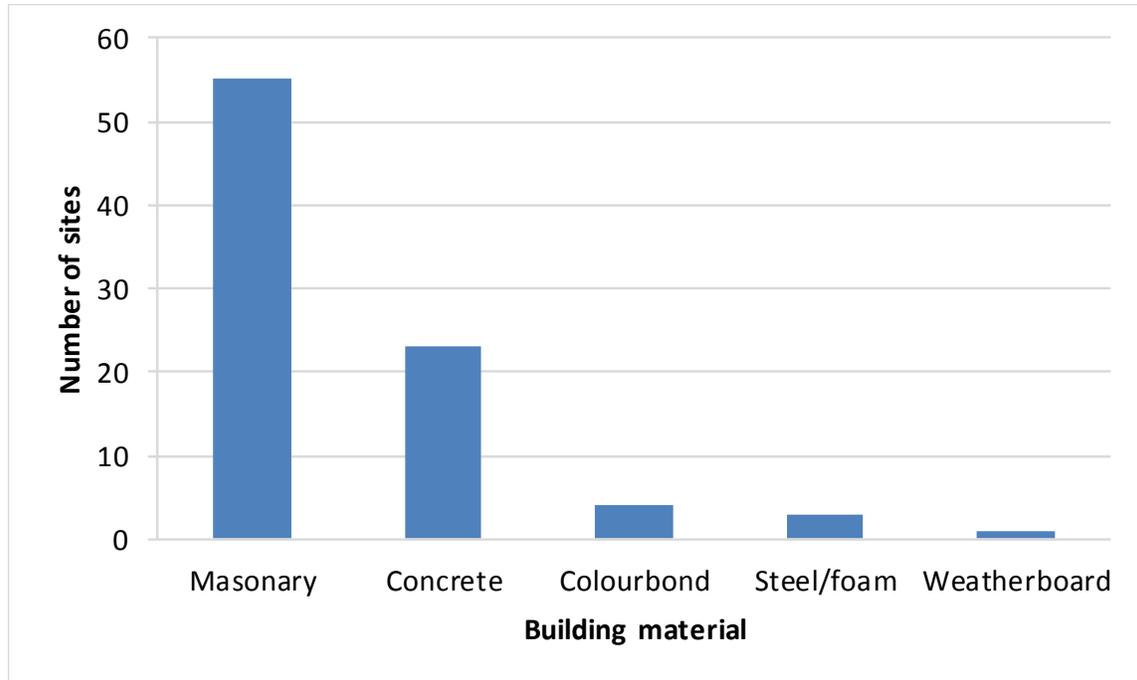
Figure 7 – Number of buildings by construction

Substation buildings are constructed using masonry or precast concrete, with steel trussed colour bond roofs. Windows are not normally installed due to fire rating requirements.

The following chart shows the main construction material for the population of buildings.

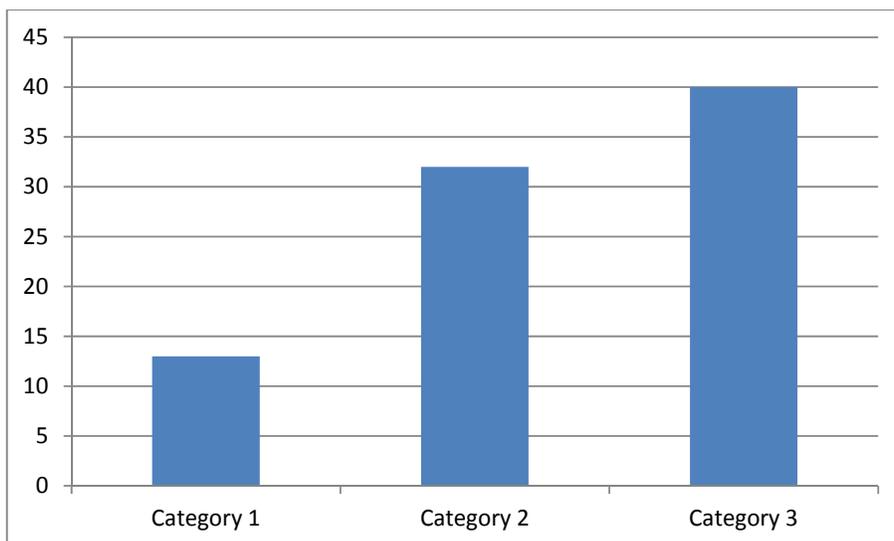
Figure 8 – Number of buildings by category allocation

- Category 1 – Multistorey, double brick construction with glass windows built prior to 1970.
- Category 2 – Single storey brick construction, windowless, flat roofed, built between 1970 and 1990.
- Category 3 – Single storey concrete based construction, windowless, trussed roofed built since 1990.

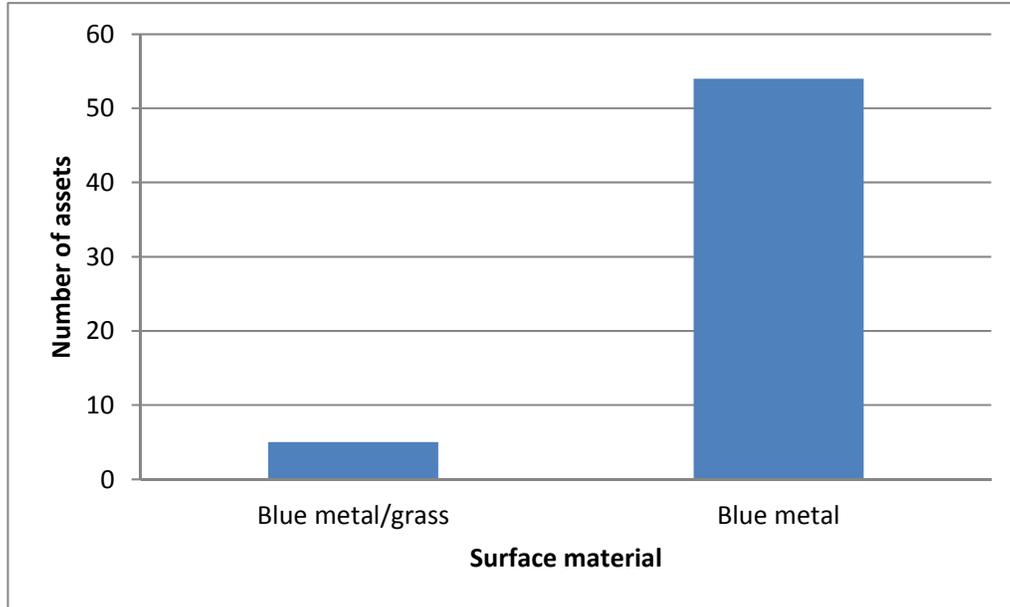
Figure 9 – Number of switchyards by surface covering

All new substations use blue stone aggregate as the switchyard surface to increase the substation earthing performance and to reduce ongoing mowing and fire risk.

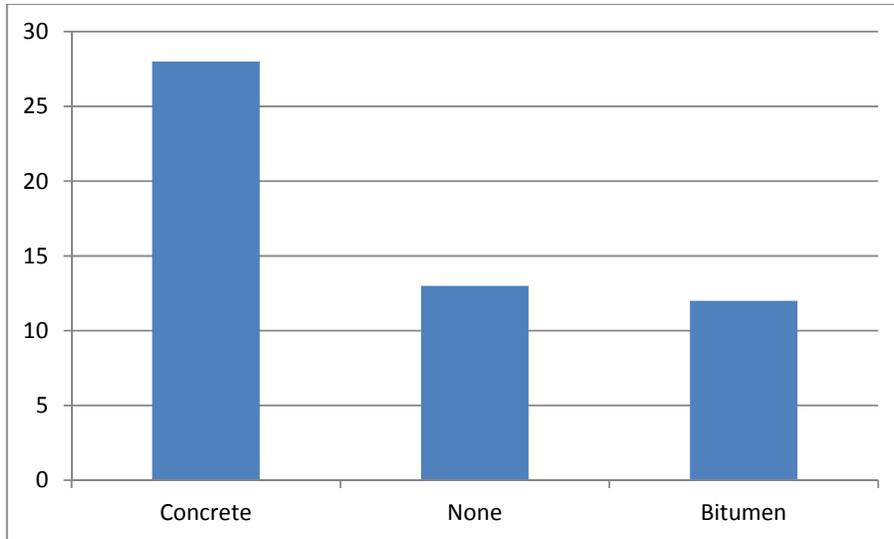
Figure 10 – Number of transformer tracks by construction

Bitumen based transformer tracks are unlikely to withstand the loading and vehicle movements associated with transformer transportation and construction.

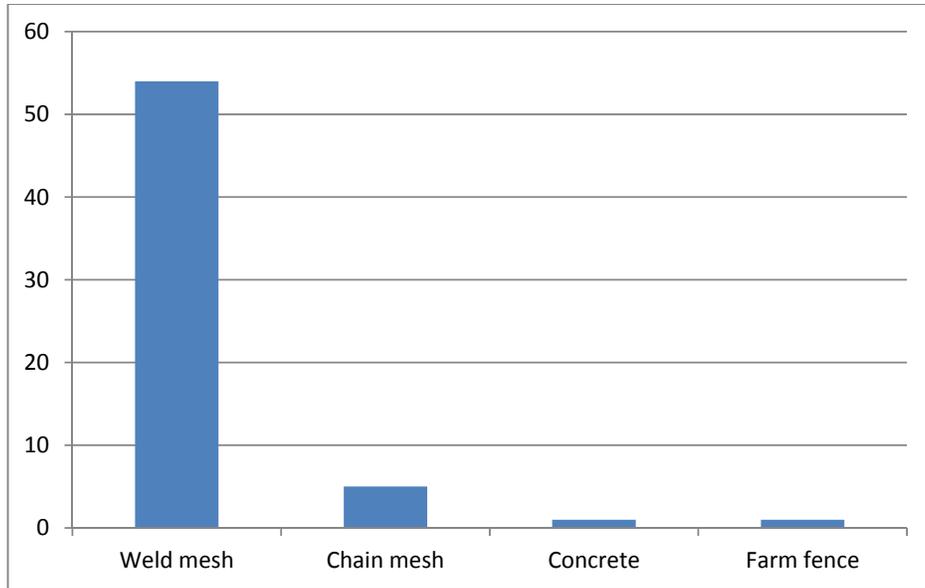
Figure 11 – Site security fencing type

Security fencing is provided to all sites and the types of fences installed are shown in the following figure.

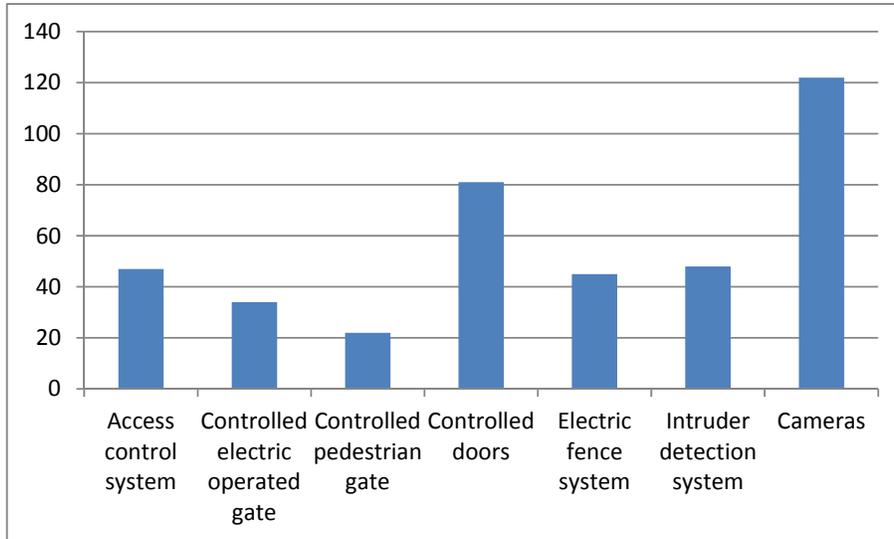
Figure 12 – Electronic security component type

Electronic security is provided to all sites and the types of components installed are shown in the following figure.

- Electric security fencing: 15 years;
- Access control systems: 10 years;
- Intruder detection systems: 10 years;
- Visual monitoring systems: 5 years.

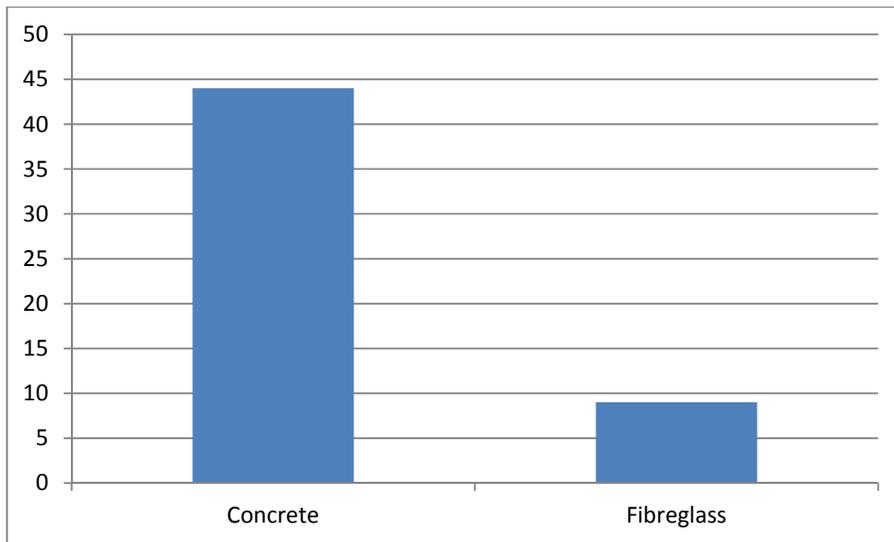
Figure 13 – Oil containment tank construction material

The following figure shows the breakdown of fibreglass to concrete tanks.

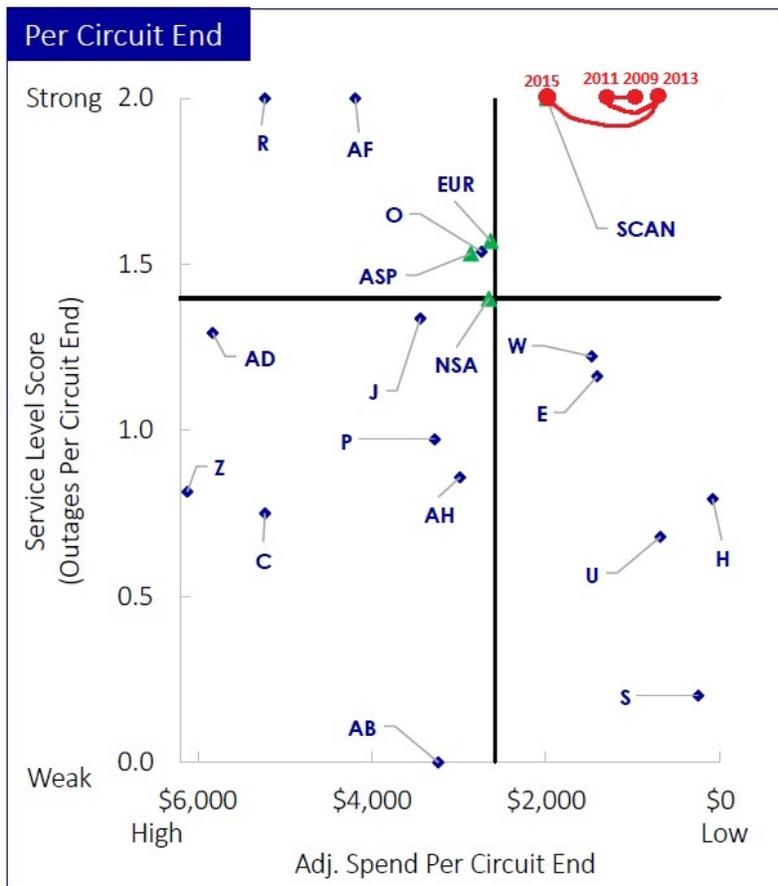
Figure 14 – ITOMS substation site maintenance benchmarked performance chart

The ITOMS results are typically presented in a scatter plot which enables comparison between participant utilities. The international benchmarked averages (cost & service) are shown as the centre crosshairs, with diamond shapes representative of surveyed participant utilities and regional averages shown as triangles marked NA (North America), EUR (Europe), ASP (Australia South Pacific), and SCAN (Scandinavia). The optimal performance location on the scatter plot is located in the upper right hand quadrant because, in this quadrant, service level is at its highest at the least cost. TasNetworks has been consistently higher than the international benchmarked average over the last reporting periods as shown in Figure 14.

Figure 14 illustrates TasNetworks benchmarked substation site infrastructure assets performance against all other ITOMS participants for the last four reporting periods on a per circuit end basis. It shows the performance, in terms of maintenance expenditure and fault outages of TasNetworks substation infrastructure, has largely maintained above average low service costs when compared to other transmission companies in the study. It demonstrates that in all reporting periods TasNetworks has managed its service cost performance to be considerably better than the benchmarked average. Note that 2 = strong service level, 0 = weak service level.

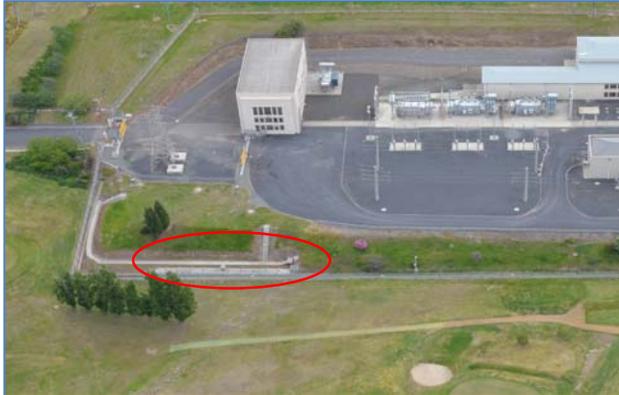
Figure 15– Risdon oil containment tank – above golf course

The concrete pipework is cracked, leaks, and is likely to crack further in the event that burning or hot oil from a transformer fire enters the containment tanks.
