Asset Management Plan

Transmission Line Support Structures

Record Number: R32681

Date: October 2017

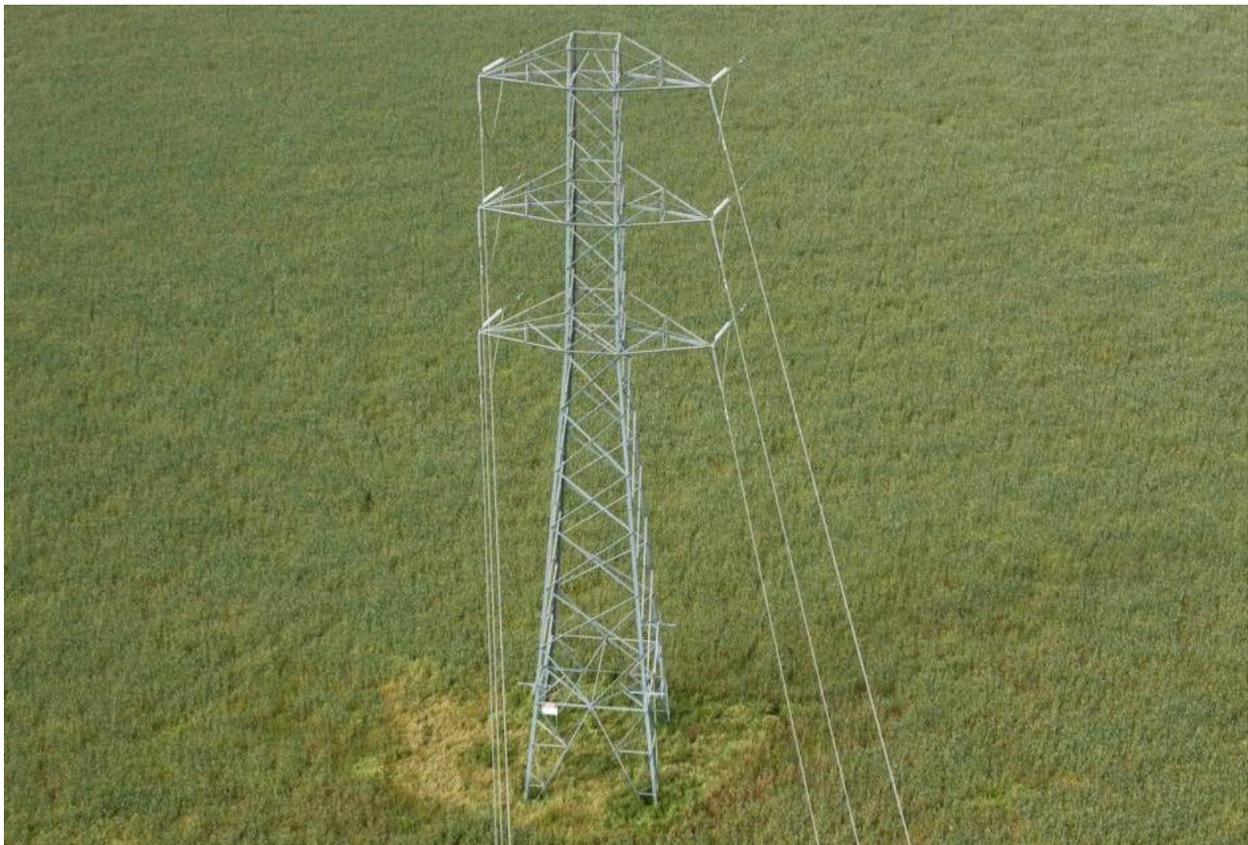
Figure 1: Steel lattice tower (galvanised)

A typical lattice tower, as shown in Figure 1, consists of numerous steel members jointed with plates and bolts for structural strength, with corrosion protection provided primarily via a galvanised layer. The design of the lattice tower can vary significantly, depending on the required structural capacity, the number of circuits required to be supported, and the associated voltage.

The most common failure mode for steel lattice towers is strength reduction due to excessive corrosion and eventual failure of bolts and members. To assist in this all vegetation must also be kept clear of lattice tower base steelwork and inspection regimes to identify loss of the protective galvanised coating.

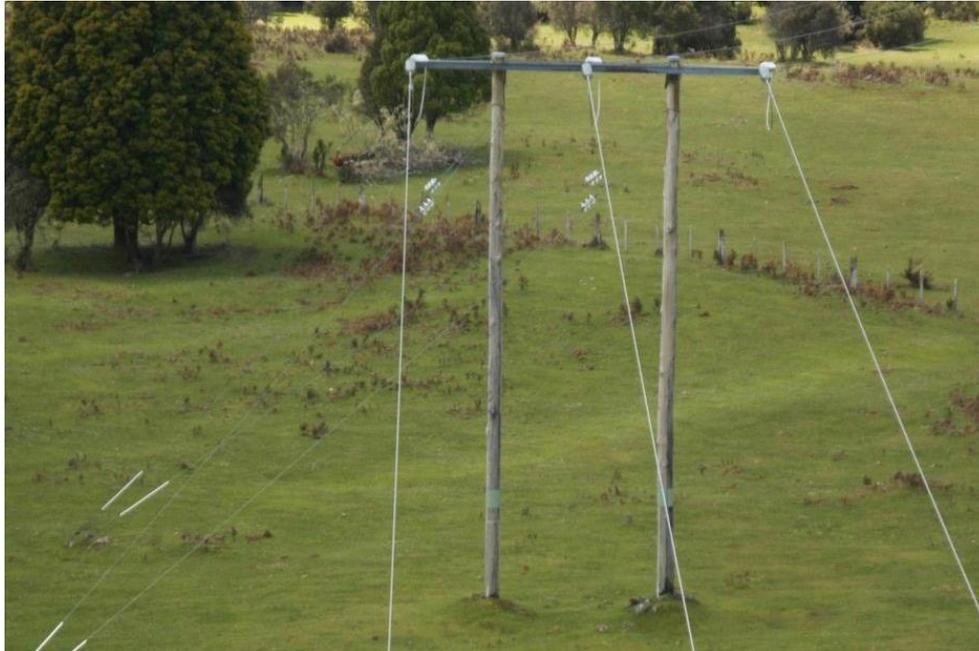
Figure 5: Wood pole structures

Wood pole structures are used on a small number of transmission lines, and have generally been unitised where either a shorter asset life or lower level of reliability can be tolerated. A typical wood pole structure is shown in Figure 5.

The most common failure mode for wood poles is structural failure due to wood rot, particularly below ground where the wood is subjected to moisture and bacteria, but also at the interface between the top of the pole and the pole riser (where fitted).

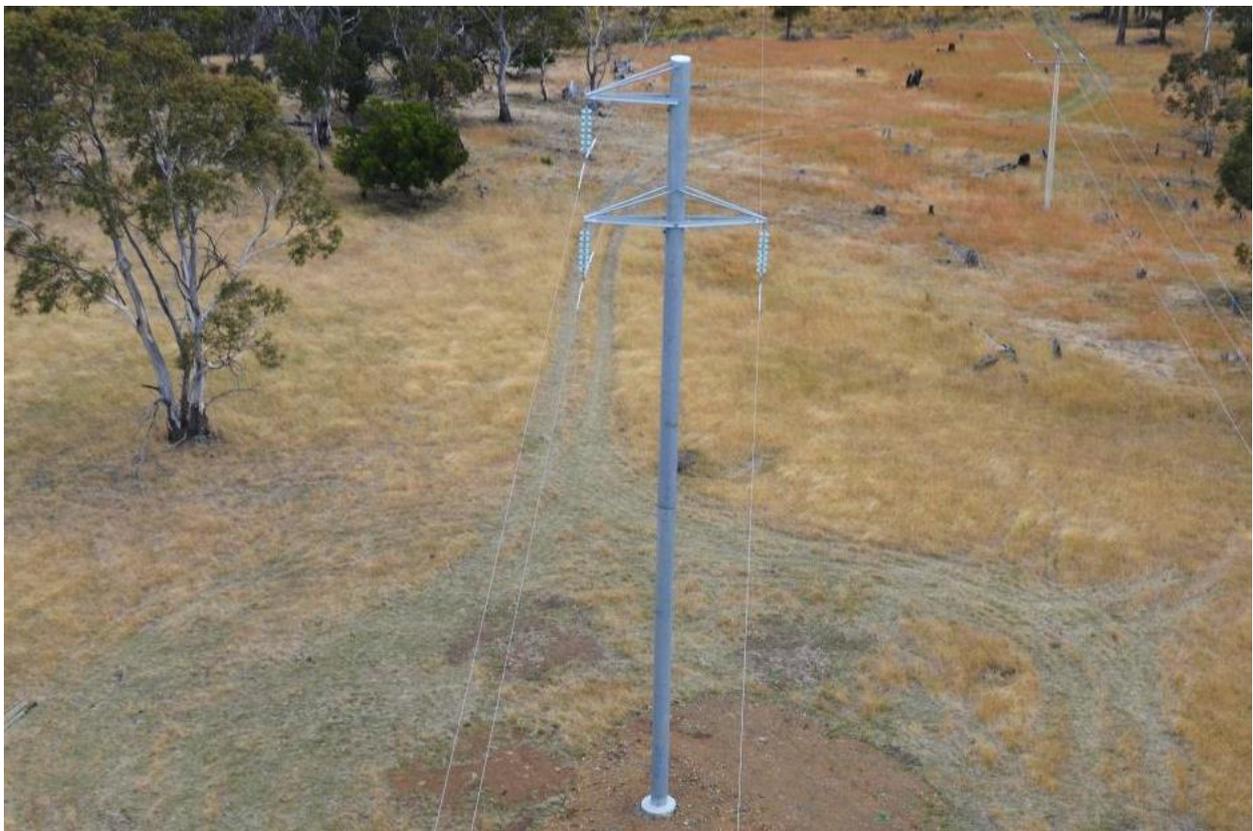
Figure 7: Steel pole structure

Steel pole structures are usually constructed from a rolled or a bent steel plate with sections joined by overlapping or bolted connections, with corrosion protection provided by a galvanised layer. TasNetworks' preferred option is the use of steel lattice structures and steel poles on new transmission lines.

Typically these structures are a single pole, as shown in Figure 7, however in high load areas an H pole arrangement utilising two steel poles maybe required.

The most common failure mode for steel poles is structural failure due to corrosion, particularly below ground where water can collect in the pole base. All vegetation must also be kept clear of steel pole bases.

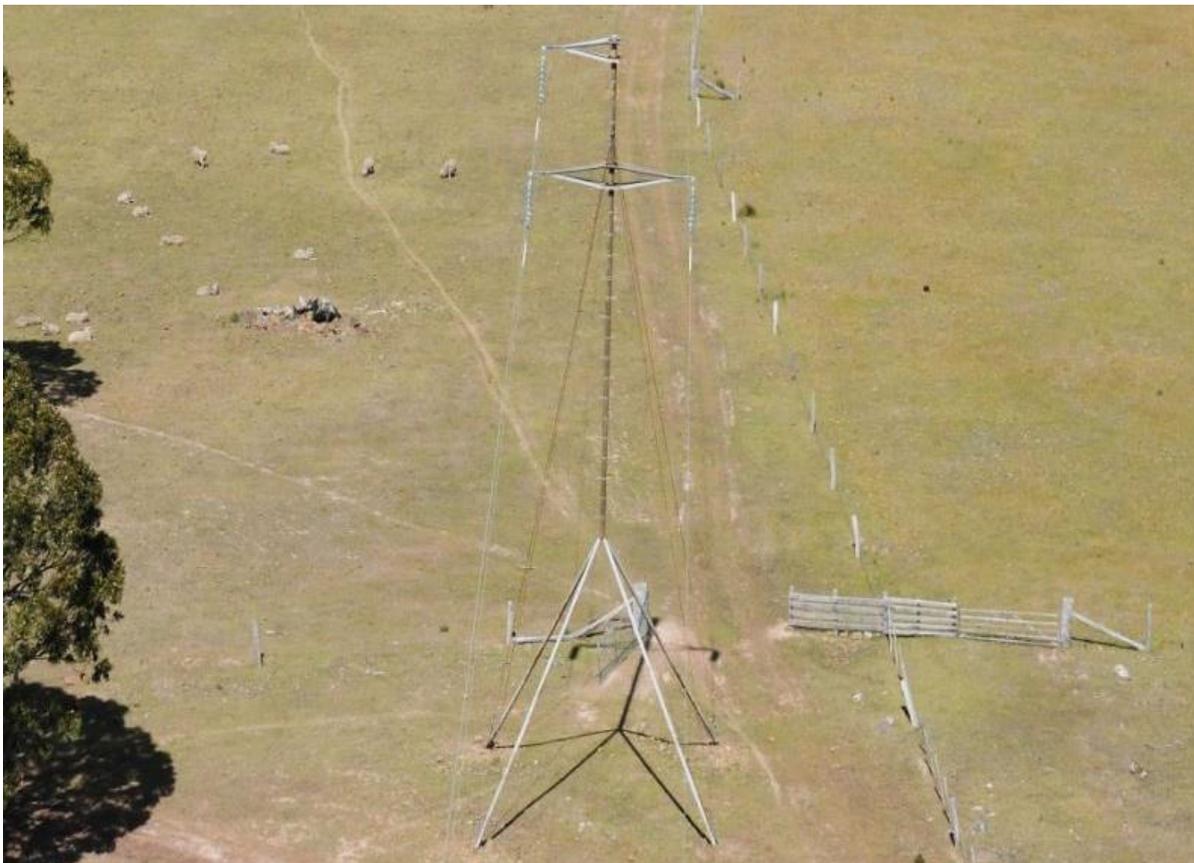
Figure 9: Kay pole structure

As can be seen in Figure 9, Kay pole support structures consist of a single vertical steel pole supported by four, shorter, steel pole 'legs', stabilised by guy wires attached between the base of each leg and the top of the vertical steel pole. These poles were designed during the First World War when steel availability was limited.

The most common failure mode for Kay poles is structural failure due to guy wire corrosion, internal tube corrosion, and foundation degradation.

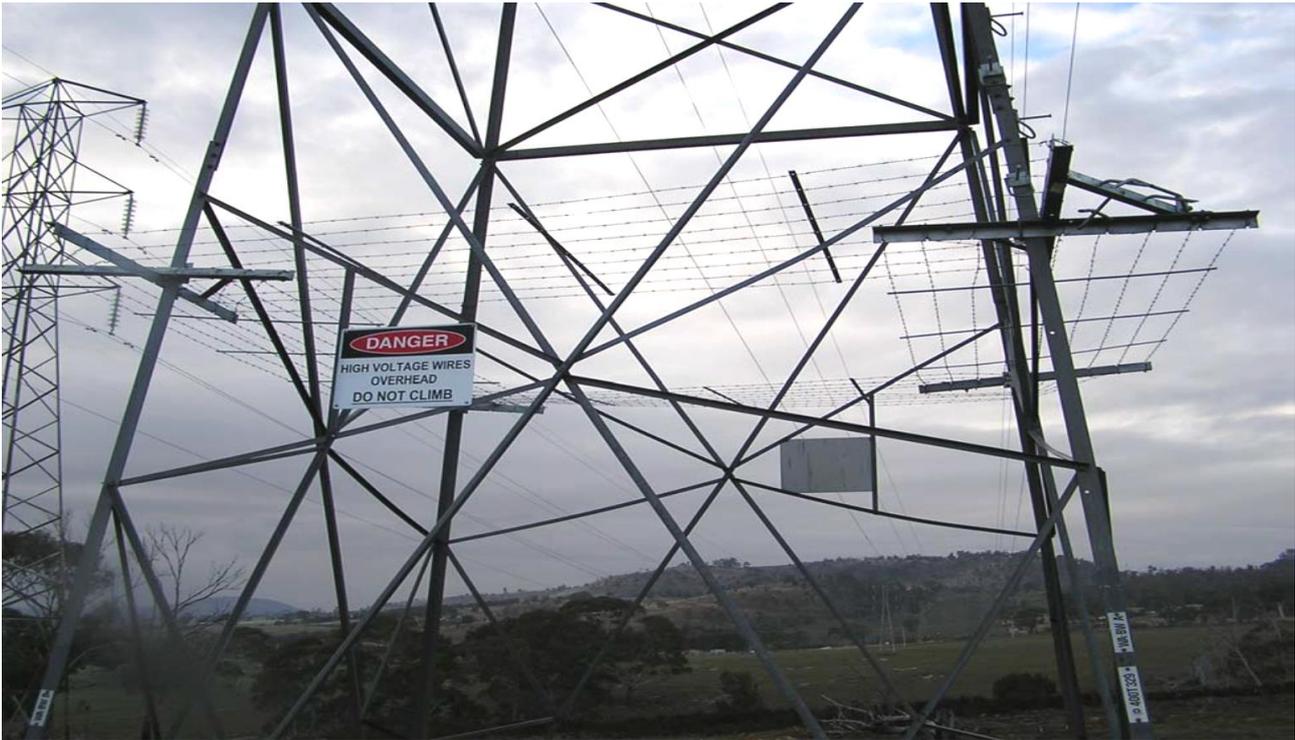
Figure 11: Climbing barrier

Where old type barriers exist (no access gate and require a ladder to access the structure), it is TasNetworks policy to replace these barriers with the modern equivalent, but only where the condition of the barrier is sufficiently poor.

The most common failure mode for climbing barriers are strength reduction due to steel corrosion and degradation.

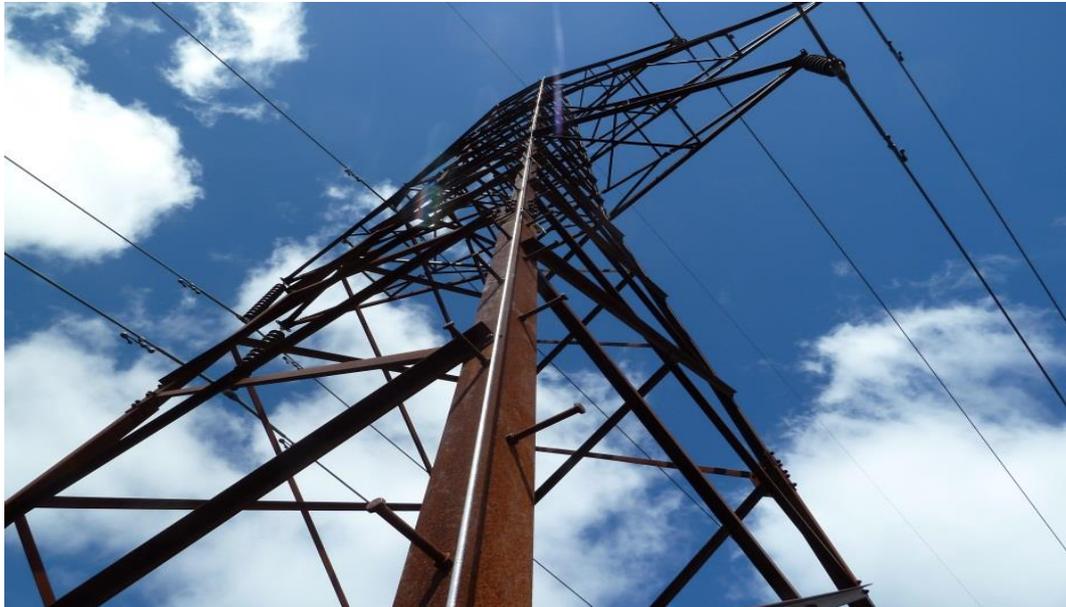
Figure 12: Fall Arrest System

Figure 12 shows a typical Latchways® fall-arrest system fitted to a transmission line support structure.

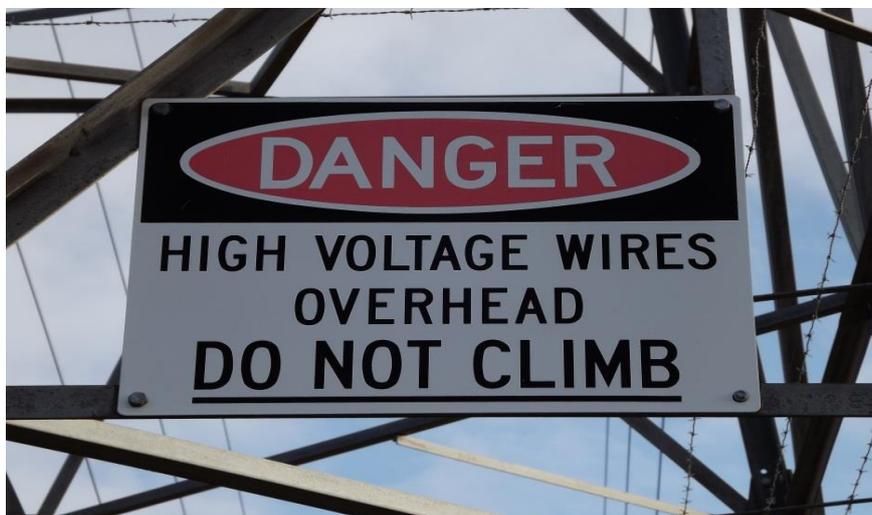
Figure 13: Warning signage

The most common failure mode for warning signs is fading due to UV exposure, particularly the colour red.

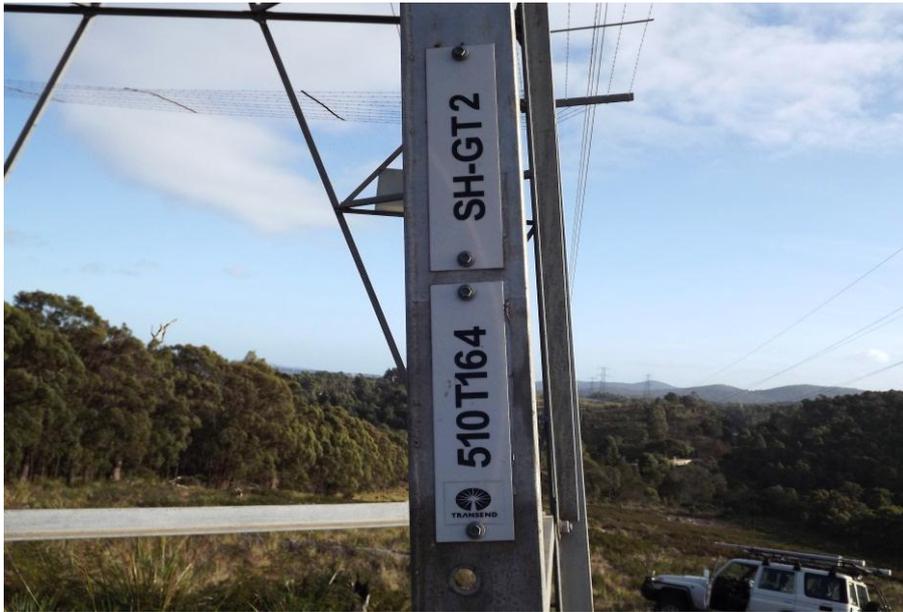
Figure 14: Identification labels

Transmission line identification labels are installed to provide advice to TasNetworks employees and contractors regarding the name of a particular structure, circuit, transmission line or other asset type.

To comply with the Power System Safety Rules transmission line identification labels are required to be fitted to all transmission line structures to allow positive identification of the transmission line, structure number and circuit before work can commence.

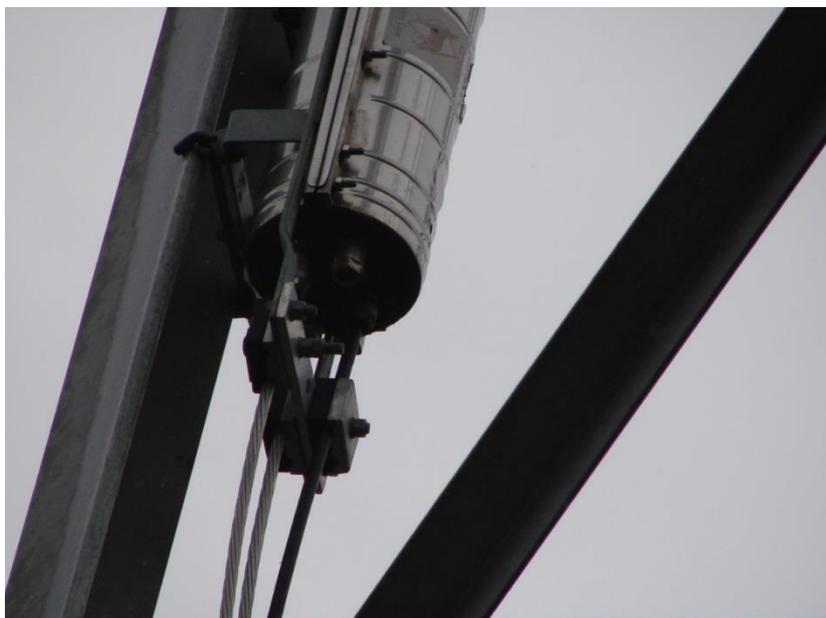
Figure 15: OPGW Splice Pod

OPGW splice pods are installed on transmission lines that have OPGW installed. The splice pods are installed approximately every 10 structures, or at strategic points as required. These pods are installed on structures using brackets and allow for connection to the OPGW fibres.
