Asset Management Plan

Transmission Line Insulator Assemblies Asset Management Plan

Record Number: R32678

Date: October 2017

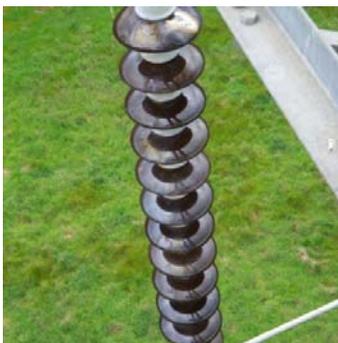
Figure 2: 220 kV porcelain disc insulator assembly

Porcelain insulator assemblies, shown in Figure 2, have been utilised extensively in the past, and upon failure would normally be replaced with a similar porcelain insulator assembly. These insulators are able to withstand attempts at vandalism more effectively than glass insulators. However, porcelain insulators are not preferred for new transmission lines, as failure often manifests itself in a small puncture of the insulator disc that is often visibly undetectable by field personnel, requiring costly condition monitoring.

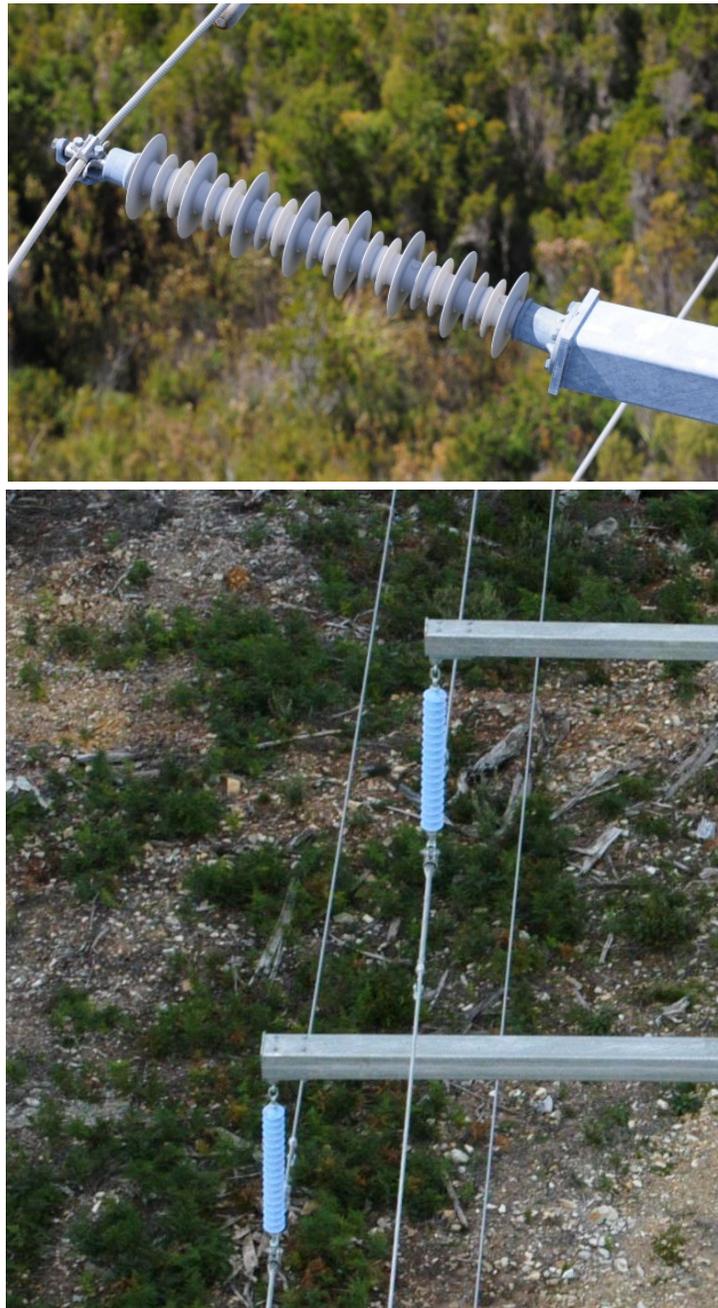
Figure 5: Post and long rod synthetic insulators

Figure 5 shows typical synthetic post and suspension insulator assemblies.

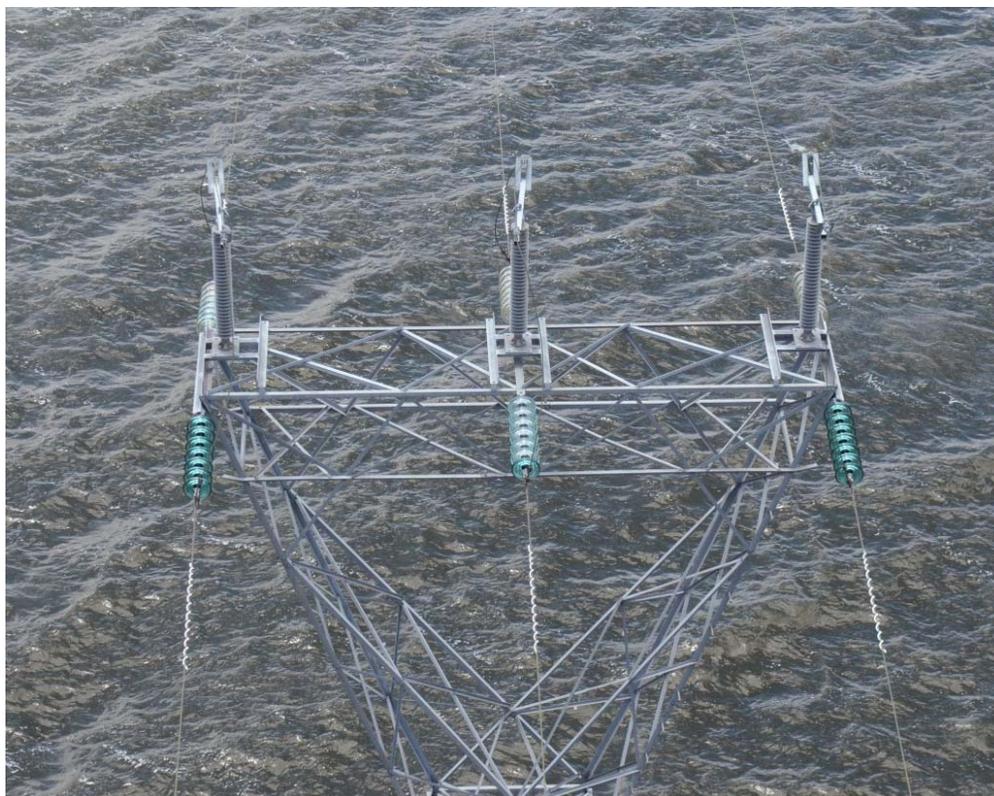
Figure 7: Porcelain post insulators

Only 56 porcelain post insulators have been installed on the transmission network. Porcelain post insulators are no longer installed by TasNetworks, but historically were typically used as an option to obtain additional ground clearance. A typical post installation is shown in Figure 7.

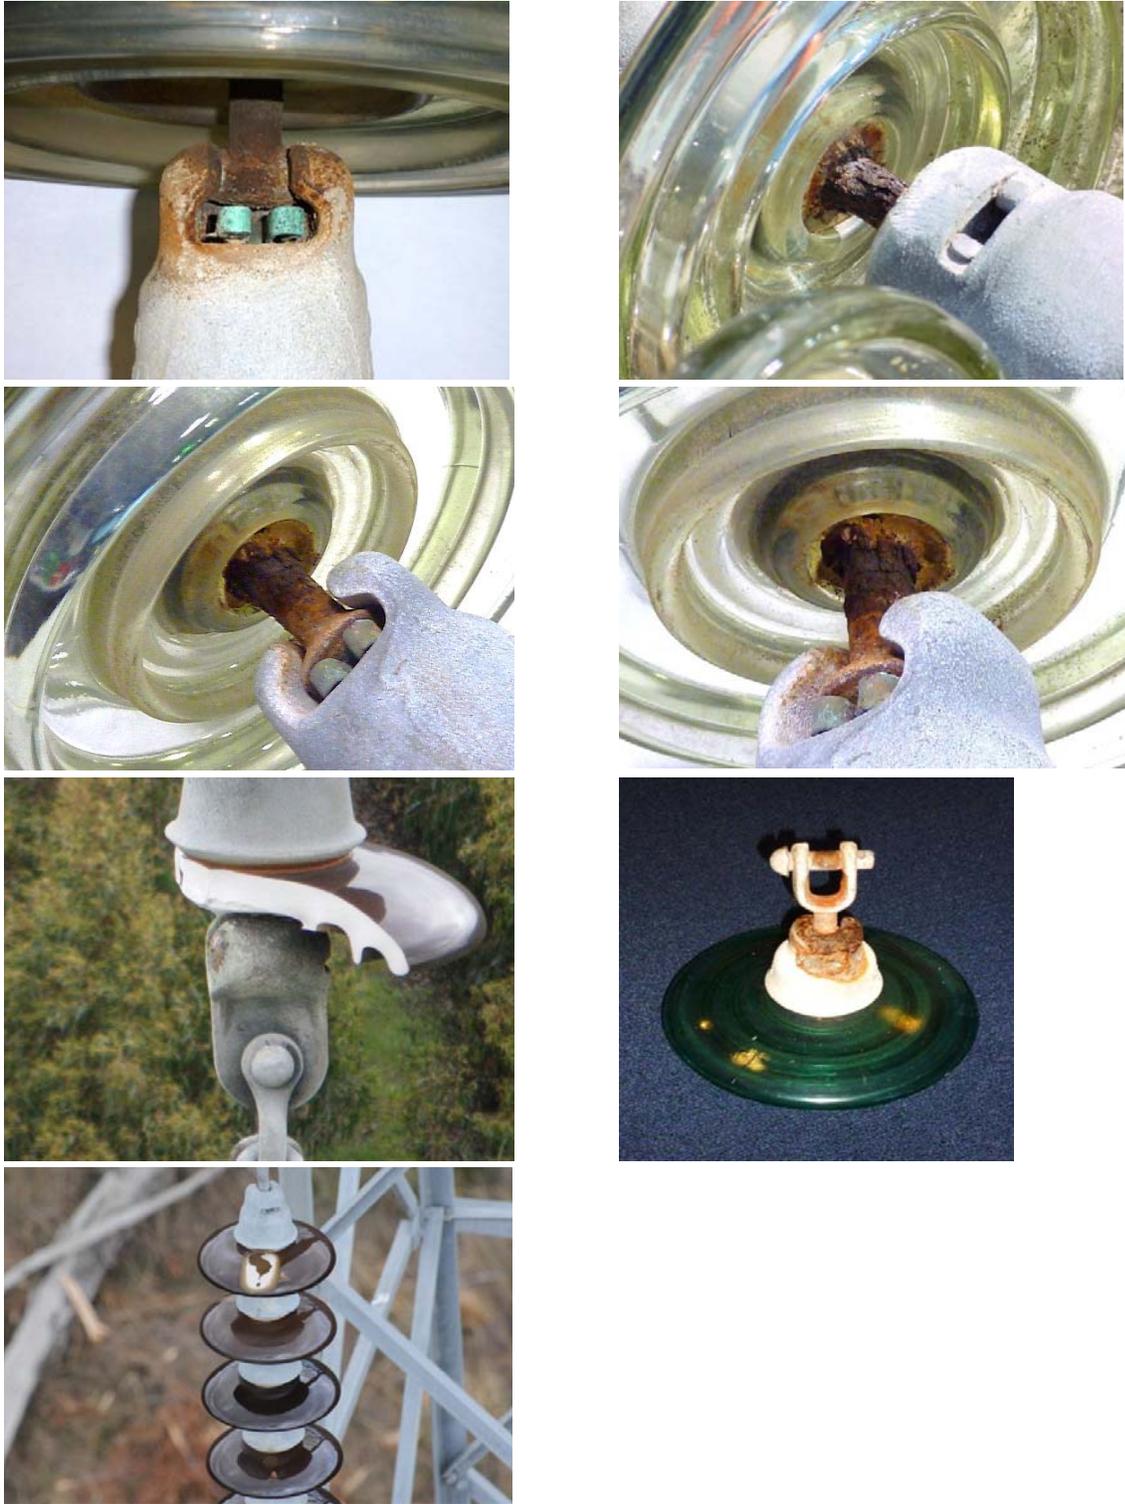
Figure 9: Typical defective insulators

Some photos of typical insulator defects are presented in Figure 9.

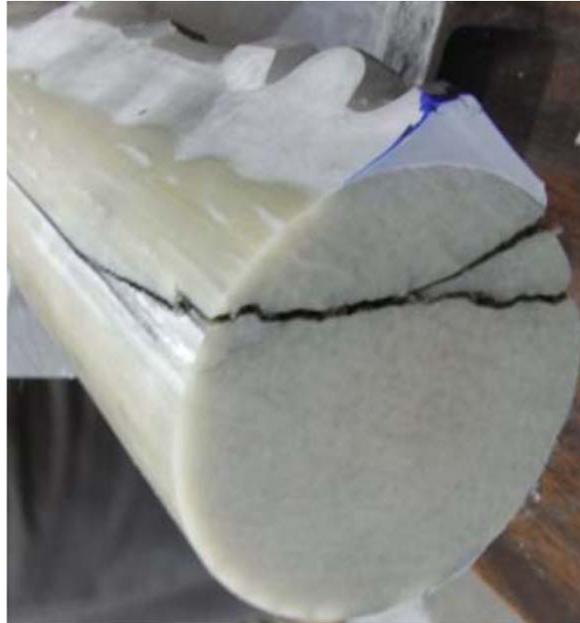
Figure 10: Cracking of fibreglass rod of insulator on TL446T232 (2013 failure)³

A second failure of the same type of insulator occurred in June 2013 on the same transmission line, and in this instance the insulator was sent back to the manufacturer to facilitate an examination through dissection of the insulator. The manufacturer produced a report from this examination which found that mechanical failure of the insulator had resulted in a crack developing in the fibreglass centre of the insulator and that over time this crack had extended to the point where electrical failure occurred by means of flash-under. The report also concluded that complete mechanical failure would have eventually occurred, similar to that experienced in 2009.

Subsequent to the June 2013 failure, TasNetworks performed visual, infrared and corona scans of the remaining in-service insulators on the Savage River Spur 110 kV transmission line to determine their condition. The condition monitoring results highlighted a level of thermal hot-spots on insulators that are indicative of mechanical and electrical insulation breakdown.
