Asset Management Plan

Overhead Line Structures - Distribution

Record Number: R260425

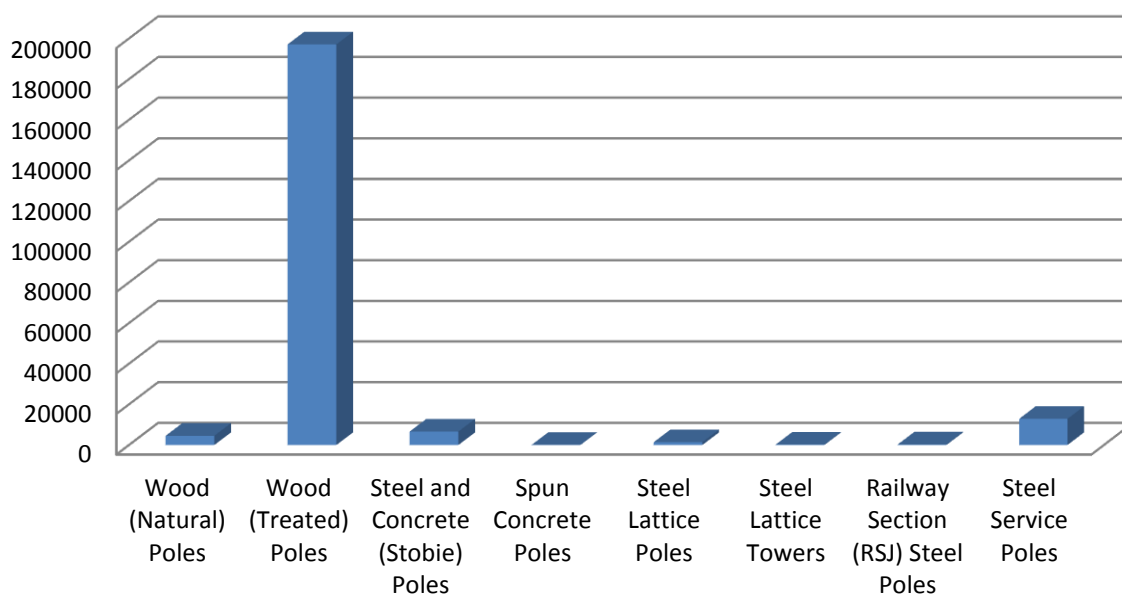
Figure 2: TasNetworks Pole Types

Description	Number Installed (Total)	Number Installed (TasNetwork Owned)	Number Installed (Privately Owned)
Natural Wood Poles	5,628	4,019	1,609
CCA Treated Wood Poles	234,121	198,822	35,299
Steel and Concrete (Stobie) Poles	6,779	6,577	202
Spun Concrete Poles	86	63	23
Prestressed Concrete	80	80	0
Steel Lattice Poles	1,383	1,331	52
Steel Lattice Towers	339	148	191
Railway Section Steel Poles	527	216	311
Steel Other	45,011	8,701	36,310
Other/Unknown	449	261	188
Total	294,403	220,218	74,185

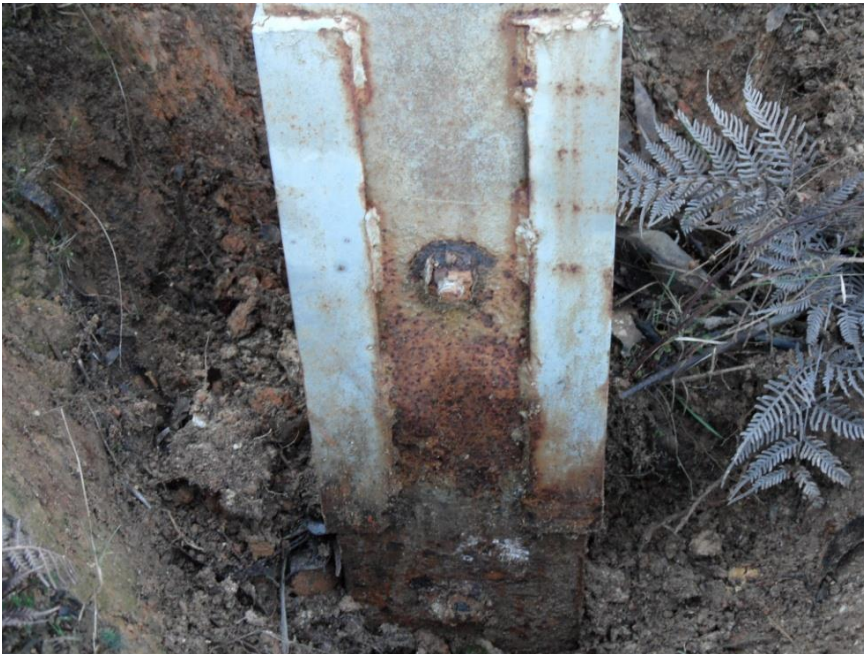
Figure 10: Poor condition steel and concrete (Stobie) pole

Repairing the below section of direct buried Steel and Concrete poles is cost effective as it will extend their lives by 15 to 20 years.

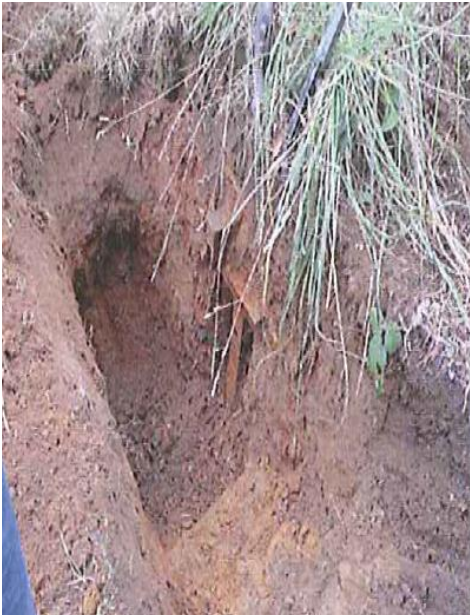
Figure 21: Corrosion on surfaces of underground portion of Steel Tower Leg

The aim of this program is to undertake major remedial works on the below ground portion of TasNetworks’ distribution line steel towers. As with wood poles, steel towers deteriorate below ground at a faster rate than above ground.
