Investment Evaluation Summary (IES)

Project Name:	BFM - project replace aged/deteriorated Cu conductor
Project ID:	01509
Business Segment:	Distribution
Thread:	Overhead
CAPEX/OPEX:	CAPEX
Service Classification:	Standard Control
Scope Type:	A
Work Category Code:	REMCU
Work Category Description:	Replace HV copper conductor
Preferred Option Description:	Review and replace HV copper conductor based on condition and risk of fire start.
Preferred Option Estimate (Dollars \$2016/2017):	\$12,772,000

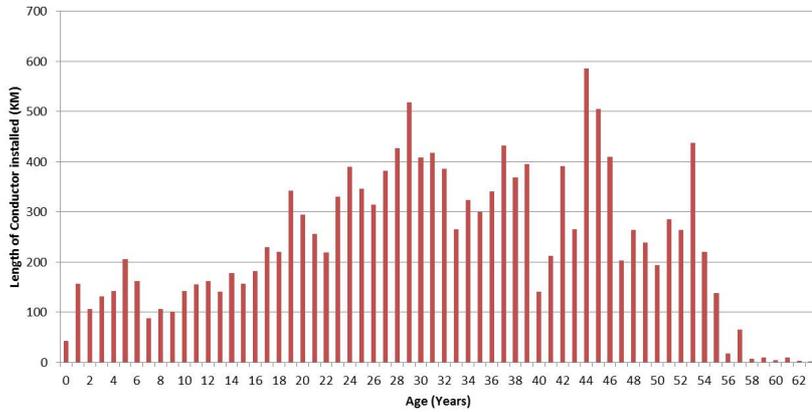
Figure 1: Estimated age profile for all HV conductor in the network

The makeup of all high voltage (HV) conductors in the distribution network and the number of bare wire overhead conductor breakages (from WASP Outage Data) is shown in Table 2, and Figure 1 shows the current estimated age profile of HV overhead conductor within the network. Table 2 is ordered in terms of most failures per 1000 KM for each conductor type with copper showing the highest failure rate.

HV Conductor Age Profile
