Investment Evaluation Summary (IES)

Project Name:	Replacement Substandard Overhead Copper Conductor (REMCU)
Project ID:	00591
Business Segment:	Distribution
Thread:	Overhead
CAPEX/OPEX:	CAPEX
Service Classification:	Standard Control
Scope Type:	A
Work Category Code:	REMCU
Work Category Description:	Replace HV copper conductor
Preferred Option Description:	Review and replace defective and substandard Copper Conductor based on condition.
Preferred Option Estimate (Dollars \$2016/2017):	\$8,523,240

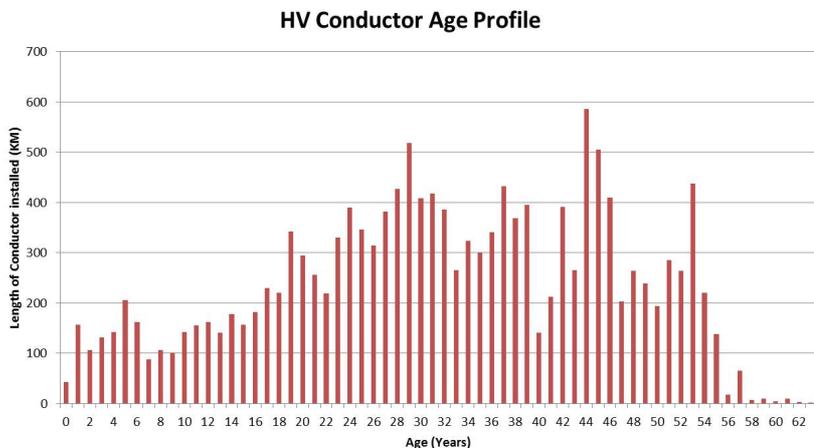
Figure 1: Estimated age profile for all HV conductor in the network

The makeup of HV conductors in the distribution network and the number of bare wire overhead conductor breakages (from WASP Outage Data) is shown in *Table 1*, and *Figure 1* shows the current estimated age profile of HV overhead conductor within the network. *Table 1* is ordered in terms of most failures per 1000 KM for each conductor type with copper showing the highest failure rate.
