# Investment Evaluation Summary (IES)

Project Name:	Pole Replacements
Project ID:	00661
Business Segment:	Distribution
Thread:	Structures
CAPEX/OPEX:	CAPEX
Service Classification:	Standard Control
Scope Type:	B
Work Category Code:	REPOL
Work Category Description:	Pole Replacements
Preferred Option Description:	Replace poles based on condition.
Preferred Option Estimate (Dollars \$2016/2017):	\$70,720,260

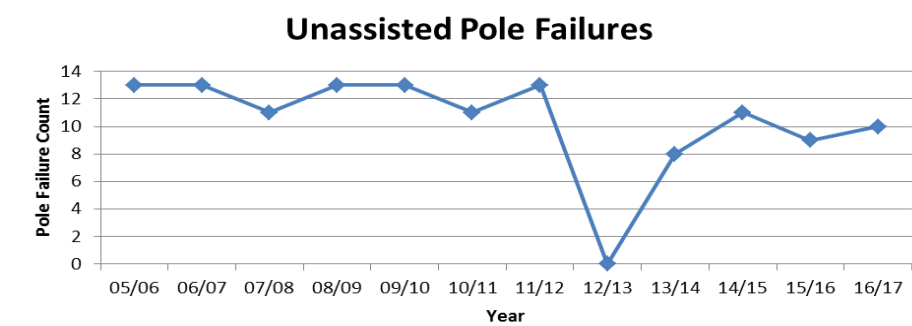
Historically TasNetworks has experienced on average 12 unassisted pole failures per annum as shown in Figure 1.

Figure 1: TasNetworks owned unassisted pole failures trend

TasNetworks pole failure rates are consistent with the national average based on other distribution network service providers wood pole failure rates. Details obtained from the Energy Networks Australia (ENA) working group and shows TasNetworks compares favourably within its peer group.

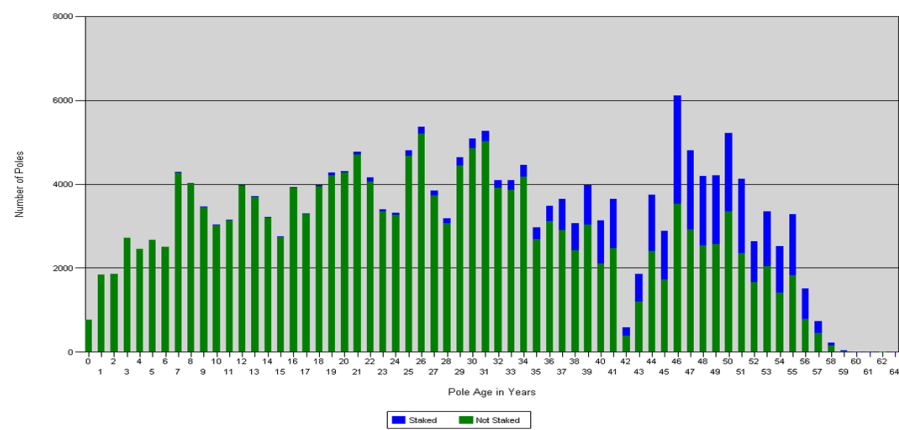
Wood pole staking commenced in 2002 and the current staked wood pole population is approximately 30,000 poles. Wood poles are generally staked at 30-45 years of age with the staked pole typically lasting 10-15 years. Staking has proven to be a cost-effective way of ensuring the service life of 40-50 years is attained. Figure 2 shows the proportion of staked poles compared to the wood pole population. It shows that a large number of staked poles have now reached or are approaching end of life. On this basis it is anticipated that the number of staked poles needing to be replaced will increase in forthcoming years. Figure 2 below shows the age profile of all installed poles on the distribution network including staked structures.

Figure 2: Age profile of distribution wood poles (natural and CCA treated) including staked poles

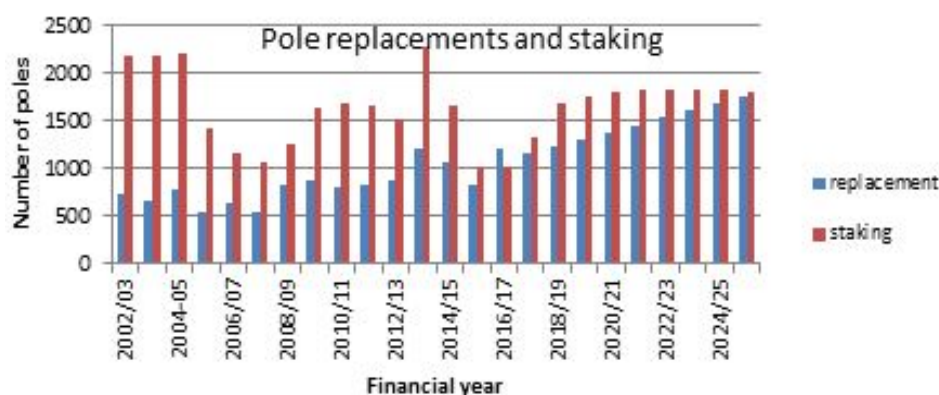
As shown in Figure 3 below, there is an increasing annual rate of pole replacements based on the inspection results. This rise follows the ageing trend of the pole population, however, this annual increase does not fully cover the ageing profile rate. Parallel to this, the condemning and subsequent replacement of already staked wood poles is also anticipated to rise over the coming years as an increase in staking works carried out around 15 years ago reaches the end of their lifespan and thus, the annual replacement volumes will need to be further increased in the coming years as shown in Figure 3.

Figure 3: Historic and forecast replacement and staking volumes

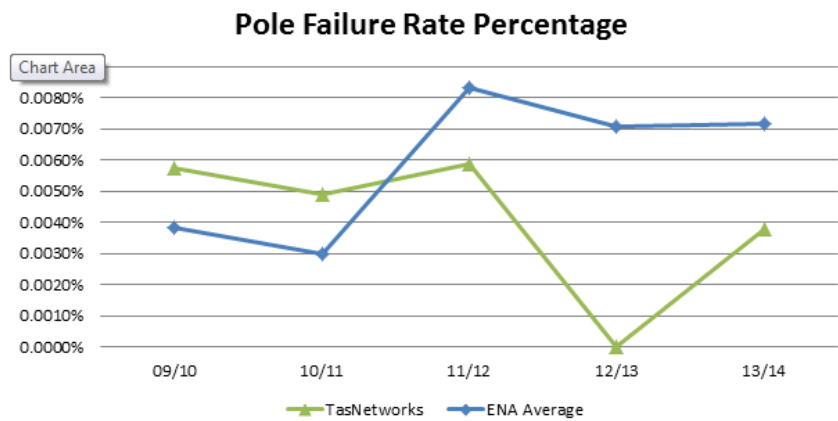
In the past TasNetworks unassisted pole failure rate has been consistently below the average pole failure rate for all networks. The reduction in 2012/13 of no TasNetworks owned unassisted pole failures is due to an increased volume of pole replacements that year due to a change in work practices for applying pole safety factors, which lead to poles being condemned prematurely. The work practice has since reverted to previous, as the increased condemning rate was not sustainable. Figure 4 outlines the pole failure rate as provided by the Electricity Networks Australia annual Pole Failure Survey.

Figure 4 - Electricity Networks Australia annual pole failure rate
