# Investment Evaluation Summary (IES)

| Project Name: | Replace Crossarm (Safety) |
| Project ID: | 00698 |
| Work Category Description: | Replace LV Feeders (Substandard) |

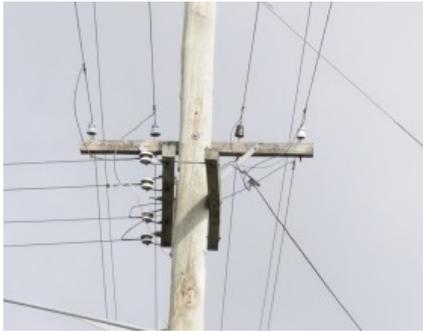
Crossarms are used to connect the insulators which hold the conductors to the support structures (poles) and provide adequate clearance between the conductors. TasNetworks' Low Voltage (LV) crossarms are predominantly manufactured from sawn timber as this medium is cost effective and offers insulation qualities to allow live line activities to be performed safely. There are around 210,000 wooden LV crossarms in the distribution network. *Figure 1* shows an example of a wooden LV crossarm, they have a relatively short service life of approximately 20 years. This Investment Evaluation Summary (IES) does not cover steel crossarms which are used for the High Voltage (HV) network or fibreglass crossarms which are currently being trialled in the LV network.

Figure 1: Sawn wooden LV crossarms

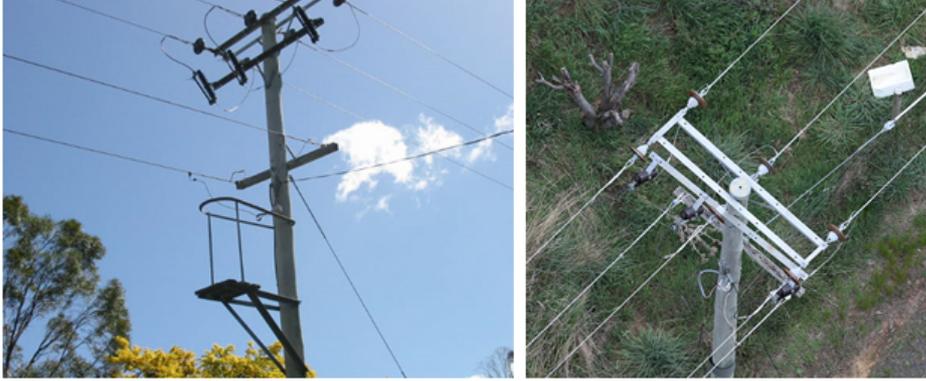
In 2014/2015 for the first time TasNetworks started inspecting its assets from the air to supplement the traditional ground based inspection methods. This provided a previously hidden view of the network that showed many wooden LV crossarms were in worse condition than previously thought. In particular there was a spike in decayed timber crossarms reported, as these tend to rot on top while remaining intact on the underside, making it difficult to detect from ground patrols. *Figures 3 and 4* show the same pole from both ground level and from an aerial inspection view point, the advantage of using aerial inspections to better assess the condition of crossarms is apparent.

Figures 3 and 4: The same pole seen from the ground and from the air
