Asset Management Plan

Ground Mounted Substations – Distribution

Record Number: R301623

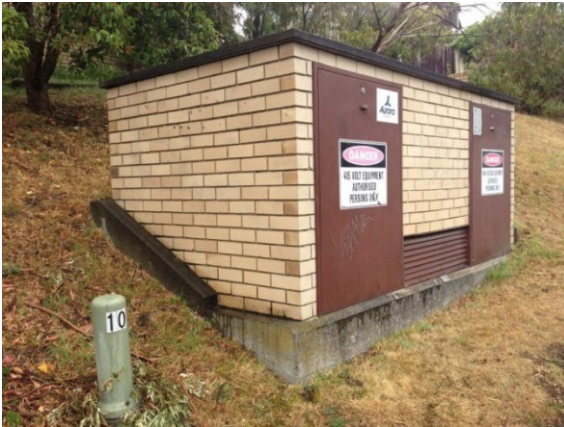
Figure 1 Block wall kiosk (1977)

Kiosk type substations have been installed on the network since the late 1960s.

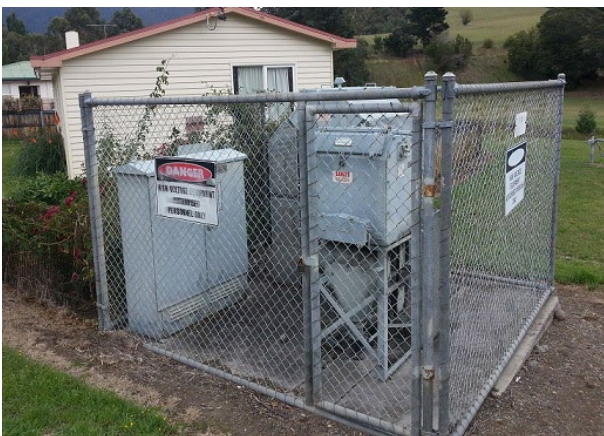
Figure 3 Fence type substation (1967)

Fence type substations are stand alone outdoor installations. These substations have an external perimeter fence and usually consist of high voltage switchgear, transformer(s) and a low voltage switchboard. The equipment may be either designed to be outdoors, or indoor equipment installed in individual weatherproof cabinets. They range in size from 100 kVA to 4500 kVA. Figure 3 represents a typical fence type installation.

These substations have been installed on the network since the late 1950s.

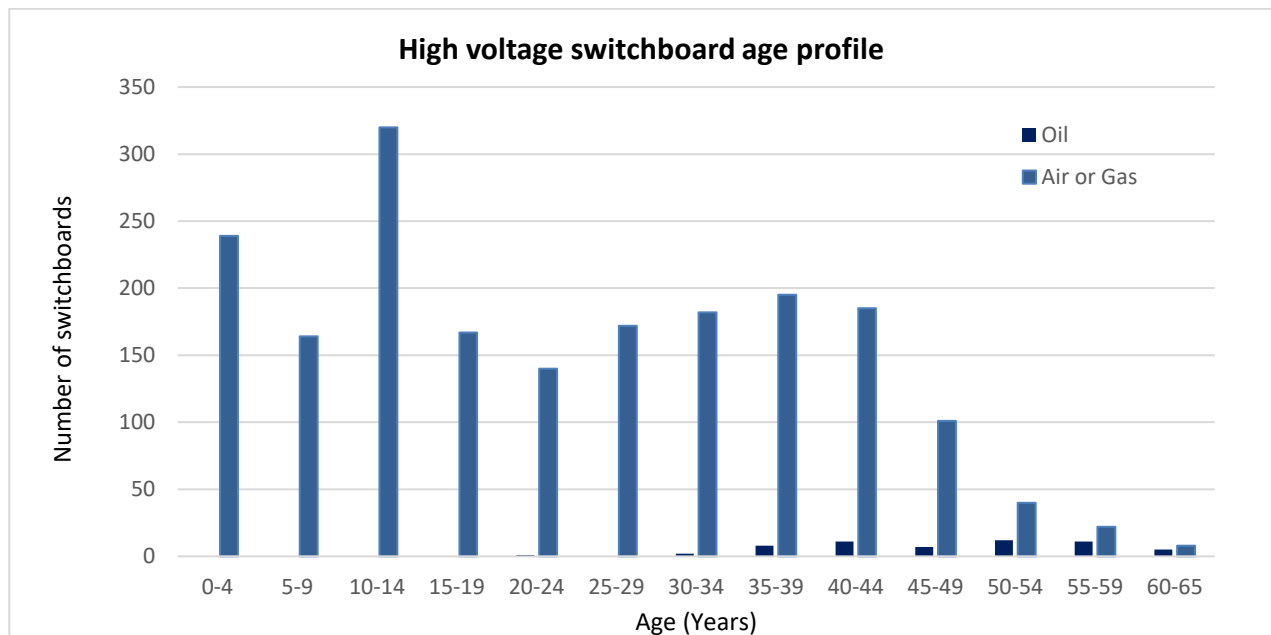
Figure 5: High voltage switchgear age profile (as at September 2022)

With a shift in the 1970s to undergrounding of urban distribution networks, there was a notable increase in the number of ground mounted substations being installed in the 1970s and 1980s. The impact of this change can be seen with the switchgear age profile shown in Figure 5.

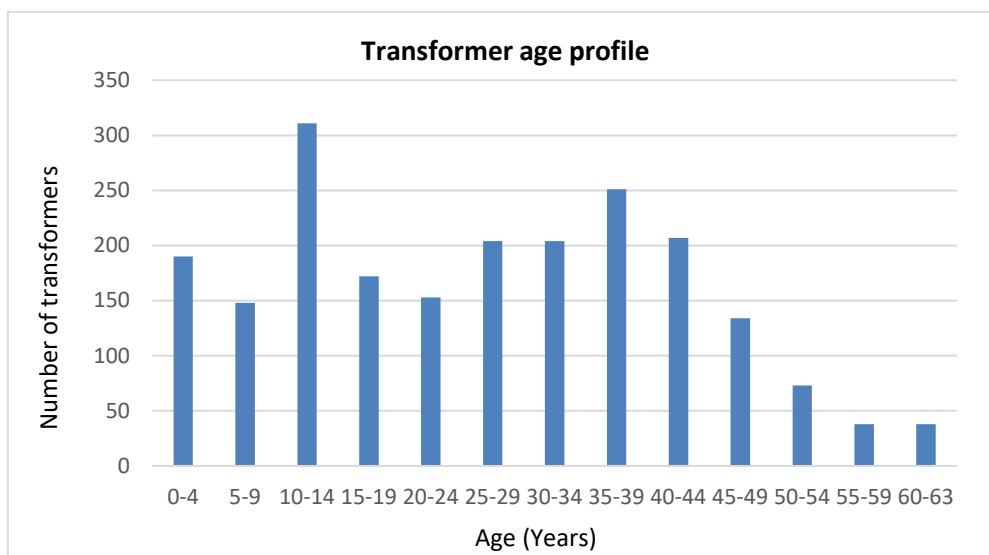
Figure 5 Transformer age profile (as at Sep. 2022)

* There are an additional 61 transformers with unknown ages.
