# Asset Management Plan

## Overhead Line Support Structures – Distribution

Record Number: R2355521

Date: October 2022

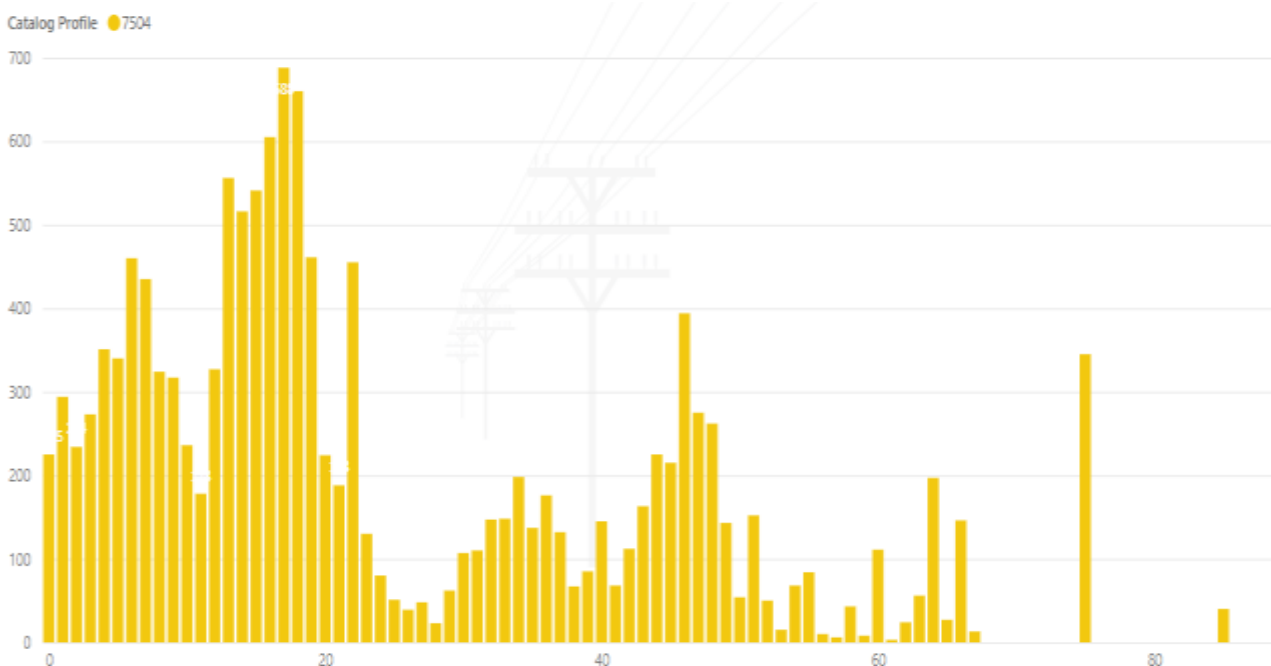
**Figure 3 Steel poles by installed date age profile and locations**

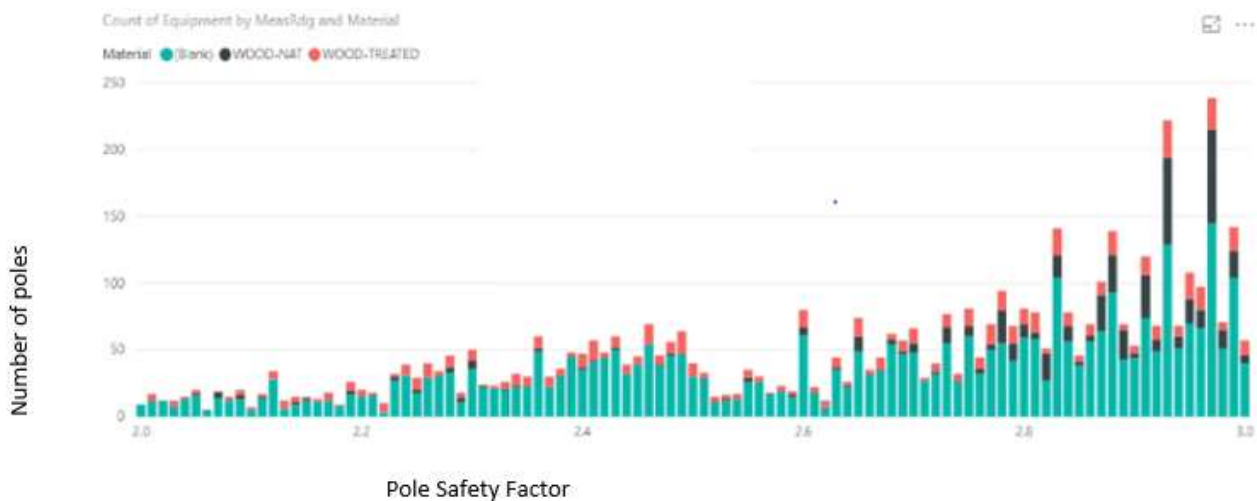
A life cycle history review of 4,000 poles showed that wood poles typically stay at a high level Safety Factor for many years, then they can reach condemned Safety Factor for staking or replacement in only two regular inspection cycles (10 years). This supports the need to manage Intermediate Safety Factor poles via a shortened inspection cycle (currently 2.5 years) when the Safety Factor drops below 3.0.

**Figure 4 Number of Poles with a Safety Factor of less than 3.0**

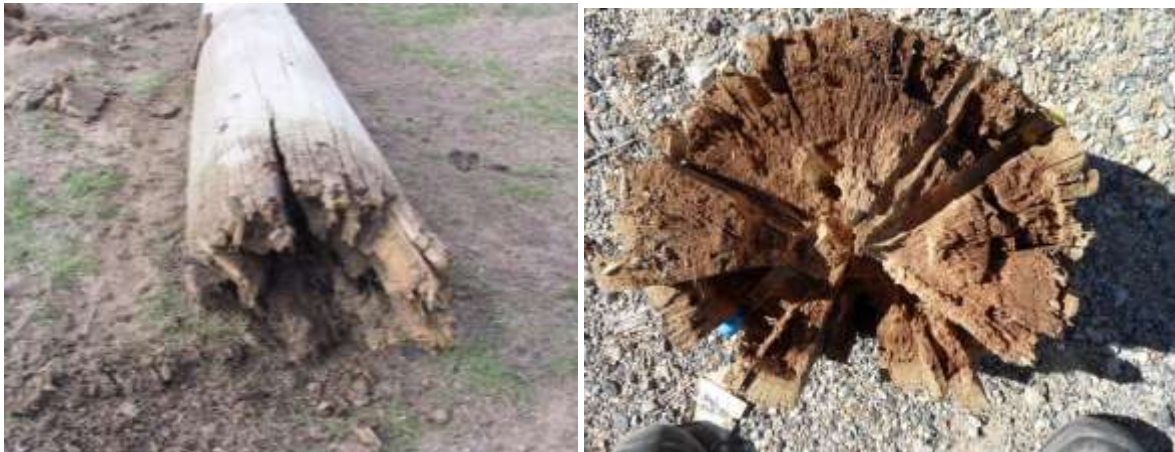
**Figure 5 Wood poles that has failed in service from rot**

Wood rot as undetected soft rot is the cause of over 50 per cent of unassisted pole failures and a contributor cause in the rest from mechanical splits. 54 per cent of the poles condemned per annum are for detected wood rot. Undetected wood rot is a significant factor in assisted pole failures in extreme events like storms, along with tree impact. Figure 5 shows unassisted pole failures from undetected carrot rot.

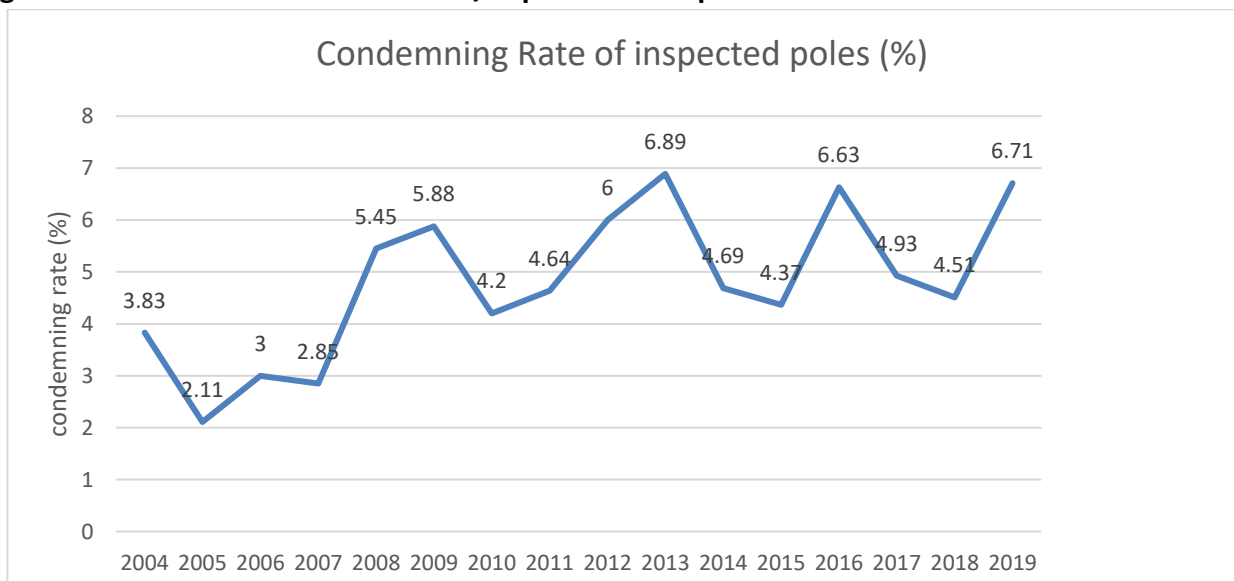
**Figure 6 Actual rate of condemned/impaired wood poles**

The longer term trend of the annual pole condemning rate for the number of poles inspected is increasing over time as shown in Figure 6 below. This is in part due to the pole fleet aging and the trend is forecast to peak in 2027-28 before reducing.

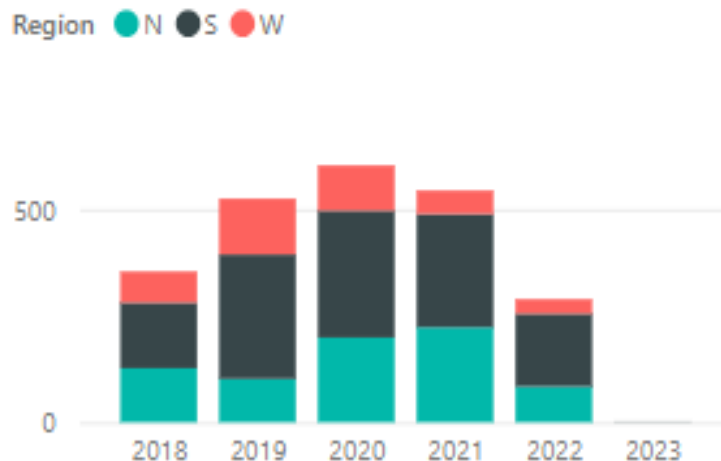
**Figure 7 Poles leaning more than 6° (4 pole top diameters) by region and year**

Pole failure history indicates pole failures are more likely to occur in extreme winds, especially in the case of excess leaning poles with water saturated soil profiles. In AS7000:2016 distribution wood poles can be designed with partial pole footing failure by design in sag clearance allowances, as a cascade failure containment feature in the overhead line tension section line supported. A leaning pole measured at more than 6 degrees from vertical is a reportable defect. Figure 7 shows leaning pole defect volumes.

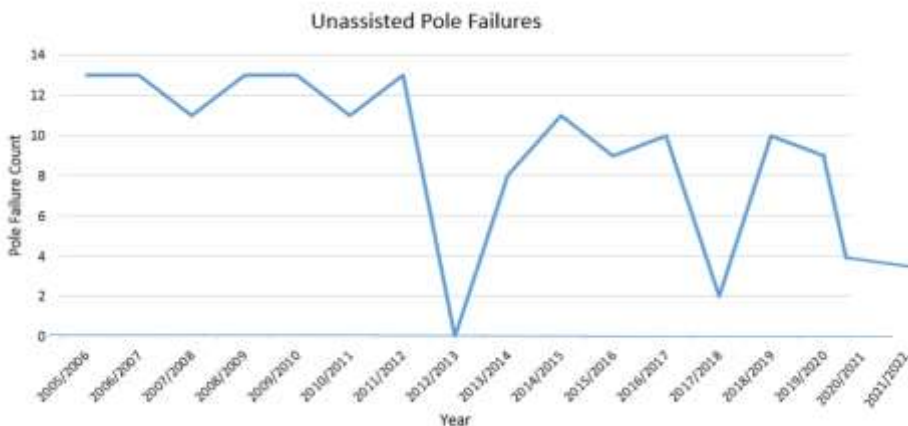
**Figure 9 TasNetworks owned unassisted pole failures trend**
