# Asset Management Plan

## Pole Mounted Transformers

Record Number: R2286977

Date: October 2022

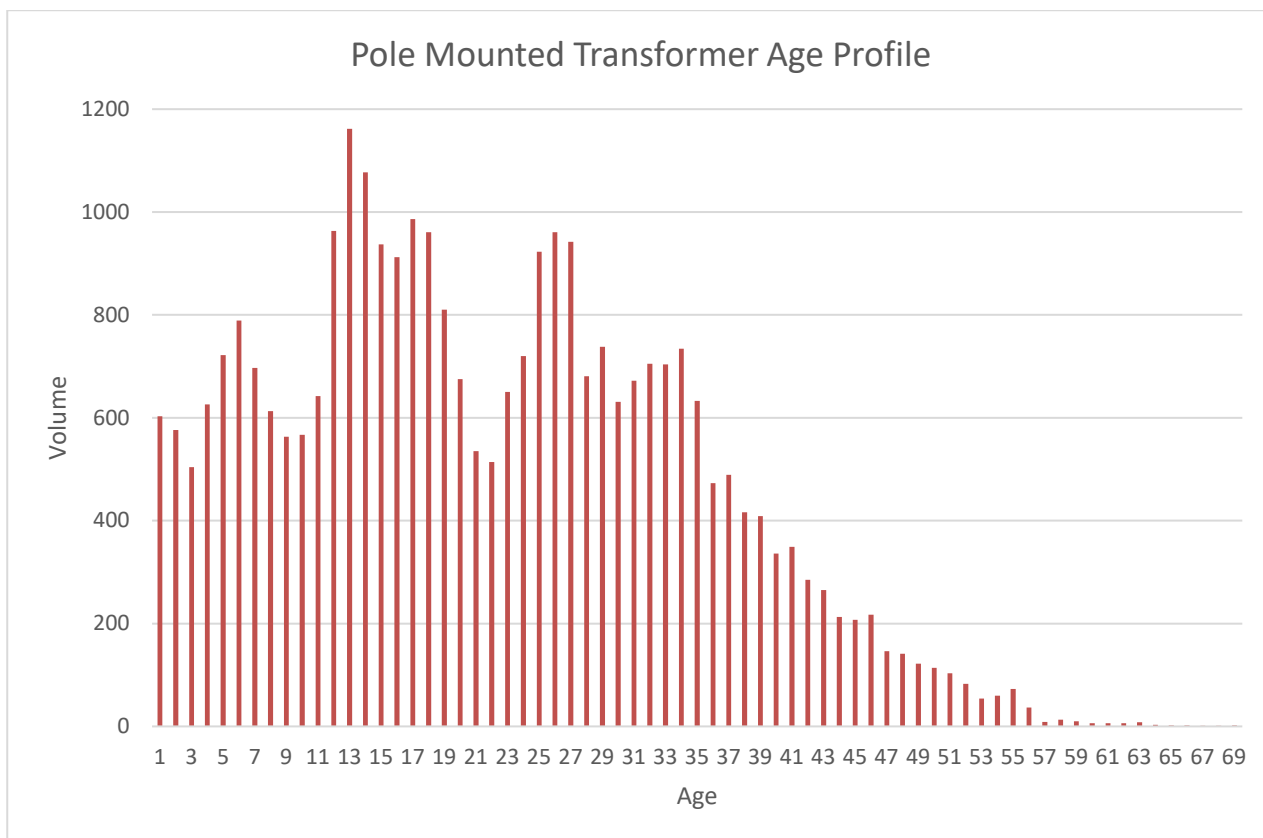
The average age of TasNetworks’ pole mounted transformer population is 35 years. The age profile of pole mounted transformers is shown in figure 2. The AER benchmark for mean economic life of transformers is 40 years.

Figure 2: Transformer age profile

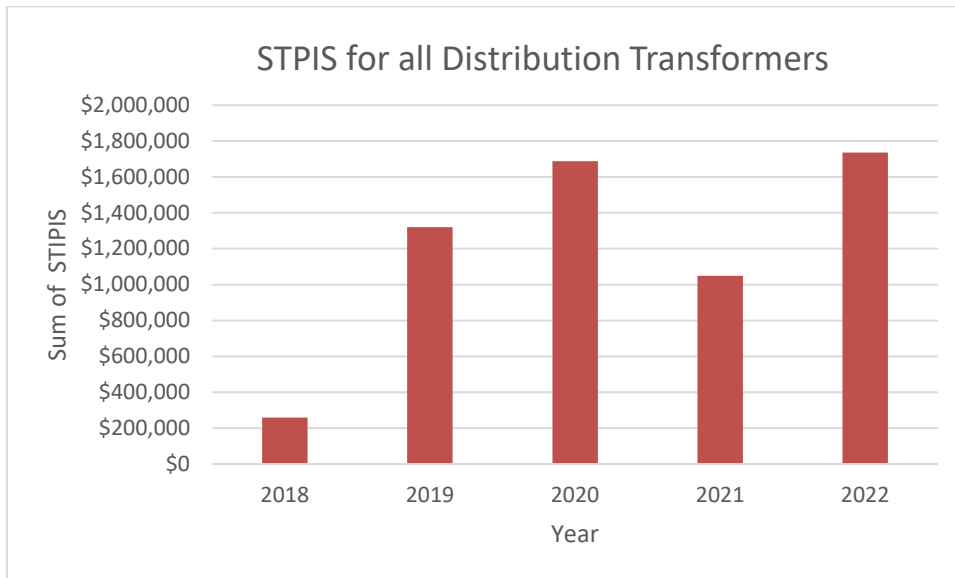
Figure 3 show the historical sum of STIPIS resulting from distribution transformer outages. Note this is only broken down to high level, so total includes pole mounted and ground mounted transformers combined.

**Figure 3: STPIS for all distribution transformers**

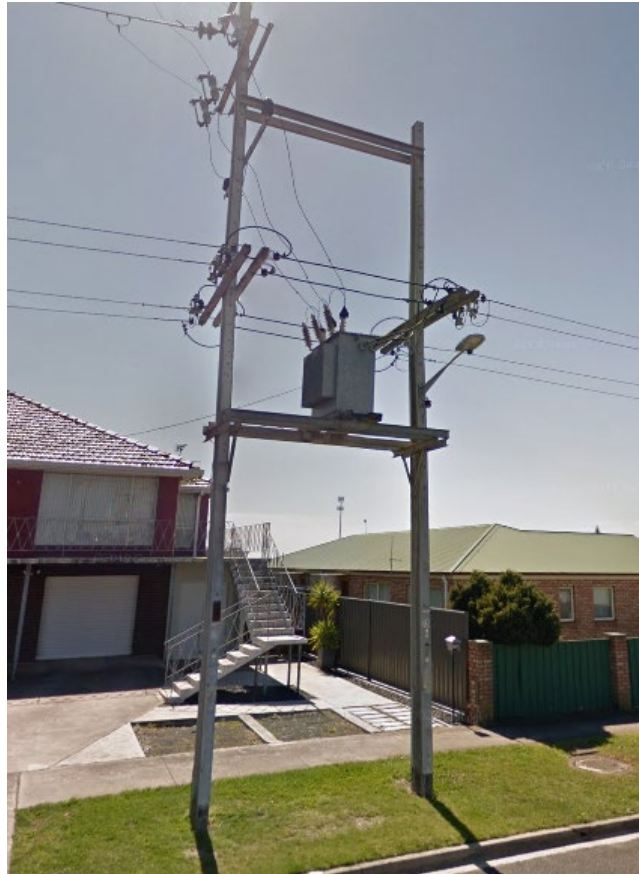
Figure 5 shows an example of a transformer H-structure in an urban area.

**Figure 5: Transformer H-structure**

The structural failure of an H-structure has the potential to cause serious injury but the probability of occurrence is considered unlikely. H-structures are generally replaced when one of the supporting poles is condemned (as part of the normal pole inspection program). Sites are prioritised based on condition (identified through asset inspections) and locations for public safety issues. The H-structures themselves are managed as structures in the structures asset portfolio, when required the transformer will be replaced

under the Replace OH Transformer program RETXL. H-structures are no longer installed, the replacement solution is a single pole substation or in some instances the installation of a ground mounted substation if the load is large.

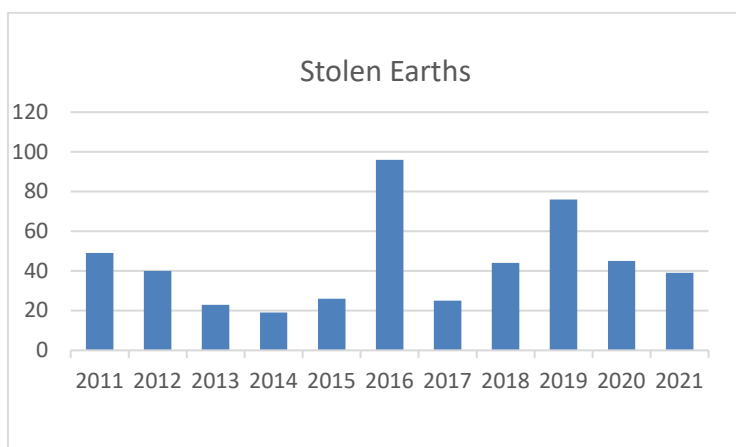
Copper earthing conductor is a target for theft as the salvage prices for copper are significant. There have been instances in the past where the copper conductor associated with the pole earthing system has been stolen from various locations. From the 2009/2010 financial year onwards there has been a significant increase in the amount of copper earth thefts. As a result, standard practice for TasNetworks is to have the earths covered and stapled to the pole when they are replaced at sites targeted by copper thieves. Figure 7 below shows TasNetworks records of reported stolen earths.

**Figure 6: Volume of stolen earths**
