# Asset Management Plan

## Transmission Line Insulator Assemblies

Record Number: R32678

Date: November 2022

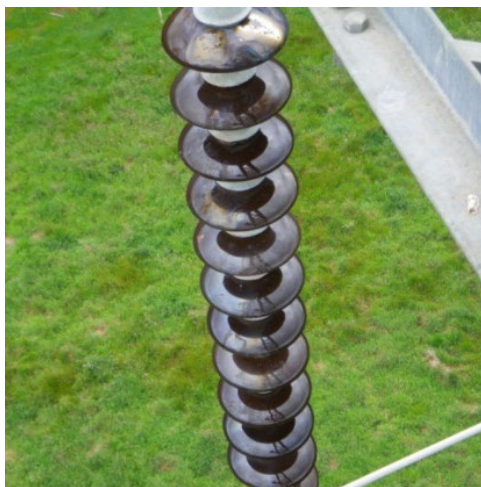
Porcelain insulator assemblies, shown in Figure 2, have been utilised extensively in the past, and upon failure would normally be replaced with a similar porcelain insulator assembly. These insulators are able to withstand attempts at vandalism more effectively than glass insulators. However, porcelain insulators are not preferred for new transmission lines, as failure can manifest itself in a small puncture of the insulator disc that is often visibly undetectable by field personnel, requiring costly condition monitoring.

**Figure 2 220 kV porcelain disc insulator assembly**

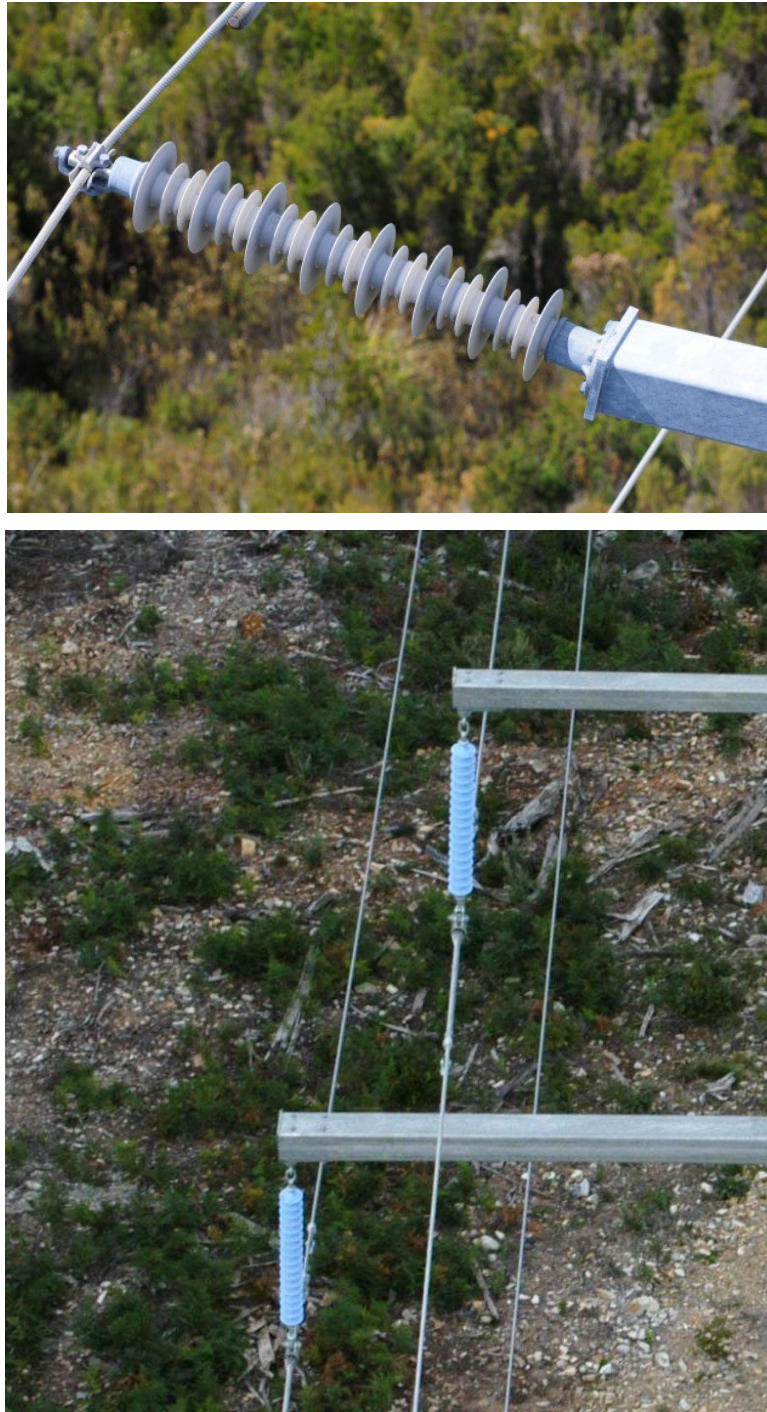
Figure 4 shows typical synthetic post and suspension insulator assemblies.

**Figure 4 Post and long rod synthetic insulators**

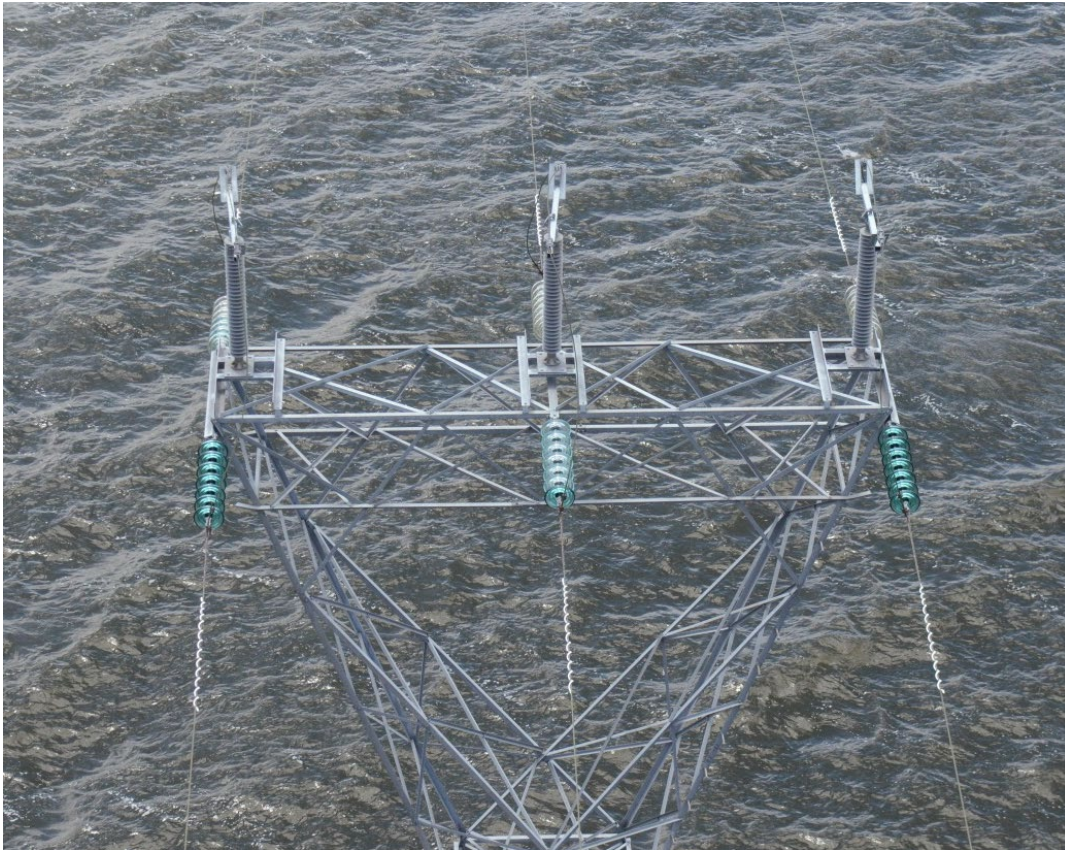
**Figure 5 Porcelain post insulators**

TasNetworks' population of 110 kV and 220 kV porcelain post-type insulators is relatively small, with most being less than 20 years of age. This population is currently being managed with a condition based approach.

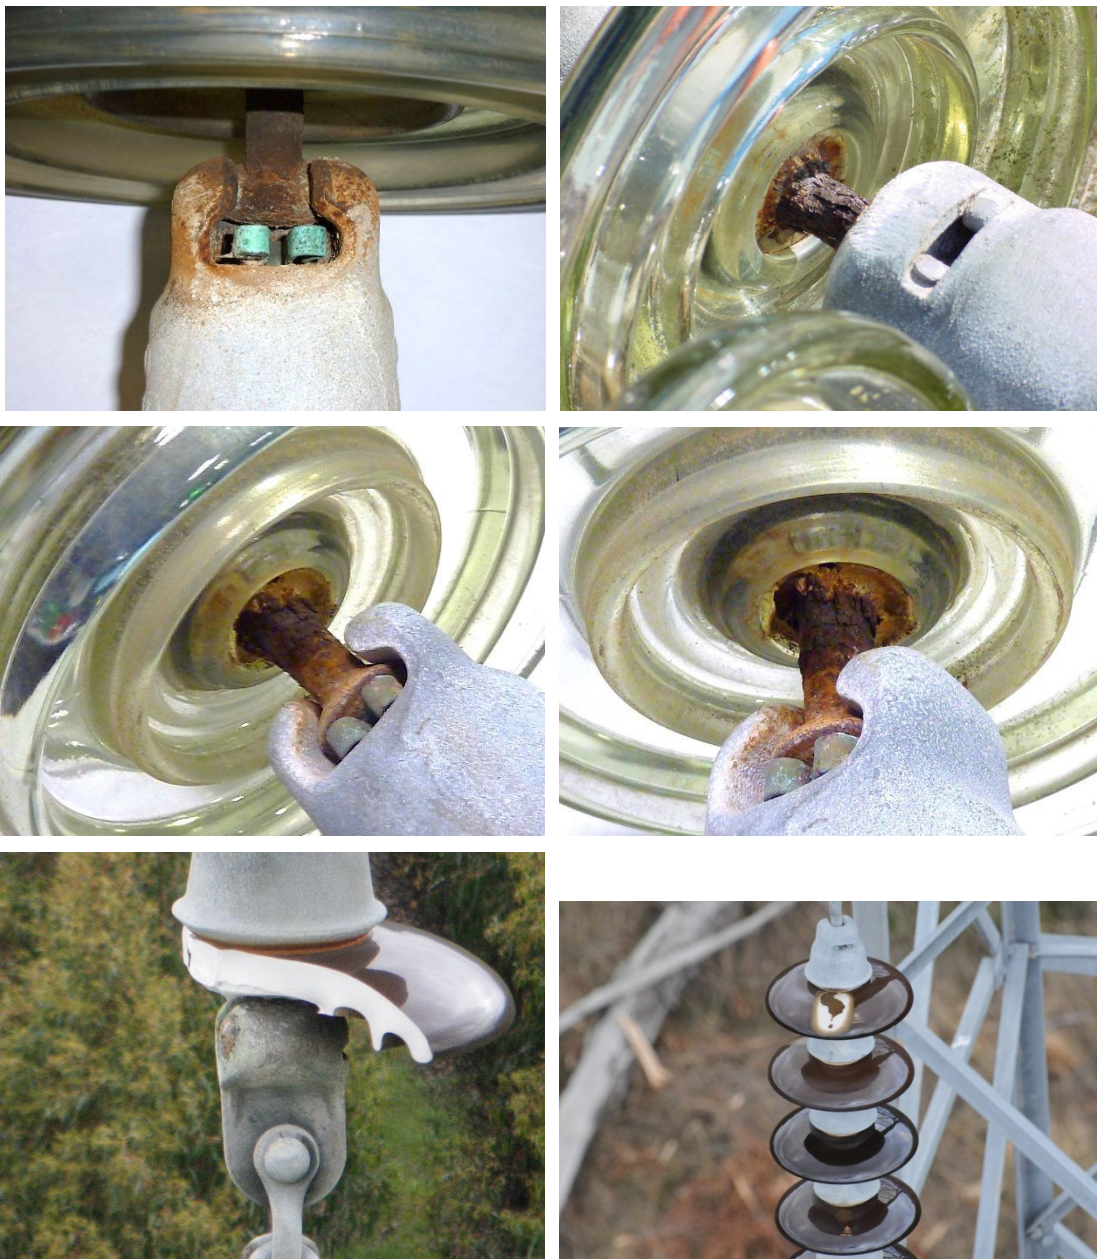
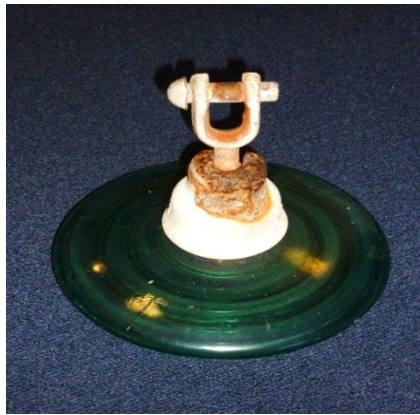
Some photos of typical insulator defects are presented in Figure 6.

**Figure 6 Typical insulator defects**

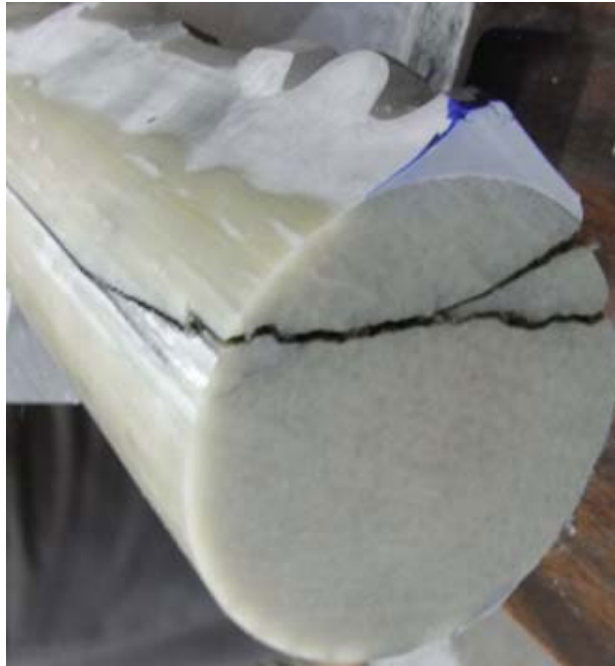
A second failure of the same type of insulator occurred in June 2013 on the same transmission line, and in this instance the insulator was sent back to the manufacturer to facilitate an examination through dissection of the insulator. The manufacturer produced a report from this examination which found that mechanical failure of the insulator had resulted in a crack developing in the fibreglass centre of the insulator and that over time this crack had extended to the point where electrical failure occurred by means of flash-under. The report also concluded that complete mechanical failure would have eventually occurred, similar to that experienced in 2009.

**Figure 7 Cracking of fibreglass rod of insulator on TL446T232 (2013 failure)<sup>2</sup>**

Subsequent to the June 2013 failure, TasNetworks performed visual, infrared and corona scans of the insulators remaining in-service on the Savage River Spur 110 kV transmission line to determine their condition. The condition monitoring results highlighted a level of thermal hot-spots on insulators that were indicative of mechanical and electrical insulation breakdown.
