Asset Management Plan

Transmission Line Support Structures

Record Number: R32681

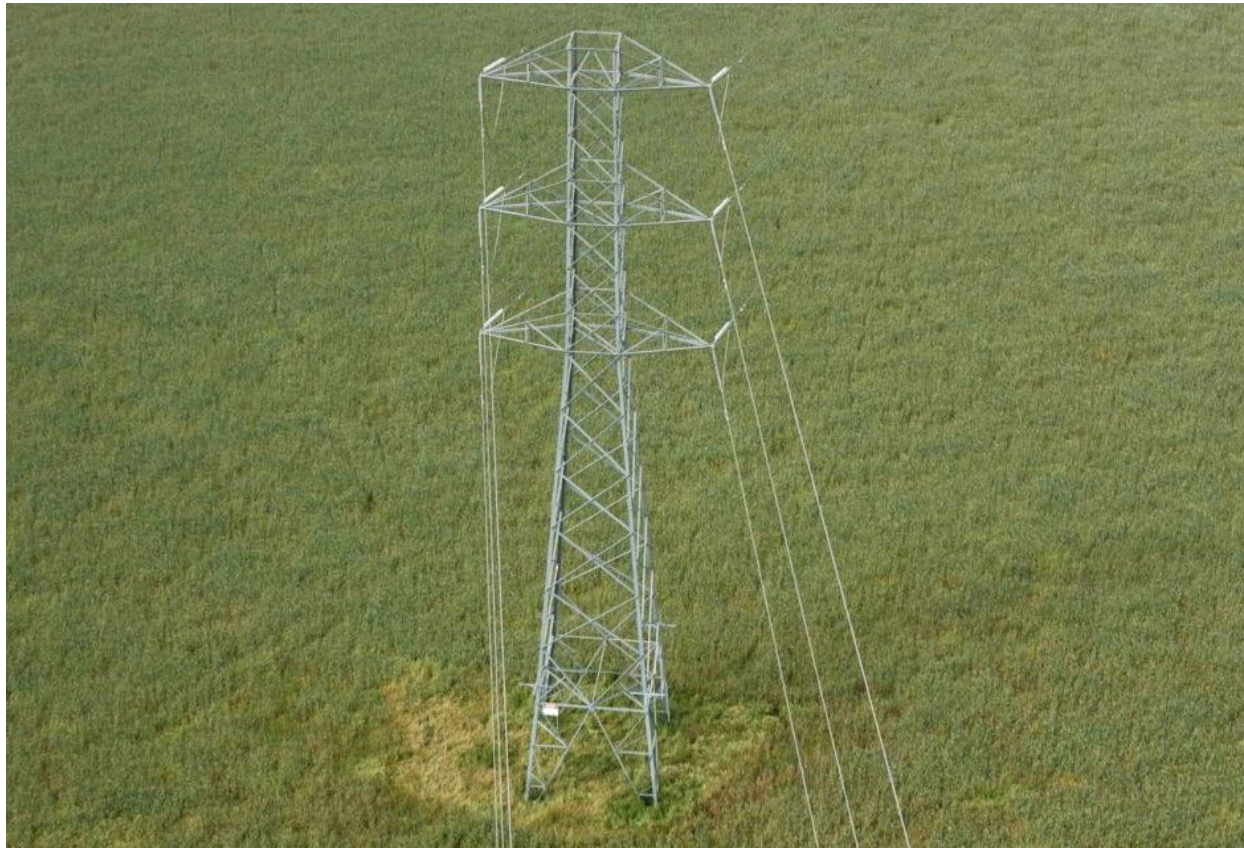
Figure 1: Steel lattice tower (galvanised)

A typical lattice tower, as shown in Figure 1, consists of numerous steel members jointed with plates and bolts for structural strength, with corrosion protection provided primarily via a galvanised layer. The design of the lattice tower can vary significantly, depending on the required structural capacity, the number of circuits required to be supported, and the associated voltage.

The most common failure mode for steel lattice towers is strength reduction due to excessive corrosion and eventual failure of bolts and members. To assist in this all vegetation must also be kept clear of lattice tower base steelwork and inspection regimes to identify loss of the protective galvanised coating.

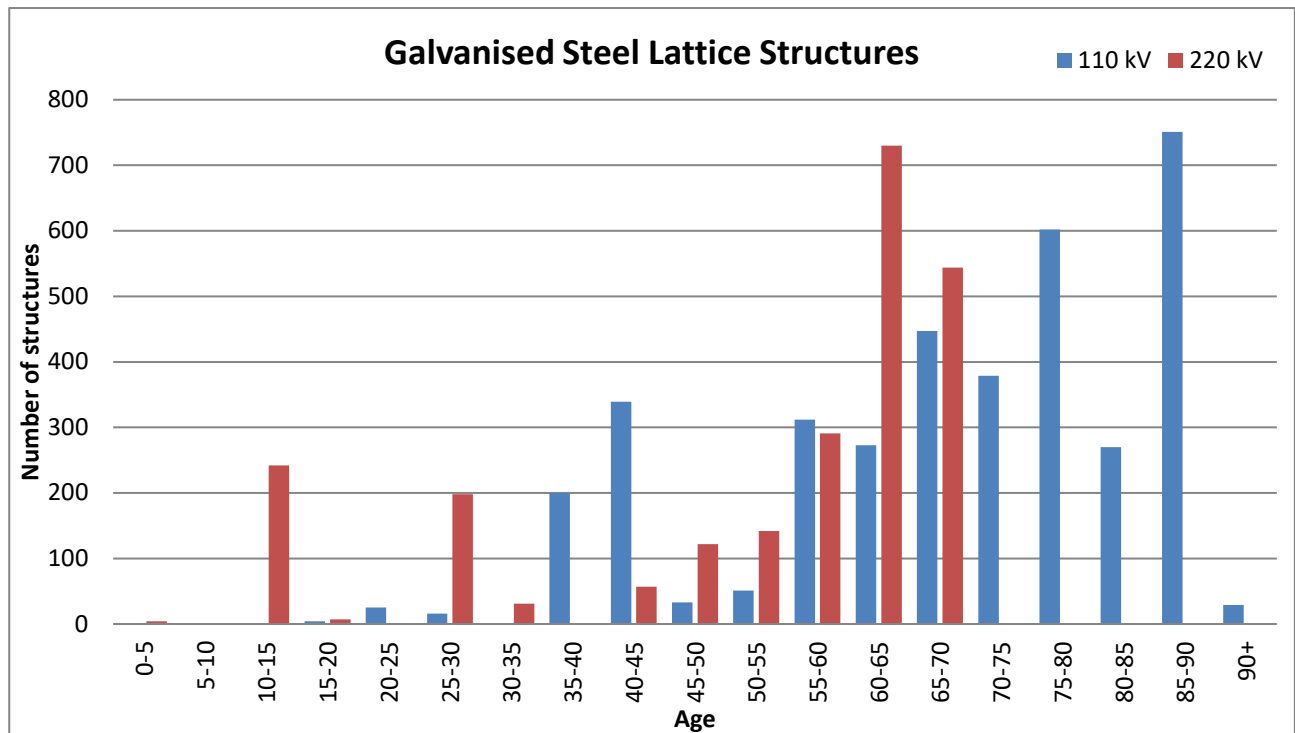
Figure 2: Galvanised steel lattice structures age profile (as at October 2022)

The age profile of TasNetworks steel lattice towers (galvanised) is shown below.

It can be seen that approximately 54 per cent of 110 kV steel lattice (galvanised) support structures are greater than 65 years of age, while approximately 23 per cent of 220 kV support structures will exceed 65 years of age in the next regulatory control period.

From the above chart it can be seen that approximately 82 per cent of the 110 kV steel lattice (galvanised) support structure population is greater than 50 years of age.

The 110 kV network has a large population of support structures currently within the 50-65 year age bracket, which will need appropriate management in the next 15 years to address deterioration of these structures due to age and the associated risk.

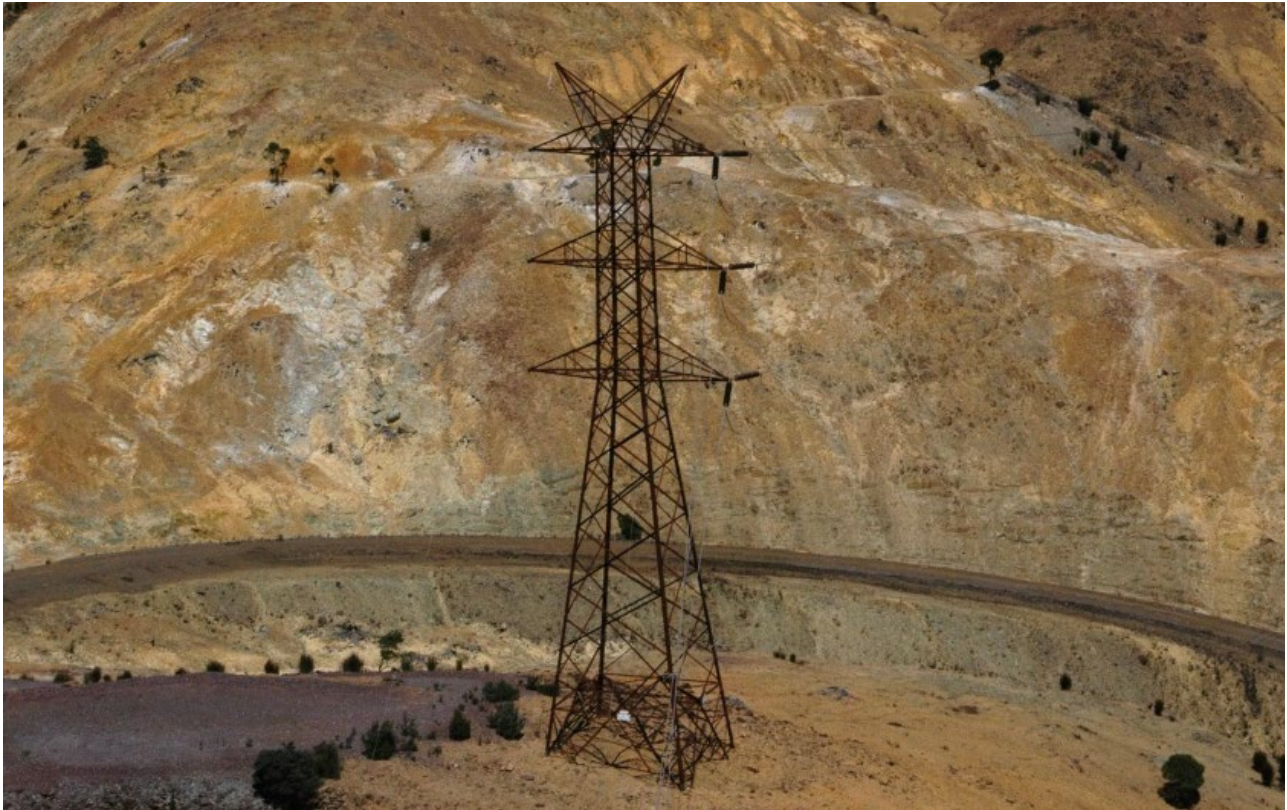
Figure 3: Steel lattice tower (weather resistant steel)

Weather resistant steel (WRS) Lattice towers, as shown in Figure 3, are similar to galvanised lattice towers in their structural design. The main difference being, the use of steel designed to corrode at the air/steel interface, providing a protective layer of ferrous oxide over the underlying steel. This ferrous oxide layer gives the steel a reddish brown appearance.

The most common mode of failure on WRS structures is caused by reduction of strength due to excessive corrosion and eventual failure of bolts and members. All base steelwork of the structure must also be kept clear of vegetation.

The use of dissimilar materials is a risk for WRS structures. Straps for signage, galvanised washers and anti-climbing barrier materials require careful consideration as their relationship to WRS in the galvanic table must be close to avoid high electrolytic potential differences which drive corrosive currents.

Recently some systemic installation issues have been identified with WRS structures. It appears that a combination of factors, is leading to the degradation of these structures. Not developing the required protective patina prior to installation and an insufficient wet/dry cycle is causing joint pack-out on some structures and significant metal loss on members.

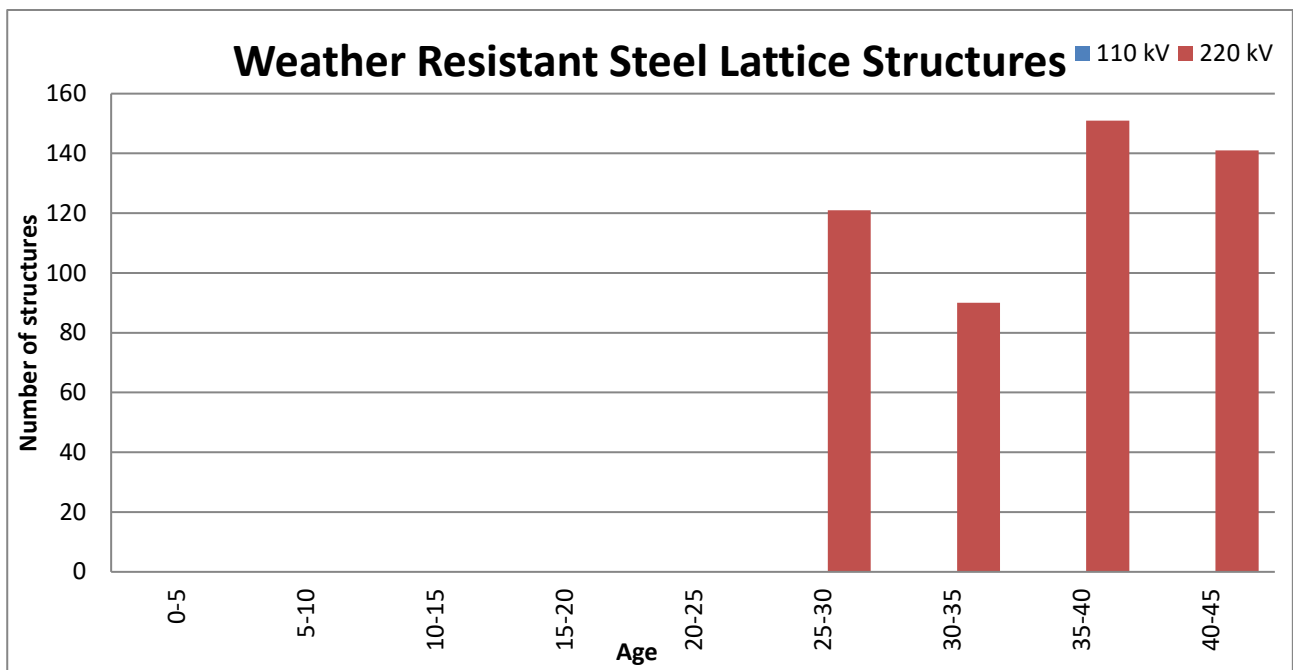
Figure 4: Steel lattice towers (weather resistant steel) age profile (as at October 2022)

The age profile of TasNetworks WRS structures is shown below. WRS structures were installed on 220 kV transmission lines between 1976 and 1994.

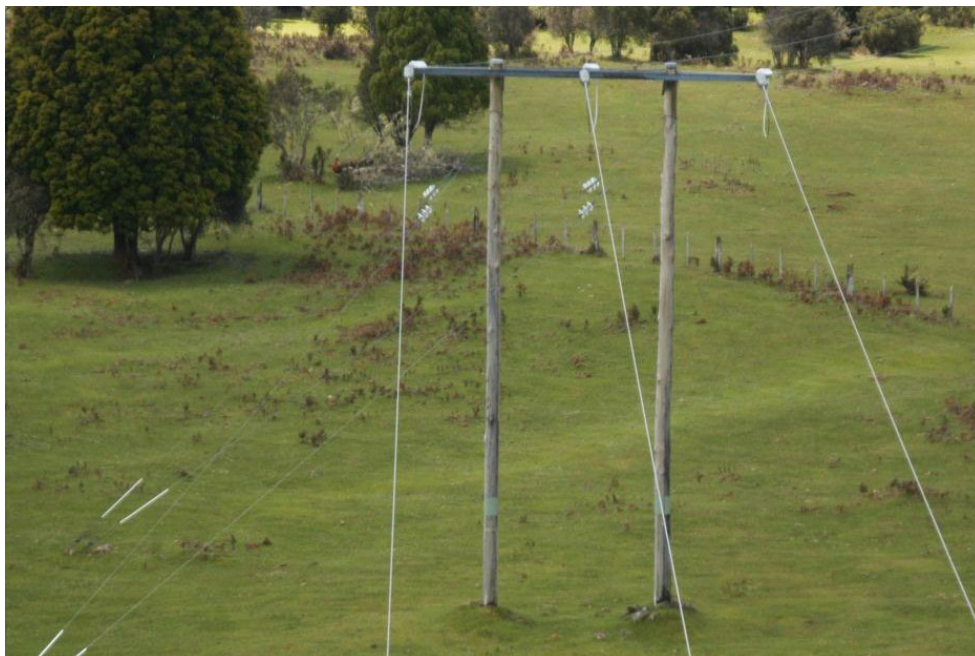
Figure 5: Wood pole structures

Wood pole structures are used on a small number of transmission lines, and have generally been unitised where either a shorter asset life or lower level of reliability can be tolerated. A typical wood pole structure is shown in Figure 5.

The most common failure mode for wood poles is structural failure due to wood rot, particularly below ground where the wood is subjected to moisture and bacteria, but also at the interface between the top of the pole and the pole riser (where fitted).

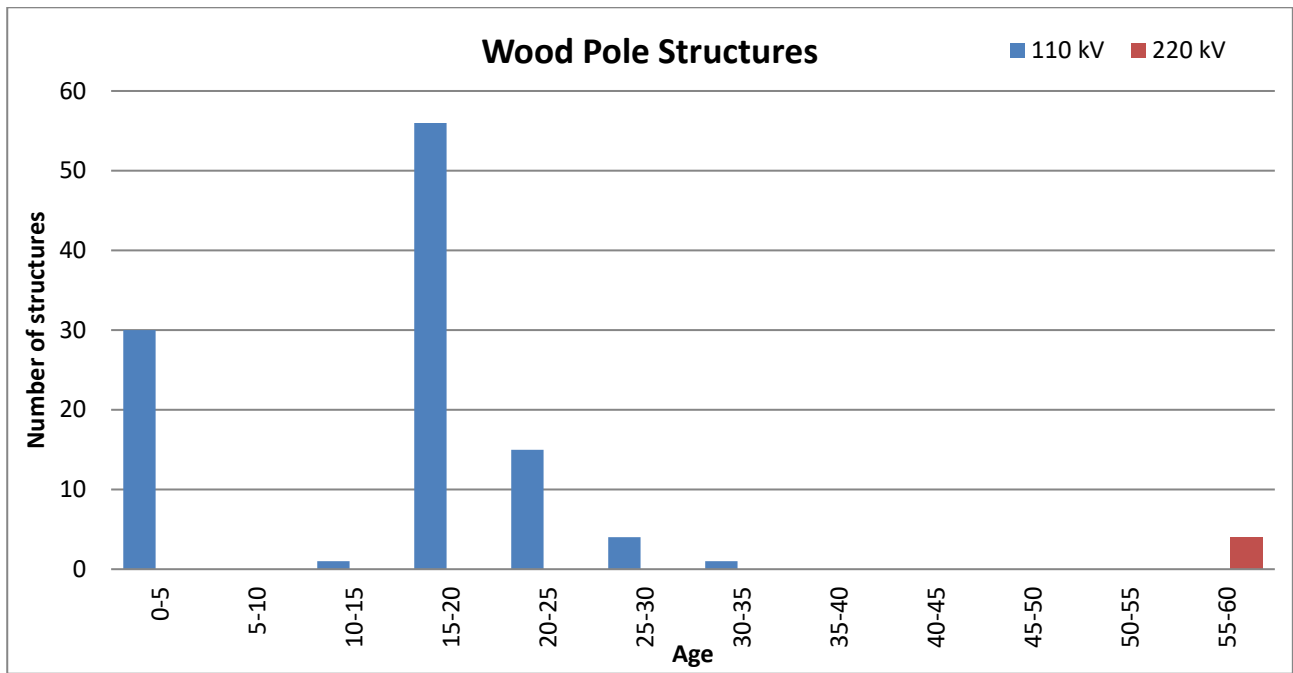
Figure 6: Wood pole structures age profile (as at October 2022)

The age profile of TasNetworks wood pole structures is shown below.

It is generally accepted that most wood poles will last between 35–45 years before their condition deteriorates and replacement is required.

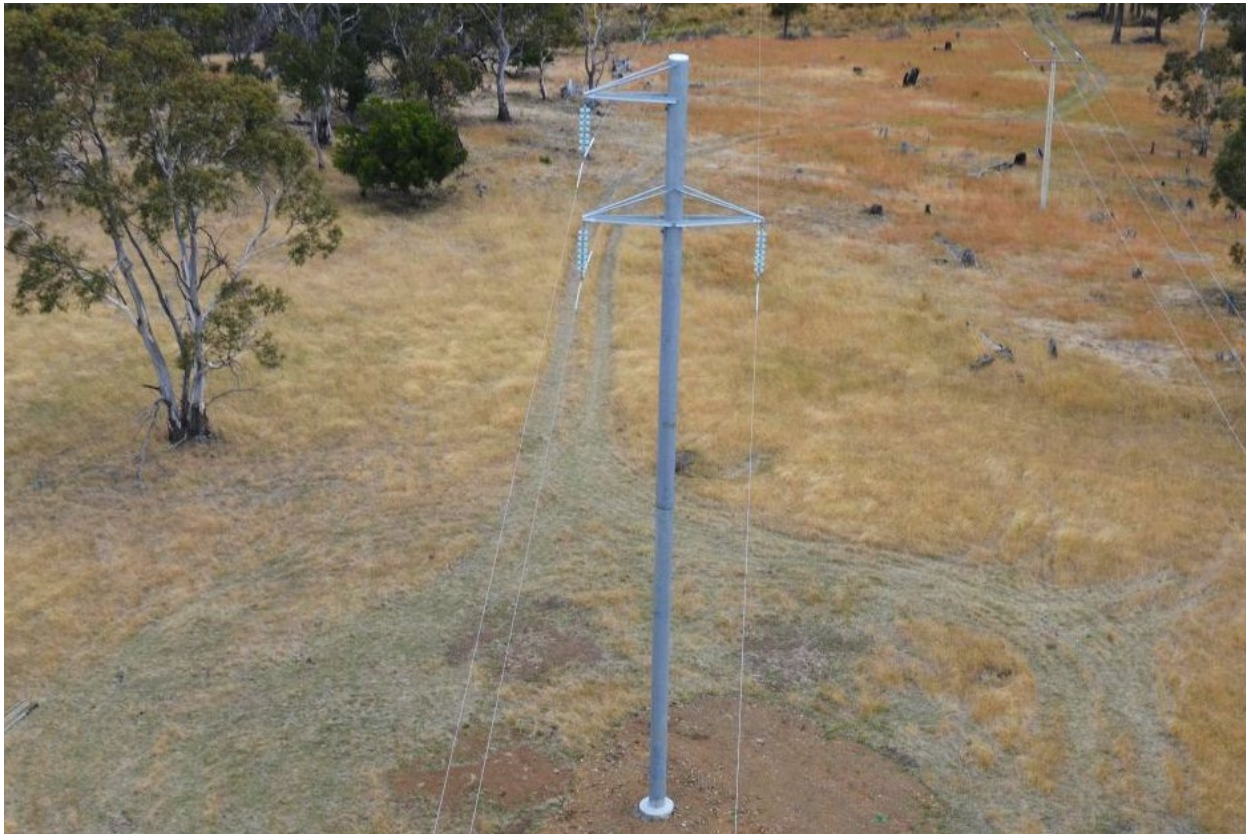
Figure 7: Steel pole structure

Steel pole structures are usually constructed from a rolled or a bent steel plate with sections joined by overlapping or bolted connections, with corrosion protection provided by a galvanised layer. TasNetworks’ preferred option is the use of steel lattice structures and steel poles on new transmission lines.

Typically these structures are a single pole, as shown in Figure 7, however in high load areas an H pole arrangement utilising two steel poles maybe required.

The most common failure mode for steel poles is structural failure due to corrosion, particularly below ground where water can collect in the pole base. All vegetation must also be kept clear of steel pole bases.

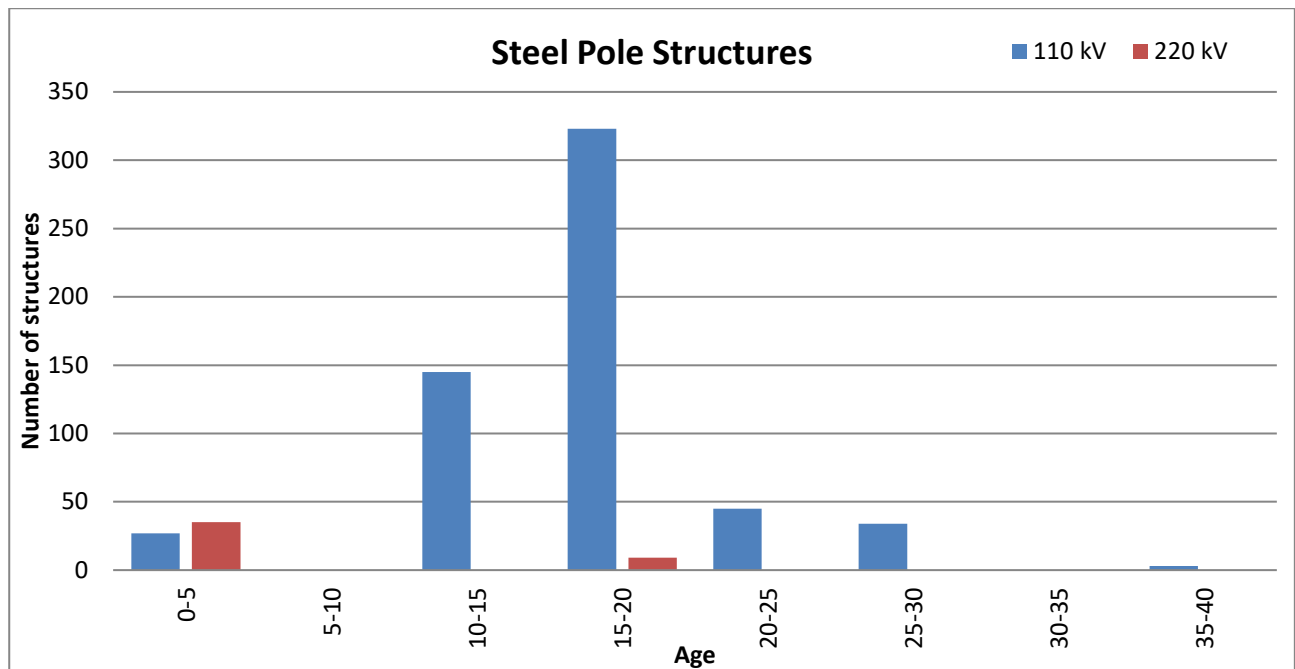
Figure 8: Steel pole structures age profile (as at October 2022)

The age profile of TasNetworks steel pole structures is shown below. It can be seen that TasNetworks steel pole population is still relatively young.

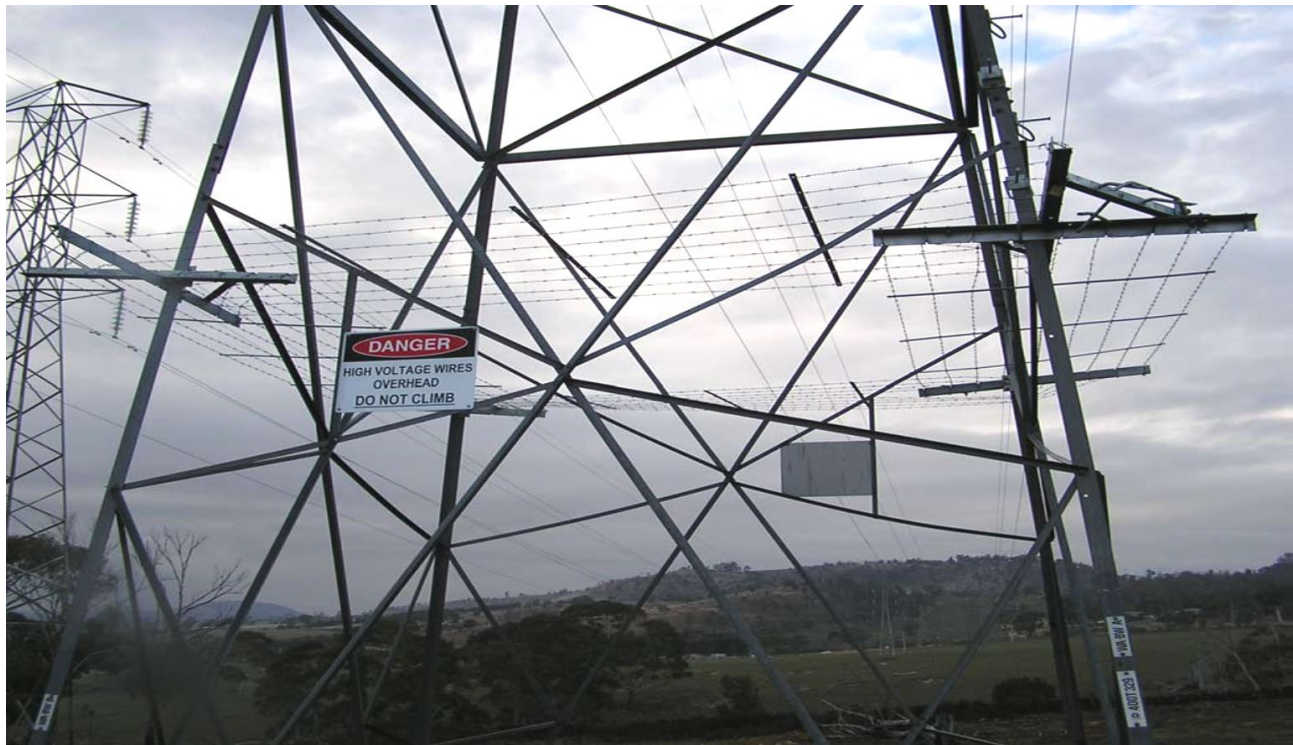
Figure 9: Climbing barrier

Where old type barriers exist (no access gate and require a ladder to access the structure), it is TasNetworks policy to replace these barriers with the modern equivalent, but only where the condition of the barrier is sufficiently poor.

The most common failure mode for climbing barriers are strength reduction due to steel corrosion and degradation.

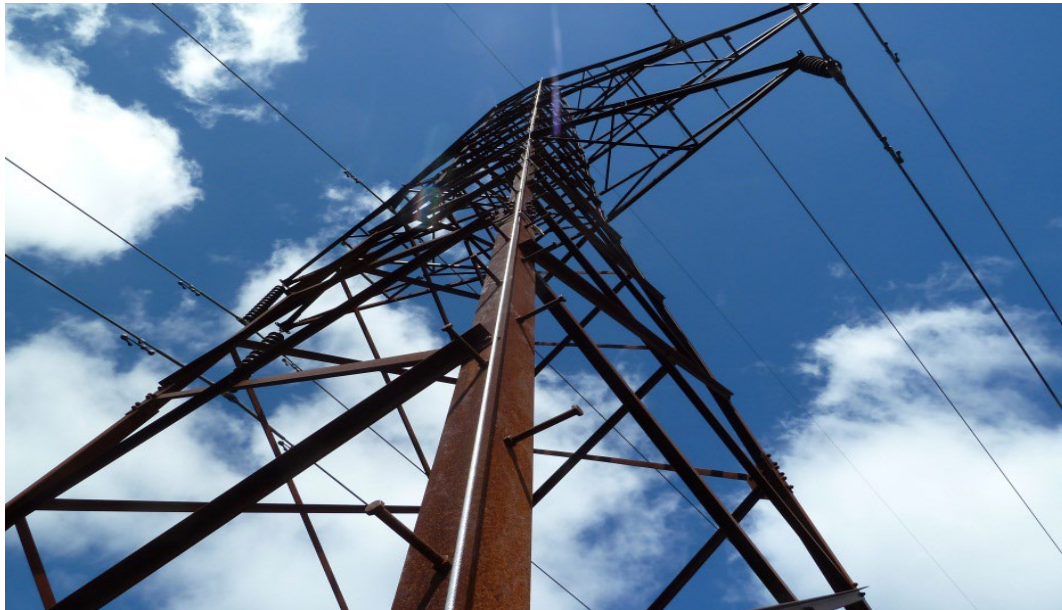
Figure 10: Fall Arrest System

Figure 10 shows a typical Latchways® fall-arrest system fitted to a transmission line support structure.

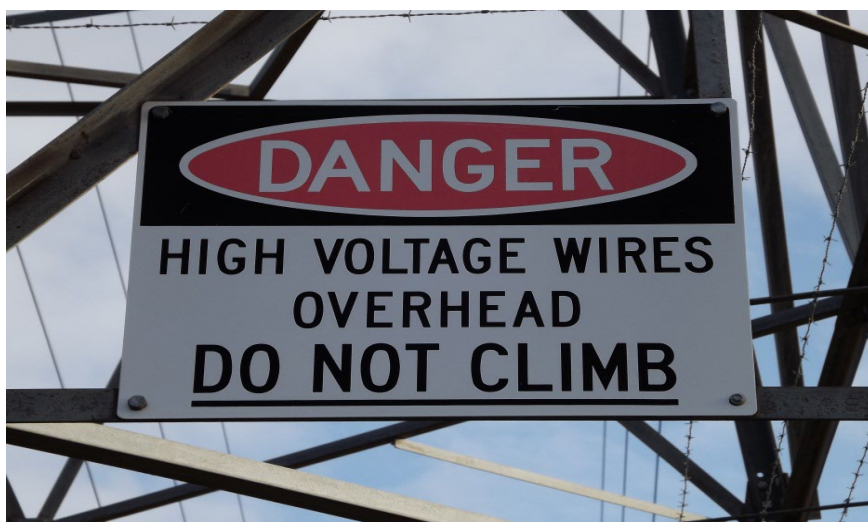
Figure 11: Warning signage

Transmission line warning signs are installed to alert the general public to the dangers of climbing transmission line support structures, and the danger of approaching high voltage conductors.

The most common failure mode for warning signs is fading due to UV exposure, particularly the colour red.

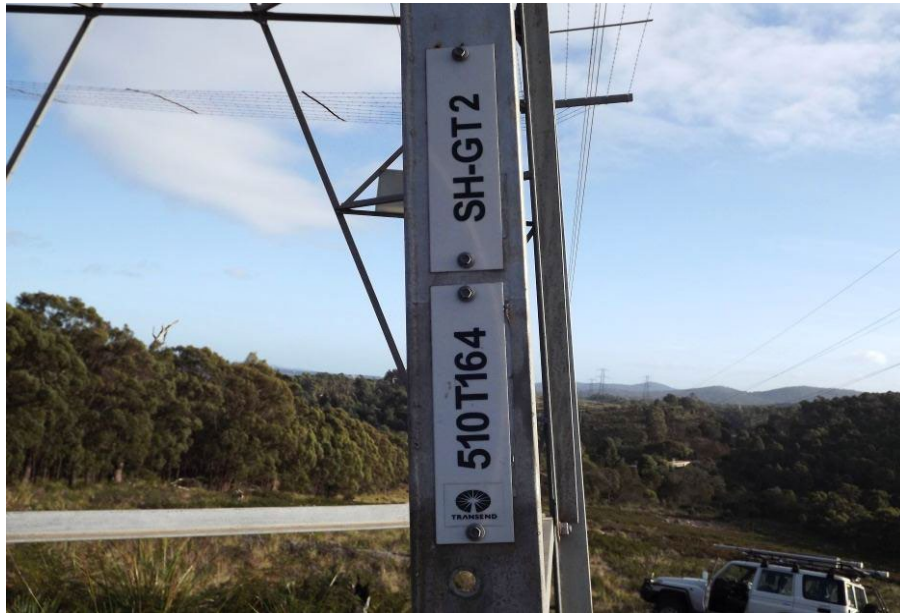
Figure 12: Identification labels

Transmission line identification labels are installed to provide advice to TasNetworks employees and contractors regarding the name of a particular structure, circuit, transmission line or other asset type.

To comply with the Power System Safety Rules transmission line identification labels are required to be fitted to all transmission line structures to allow positive identification of the transmission line, structure number and circuit before work can commence.

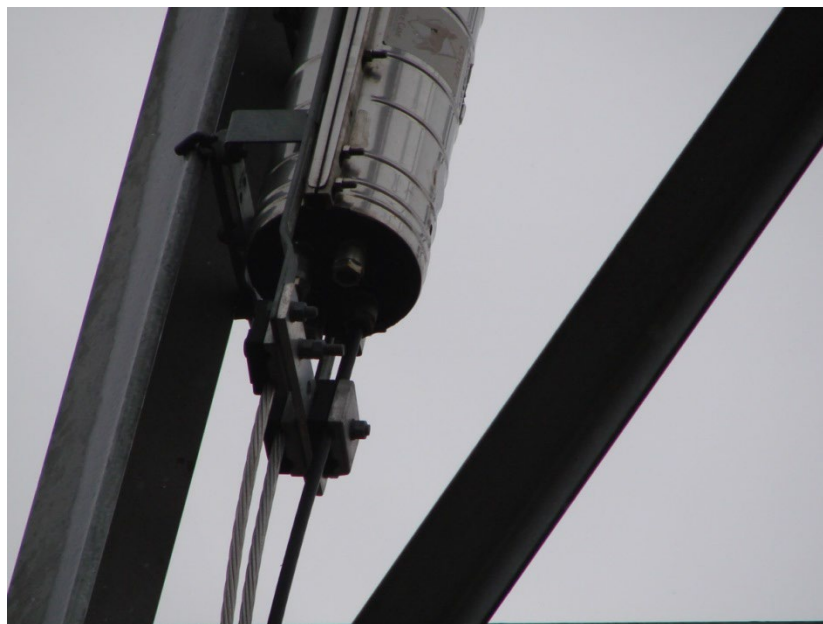
Figure 93: OPGW Splice Pod

OPGW splice pods are installed on transmission lines that have OPGW installed. The splice pods are installed approximately every 10 structures, or at strategic points as required. These pods are installed on structures using brackets and allow for connection to the OPGW fibres.
