Substations Renewal and Maintenance Strategy

AMS Asset Class Strategy

2021/2022

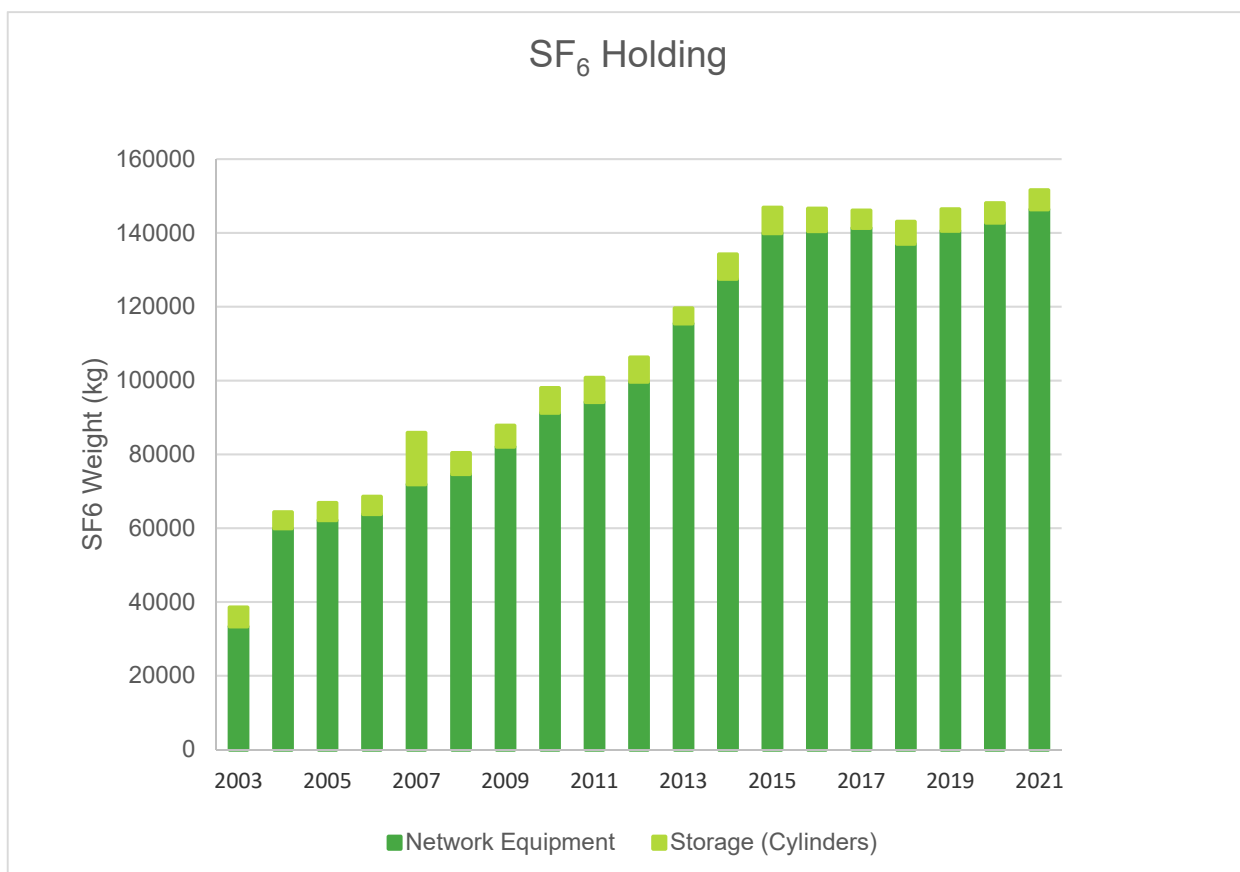
Figure 20: SF6 gas holding in kg

The reports including holding (kg) and losses, typically expressed as % of total holdings. Historical figures reported are included below.

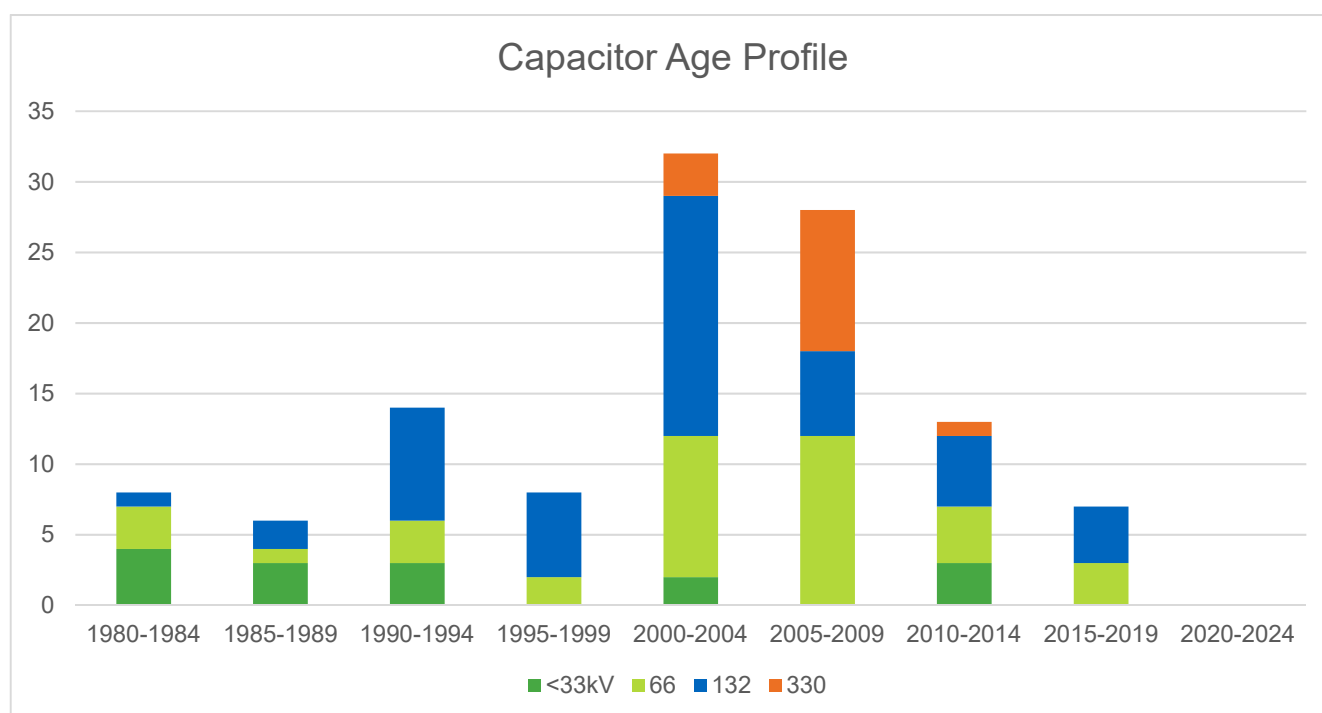
Figure 31: Capacitor Bank – Age profile

The majority of the capacitor units installed are of the internally fused type but some externally fused units are in service.
