# Transmission Line Renewal and Maintenance Strategy

AMS Asset Class Strategy

2021/2022

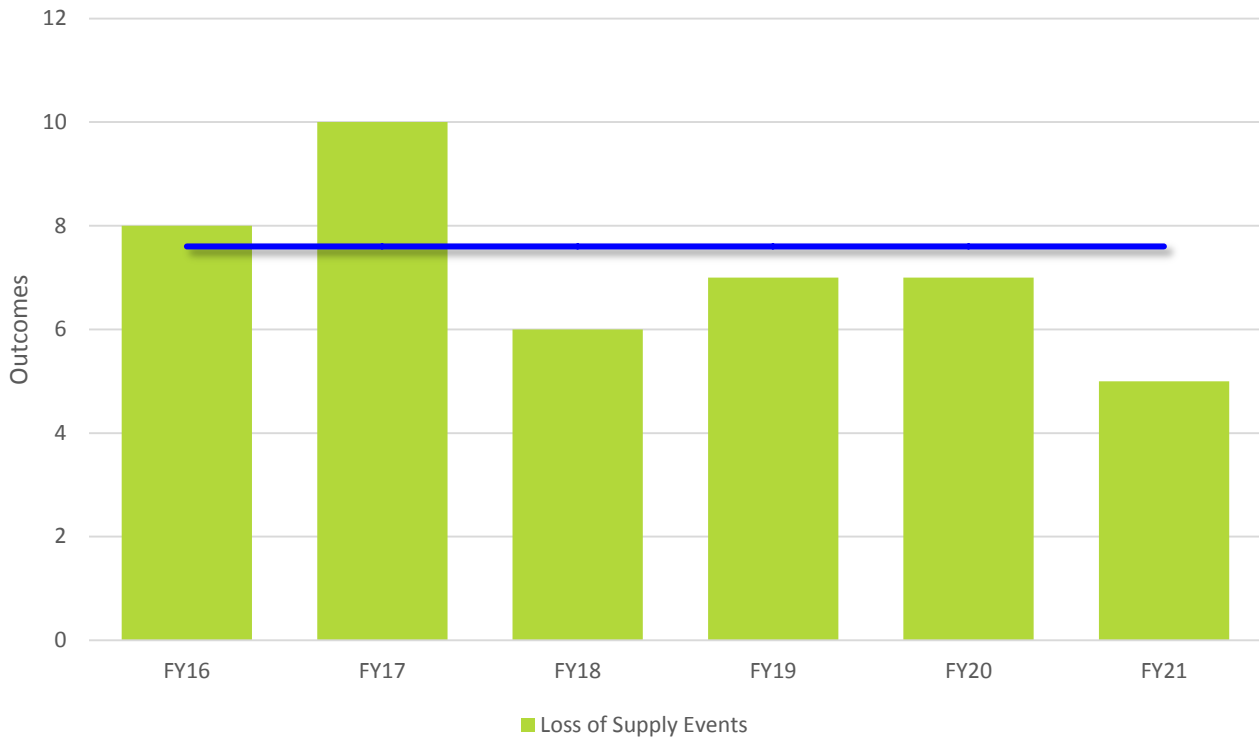
Figure 11 – Energy not supplied events

There were five energy not supplied in FY2021. The KPI for FY2021 was met.

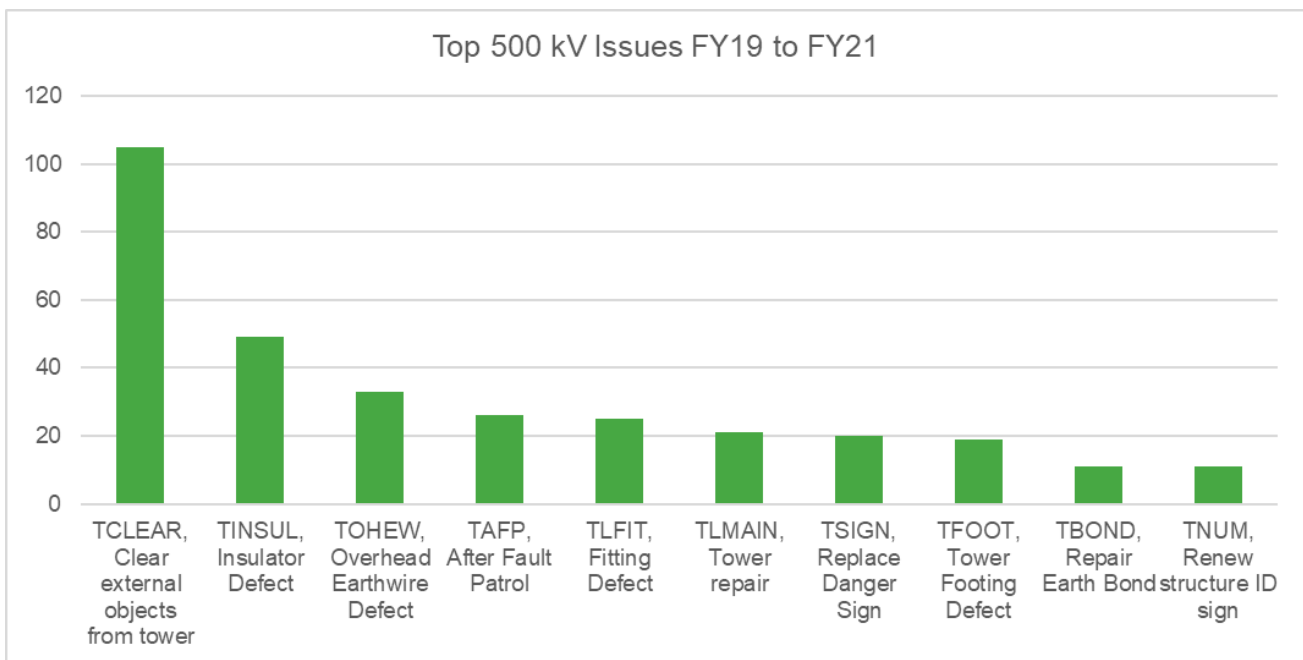
Figure 13 – Issue Quantities by Type (Top 10)

An analysis of issues raised on the 500 kV network is shown in Figure 13. The greatest proportion of defects on 500 kV lines are due to fading structure numbers. These would not lead to a key hazardous event, but can make identifying the assets during an emergency difficult.

Birds' nests on 500 kV towers continue to be an ongoing issue and result in a number of trip and reclose events each year due to suspected 'streamers'. This is particularly problematic on tension towers due to the gap from the V-string and the structure being minimal. The streamers from the nest location is more likely to cause an outage. ROTOMARKAs will be trialled on the earthwire on problematic structures. These are used for aerial markers and bird deterrents. It is hypostasised that the spinning marker will deter the bird from nesting below.

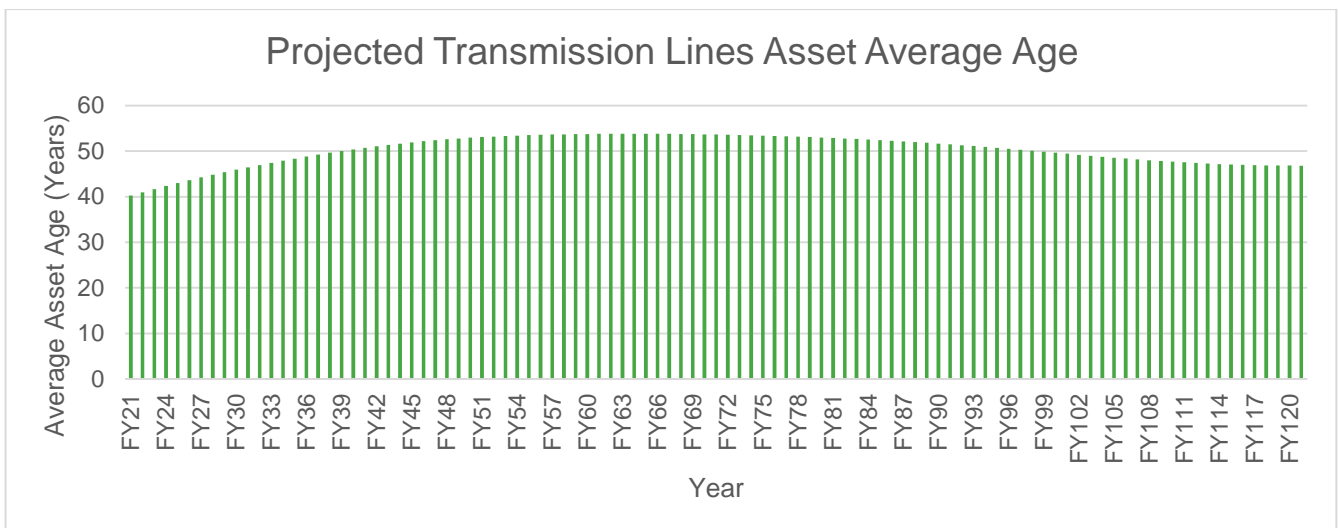
Figure 23: Projected Transmission Line Asset Classes Average Age

It is anticipated that the average age of transmission lines asset will increase at a moderate rate over the next few decades. This is due to continuing investment and advancement in technologies that will maintain the reliability of the aged asset in the future.
