Asset Management Plan Underground Cables

Executive Summary

This Asset Management Plan (AMP) focuses on the management of underground cable and accessories.

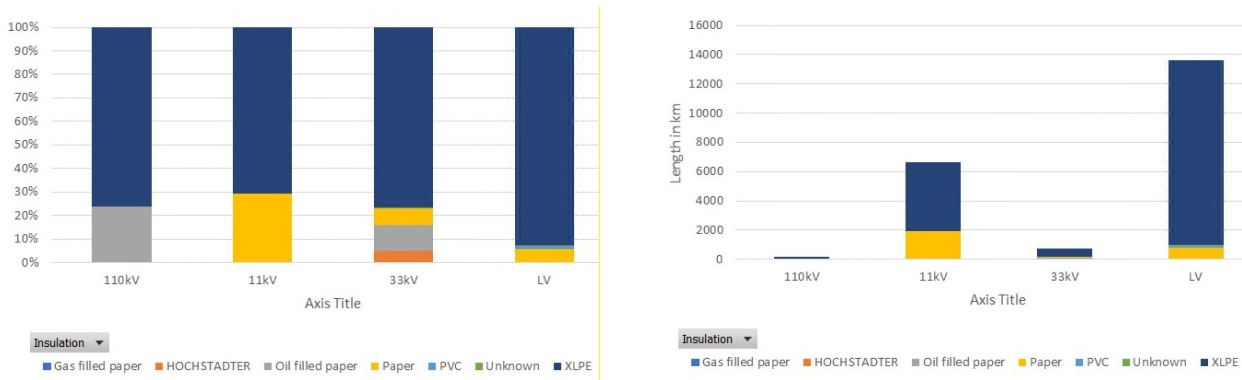
Figure 6: Energex Breakdown Of Cable Type By Voltage Class

A breakdown of known cable types installed on the EQL underground network by voltage class is shown in Figure 6 and Figure 7. Most of the cable type installed across all voltage designations (including LV) uses cross-linked polyethylene (XLPE) as the insulation medium. For Energex, where the cable information is far more extensive, 84% of all underground cables comprises XLPE construction. XLPE construction has significant advantages over legacy cable technologies with regards to cost, maintenance, and environmental risk. Globally, the electricity industry has moved to XLPE as the preferred insulation material for all underground cable systems.
