# Asset Management Plan Services

## Executive Summary

This Asset Management Plan (AMP) covers the class of assets known as Overhead Customer Services (“overhead services”).

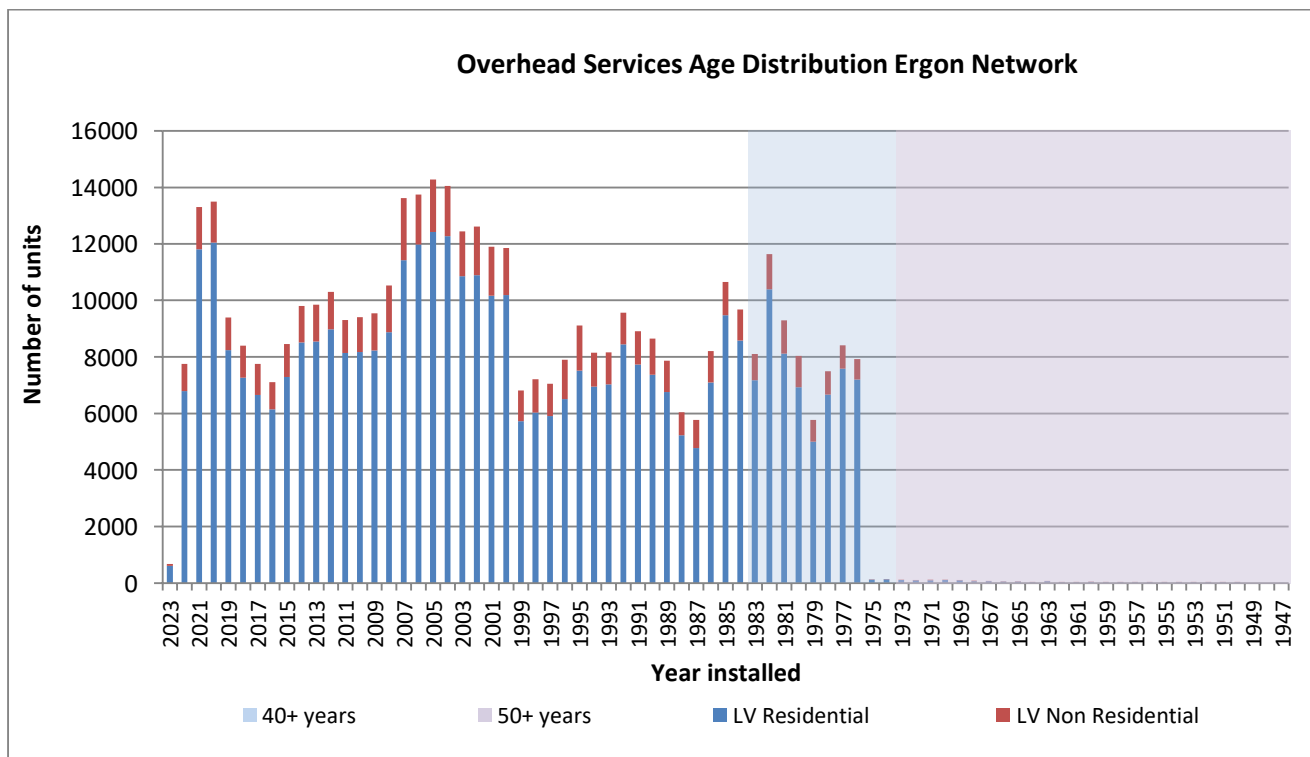
Figure 4: Age Profile Overhead Services – Ergon Energy

The actual age of overhead services has been problematic to establish, as the year of installation for the overhead services was not generally recorded until around 2006. The age data presented herein is consistent with the information reported in the annual Regulatory Information Notices (RINs) and represents the best information currently available. Figure 4 and Figure 5 show the age profile of EQL’s overhead services. While reviewing the following data, it should be assumed that data quality deteriorates with age.

Ergon Energy replacement practices have relied upon visual condition inspection and targeted overhead service line volume replacement programs (reflecting known systemic failures of specific Overhead Service cable types). The effect of this approach is reflected in the relatively consistent age (low standard deviation from the mean) of the Ergon Energy overhead services assets depicted in Figure 4.

As the replacement cycle continues, older overhead services are being replaced with the newer XLPE overhead services. The age profile information in Figure 4 combined with Table 4 suggests that around a quarter of all services in the Ergon Energy are likely to be open wire services; however, this is not the case. In 2012-2015 Ergon Energy implemented a significant replacement program of open wire overhead services with XLPE overhead service cables up to the point of connection. However, there is still a number of open wire overhead services in-situ, particularly in rural locations employing privately owned overhead circuits.

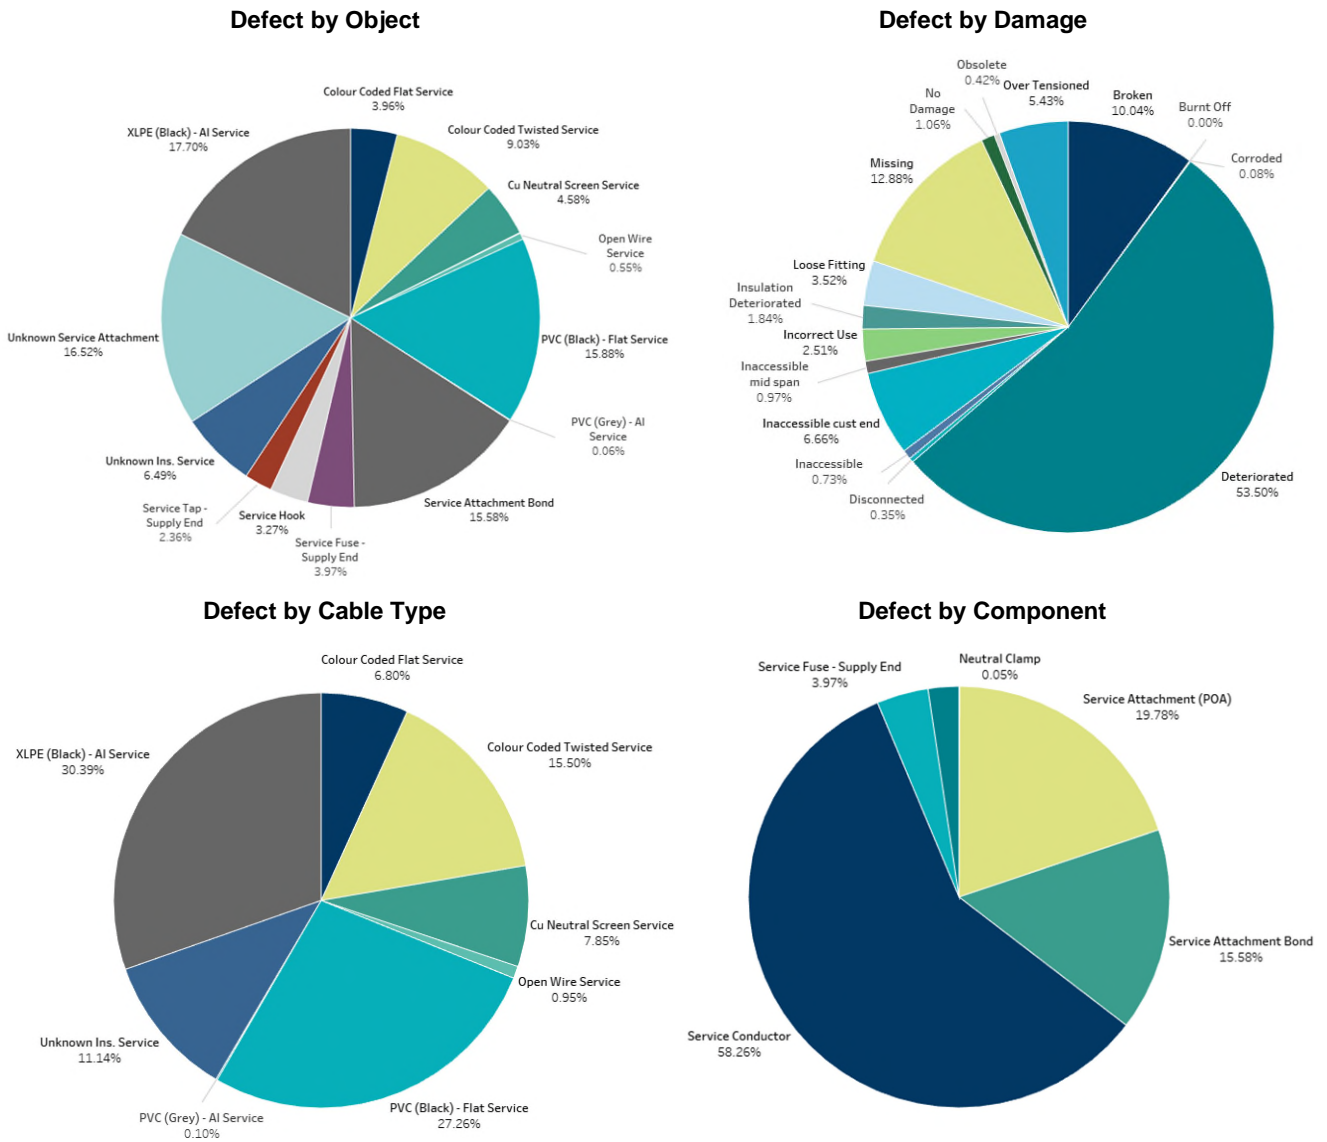
**Figure 9: Defect Repair Focus - Ergon Energy**

Figure 9 below breaks down the major overhead service component items that contributed to these works.

Defects are repaired as corrective maintenance. Faults are typically repaired as forced maintenance.

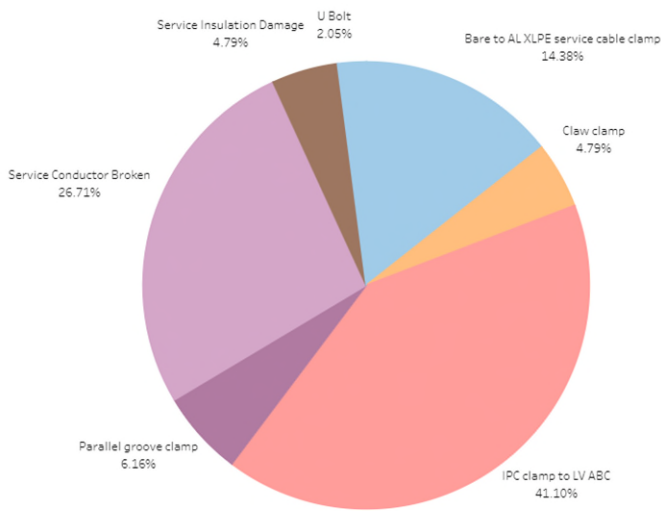
Figure 13: Average (6 Years) Overhead Service Shock Rate – Energen

Figure 13 below shows the breakdown of the overhead service shock rate for the Energex as an average over the last four years and highlights that for Energex, Mains Connection boxes continue to present performance issues. Mains Connection boxes are customer owned but required by regulations to be inspected by EQL. Clamp connections appear to present the most prevalent contributor to shock for mains-services connections. PVC cables, particularly parallel web or twisted multiphase PVC, are the worst performers.

Additionally, Figure 13 highlights the essential reasons for legacy organisation Energex’s asset management approach for services. Connections contribute to more than 50% of public shocks involving Services, divided relatively evenly between the mains connections and the customer point of connection. Replacement of problematic services directly targets the two largest root causes of shocks.

Given XLPE insulated cables are the more modern and current standard in use and that XLPE service cables make up around 70% of the population, the table reflects that both age and technology are influencing asset performance. The lifecycle strategies outlined in Section 9 reflect the different failure rates in the treatment of the different types of cable.
