# 2020-2021 Electric Line Clearance (Vegetation) Management Plan

**Administrator: Hugh Vickers-Willis**  
**Head of Vegetation Management**  
**Document No: CPPAL & UE 2020-2021 ELCMP V1.4**

**June 2020**

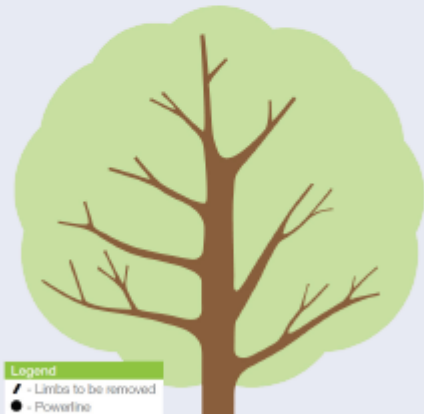
This is a representation of how your tree/s will be cleared when viewed along the line from pole
